# Metropolitan Cathedral of Cochabamba

## Conservation and maintenance plan

*Rocío Gissel Villarroel Villazón*

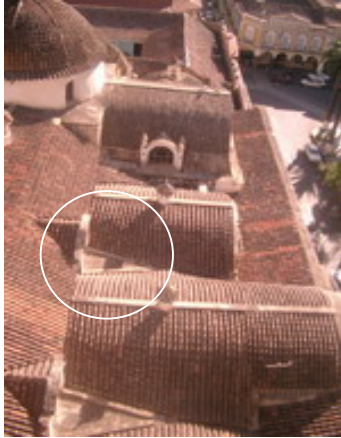
Fig. 8 Roof drainage system

Plane triangle roofs between lateral vaults, (made for water drainage), mortar; and ceramic tiles have been damaged by exposure and lack of maintenance.

The effects outside are fissures, detachment of roof material, and plant growth, all of them producing leaking of water.

Inside the building, humidity, detachment of gypsum plaster and paint, and gradual weakening of arches structure.

Ceramic tiles and mortar have to be removed from the roof. After that select the reusable ones, then put over the vault a waterproof layer, and replace mortar and tiles.

Remove plant growth.

Cleaning and fixing up drainage system.

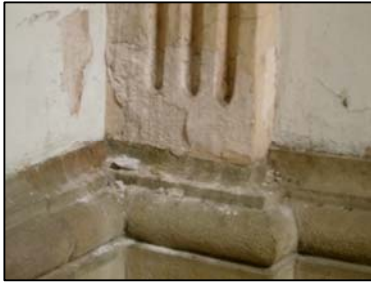
Fig. 9 Dampness and detachment of wall plaster.

Before the last intervention, walls were in the same condition as they are today. Dampness climb over the stone plinth, about 1,40 m. in every wall of the building. Salt white stains appear on the stone.

The last intervention with a concrete floor layer could be the reason of ascendant humidity on walls, also the cement plaster cover over the walls is making the problem even worse.

Detachment of plaster and paint. Weakening of wall structure produced by moisture problems, which may lead to cracking and disintegration of the masonry.

After excavations works and the determining of dampness causes, the solution has to be in terms of attacking the problem not only the consequences. If the cause, is the existence of veins of water under the church soil and the concrete layer, the procedure will be to take of floor tiles and concrete base, after that conduct and drain the water outside the building. But, if the cause is as Konrad Fischer suggest, lack of ventilation,

the procedure will be (as he explained), to desiccate the wall: 1) taking of the stone plinth, the plaster and clean the wall; 2) watering the wall in order to make the salt come out; 3) retire the salt, clean the wall; and repeat the procedure until there is no salt. After that put back the plaster but no cement, only lime plaster and no paint, 4) put back the stone plinth if required. Also is important to replace and fix old gutters.

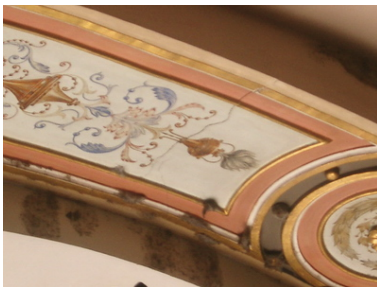
Fig. 10 Fissure on arch

Fissures on internal part of arches located in the transept, the presbytery, lateral chapels and arch windows.

Detachment of plaster ornaments and paint. Weakening of structure.

In the inside fissures on vaults and arcs will be filled up, plaster and paint.

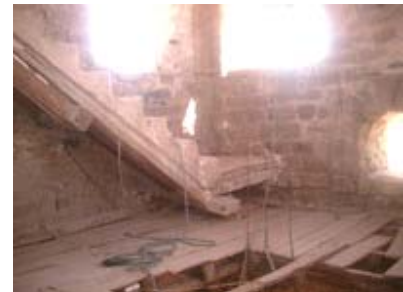
Fig. 11 Unsafe stairs and landings

The stone structure is stable, but the plaster, paint, and stone ornaments are damaged by exposure and lack of maintenance. Also in the interior, stairs and landings are in extremely bad conditions.

It's dangerous to go to the upper levels of the tower. The facade shows an old and neglected image.

Demolition of deteriorated brick and wood stairs and landings. The project design will determine the high of each level, in order to leave the openings free.

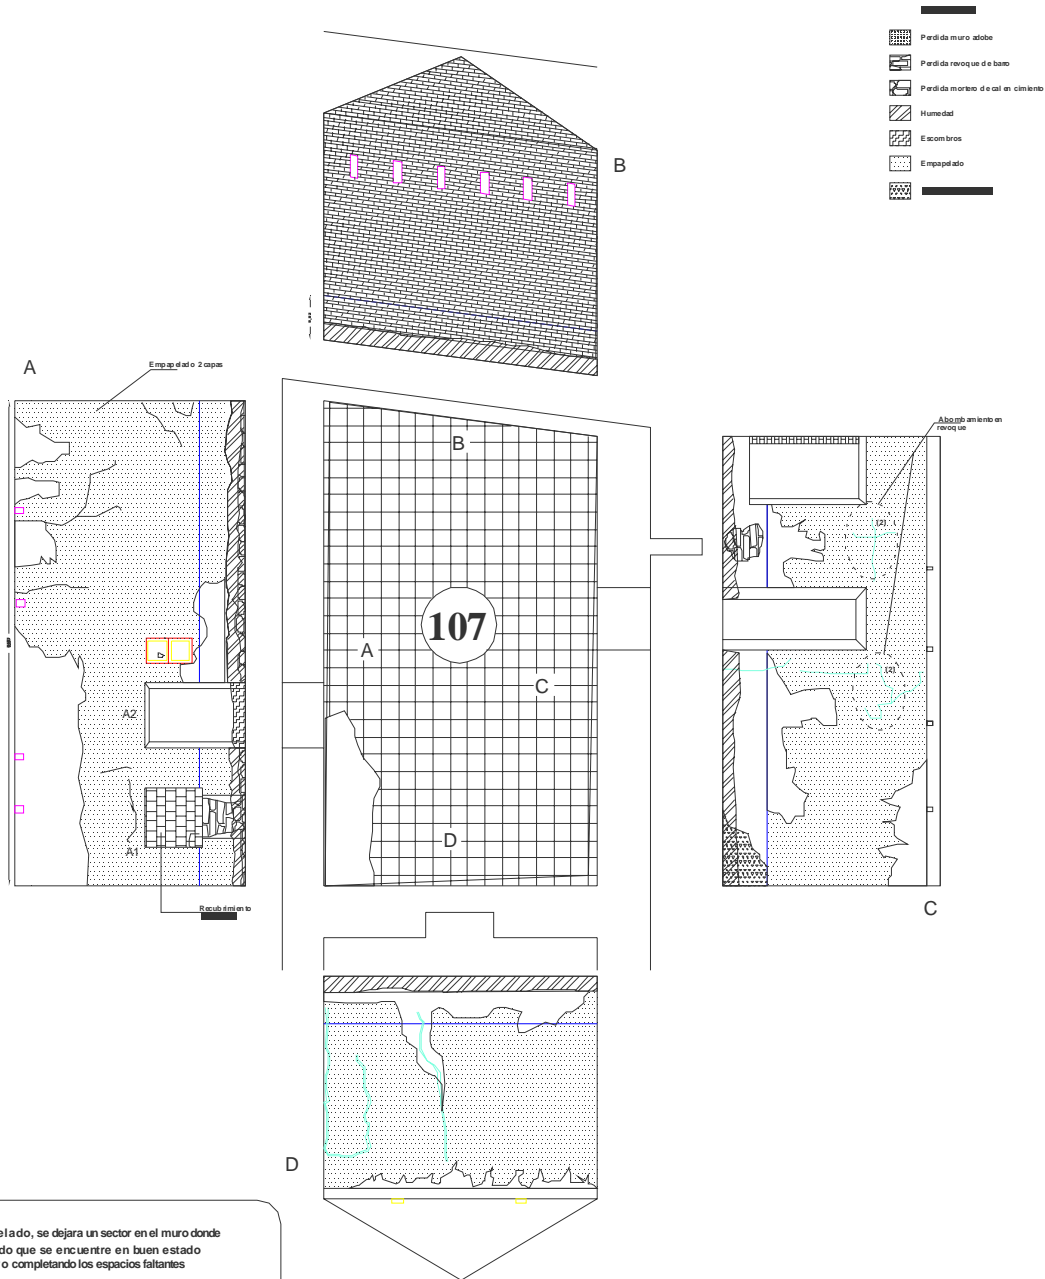
**OBSERVACIONES**  
 Muro A presenta dos capas de empapelado, se dejara un sector en el muro donde se observaran ambas capas. El empapelado que se encuentre en buen estado se mantendra y se integrara uno nuevo completando los espacios faltantes para mantener la imagen del ambiente.  
 Grietas, en muros deben ser reparadas costurando con adobe de las mismas características del original.  
 Se debe determinar si las fisuras, son solamente en revoque o si estan afectando el muro.

(1) El muro B pertenece al vecino, es necesario construir uno colindante.  
 (2) Los sectores del muro C con abombamiento de revoque por aplastamiento de material de muro seran intervenidos retirando el material danado de revoque y adobe, para ser repuestos y adecuadamente reforzados con vigas de madera e hiladas de ladrillo con mortero de cal.  
 Piso de tierra debe ser nivelado y el piso de ladrillo faltante repuesto.
