# La Parroquia Santa Cruz de Roma (The Holly Cross of Rome Church), Panchimalco, El Salvador

## Guidelines for a Conservation Plan

*Celina Ganuza Durán*

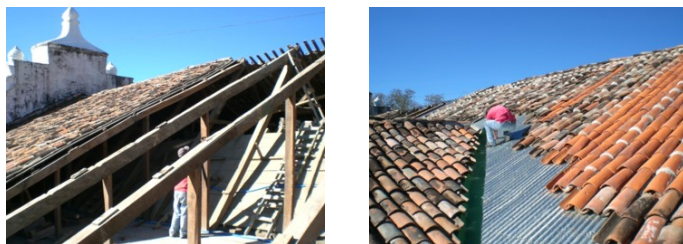
**Roofs** : one of the first works that has been going on, with the money that some people are raising is the identification of the damages of the roof system, and start to replace or reinforce beams and other wood structures, replace the terracotta tiles that need to and to introduce tin covering under these tiles to avoid weathering/leakage problems.

During the process of replacing and introducing other elements.

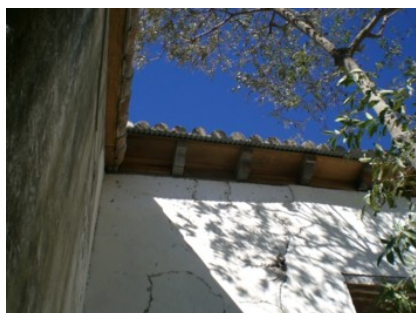
**Walls** : there are still many cracks on the walls, they can be product of not knowing how to prepare a limemortar or because of the effects of the previous earthquakes.

Preexisting cracks on the east facade

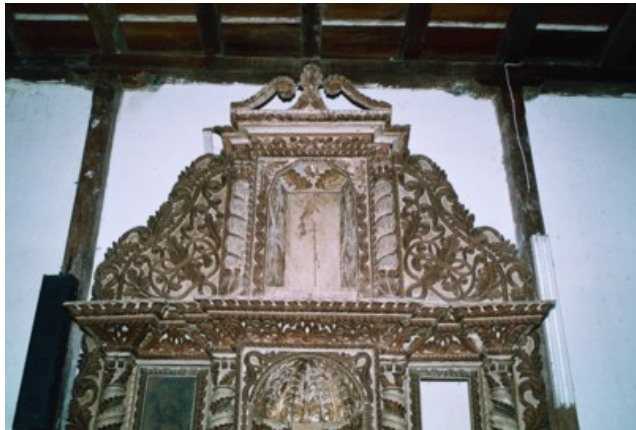
**The robbery of movable** resources as wood sculptures and paintings on wood panels that belong to the altarpieces.

There are two pieces missing on this altarpiece

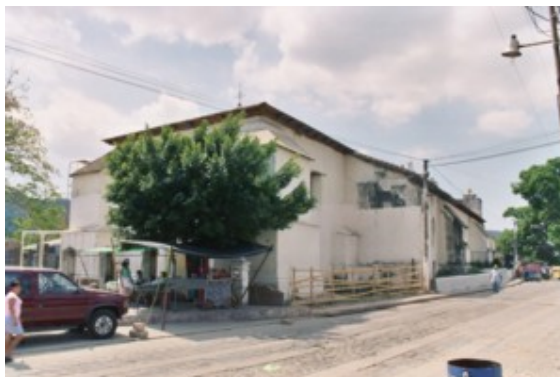
**Botanical, biological and microbiological** causes of decay

A tree has grown next to the rear or north facade

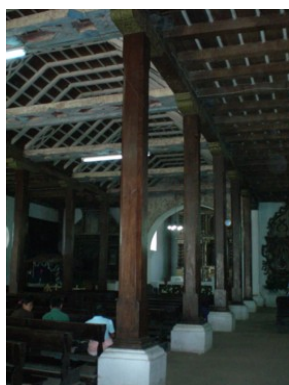
The need to have an **electric system and a sound system** in accordance to the values or the character of the building

The electric lights are attached to the tie beams over the main nave

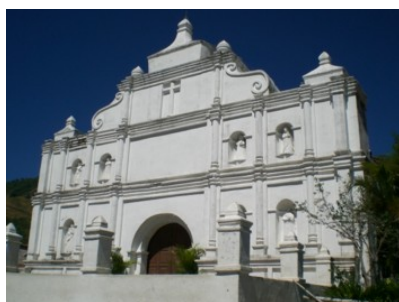
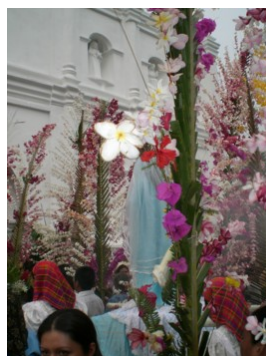
**Prior interventions** ( additions, restoration or renewal works ) without the proper knowledge

In El Salvador for at least one century the old buildings have been limewash white painted, but the evidence has shows us that the “colonial churches” were policromed. Everything in the life of Panchimalco has colours, as the processon of the Palm tree leaves that are covered with a lot of flowers, as we can see on the picture of the right.

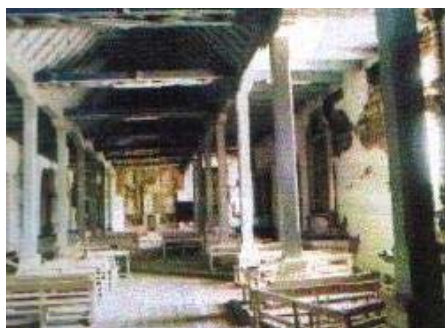
**The vulnerability** of the building and the movable resources because of the seismicity

This is Huizúcar Church after the earthquakes of 2001, and it is located about 20 km. From Panchimalco, and it's from the 17<sup>th</sup> century too.
