Reclaiming the Sounds of Silenced Walls: Urla Design Library

Tevfik Balcioglu

Izmir University of Economics

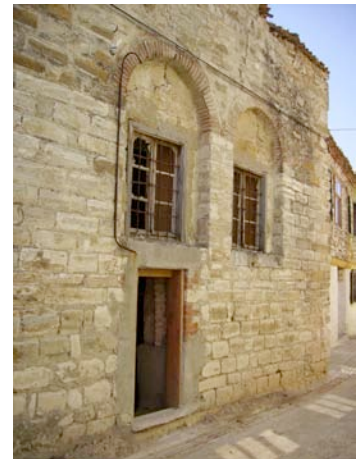
North Elevation
& Entrance

The settlement pattern and the structure of Kapani Street has important information that north elevation of the existing building was not the original entrance facade. In addition, there is no real evidence to conclude that there was even a street on the northern side. Recent repairs around the door, down to the materials used, has proved that originally there was not an opening on that elevation used as an entrance.

The second floor which is constructed with wooden beams, starts exactly from the bottom point of the two windows, but a question appears after observing the change in the type of the stone that was used in the construction of the wall. White colored clear-cut stone rows end at the top point of the windows and surround the perimeter of the building in that way. However, after that level colored (somehow deformed) stones with more varied dimensions were used until the dome. Following this style on the all facades beginning and ending at the same levels, perhaps this building should be examined in two parts on the facades (upper and lower). The reason behind this shift was not clear at this level of the study yet since the shift did not occur for differentiating the ground and first floor.

There are two brick arches on the north façade and they are connected only on this facade. The original function of the arches should be questioned. They could either define the windows or share the load of the dome since the polygon that connects the circular shape of the dome to the rectangle beneath has eight feet two of which are on this facade. Moreover, the wooden framed windows might have been constructed later than the original openings were formed, because the arches were filled with stone different than the upper level type and later covered with mortar which makes it difficult to give an exact reason.

No deformation related to damp (such as mold growth) has been observed at the bottom level of the wall. This may point out that no underground water existed close to that site. A color-change on the upper northwest corner of the wall was obviously soot probably caused by an external chimney or an oil lantern.

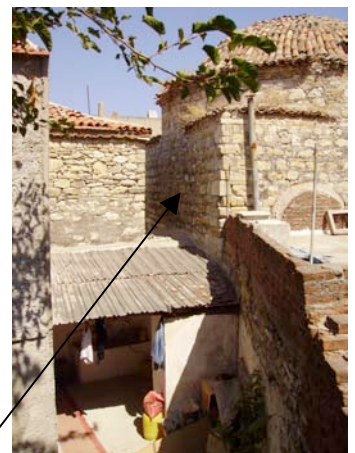
West Elevation

There is only one arch on this façade, located in the middle. The bottom part of this facade was hidden behind the wall of the neighbouring building. It is likely that this is the facade of the main entrance since there are two potential openings underneath this brick arch as it appears in the ground floor. The stones filling the openings are not well mortared and do not form a proper wall but are haphazardly placed on top of each other.

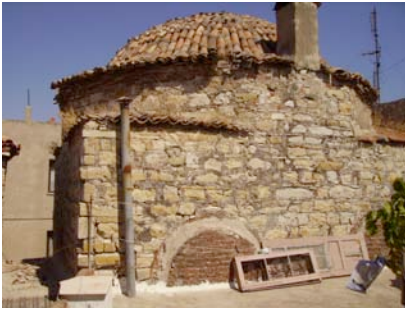
South Elevation

The bottom half of this facade is hidden because of the neighbouring concrete roof. However two arches and the undeformed upper level stonewall gives some sense about it. This time the arches were filled with brick, which leads to an idea that the reason might have been to avoid visual and physical connection between the two structures. Since the building next door was quite young, that attitude might be a recent development.

Another point is the chimney which could be observed from the exterior reaches the fire place (the bottom part) in the first floor.

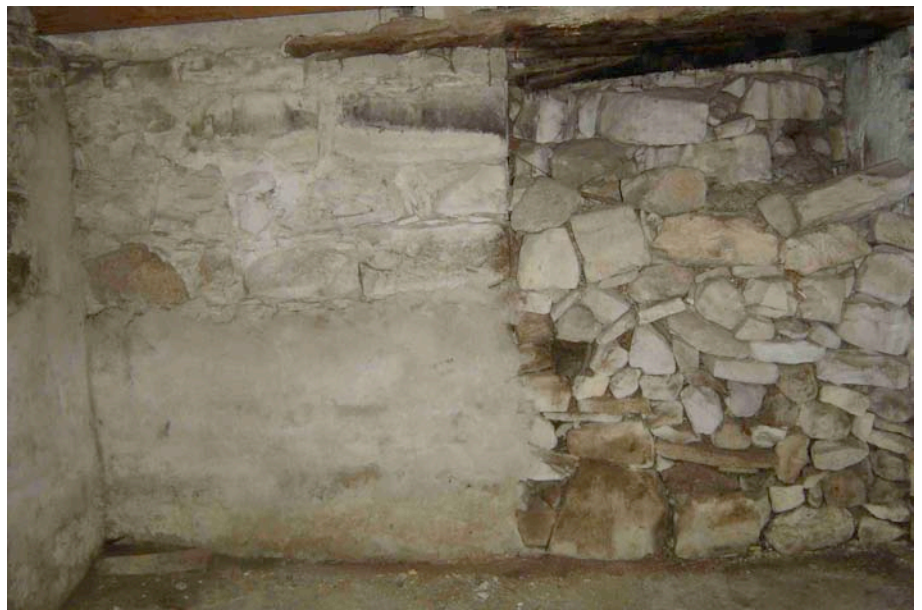
East Elevation

Unfortunately, whole of this facade is unrevealed because of the neighbouring building.

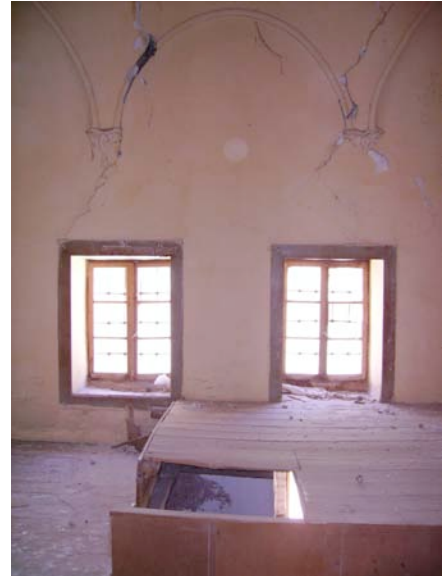
First floor, North view

The north wall has two window openings, and the wooden framed windows are located in the outer side of the wall. The glass of the windows is broken but the iron bars were still attached although corroded.

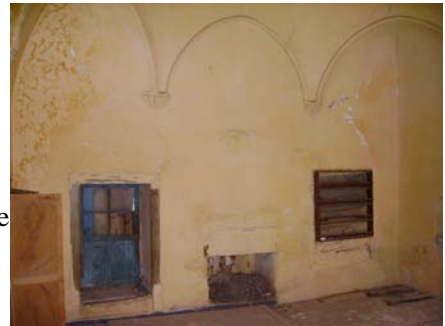
First floor, South view

The south wall has three gaps, one of which is the bottom part of a fireplace. The chimney is revealed at the top, close to the dome on the south facade. One of the gaps seems like an opening to outside, but it is covered with wooden plates. However there is also a brick filling in fill below the arches that are visible from the exterior. The other gap is totally cosed with the wooden plates from the interior, and another brick filling covers the exterior. A shelf like furniture for dishes hangs on the surface.

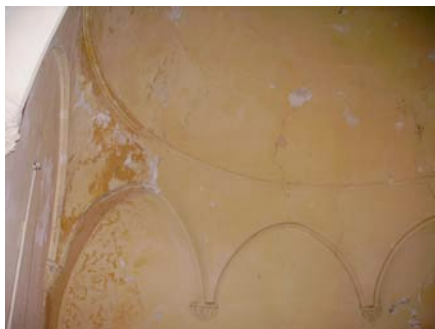
The dome is a brick structure covered with lime plaster and paint. The deformations coused by earthquakes reveal some parts of the original materials through the cracks.

The building has suffered from recent earthquakes and has cracks on the main façade and on the dome. This may not be vital at the present but repairing the structure is essential to avoid further damages. However, the main issue is to free the building from the adjacent houses and storage sheds, which are built illegally and rest on the walls of the historical monument blocking its main entrance and windows. All windows and the door must be reinstated to their original positions. Glazing and plastering are also needed together with a new door. The wooden beams holding the floorboards are not in good condition and may be replaced depending on the restoration strategy to be adopted.

- e. No other main alteration will be made. Of course, cracks will be repaired and plastering will be done with the same materials and techniques used in the original building.

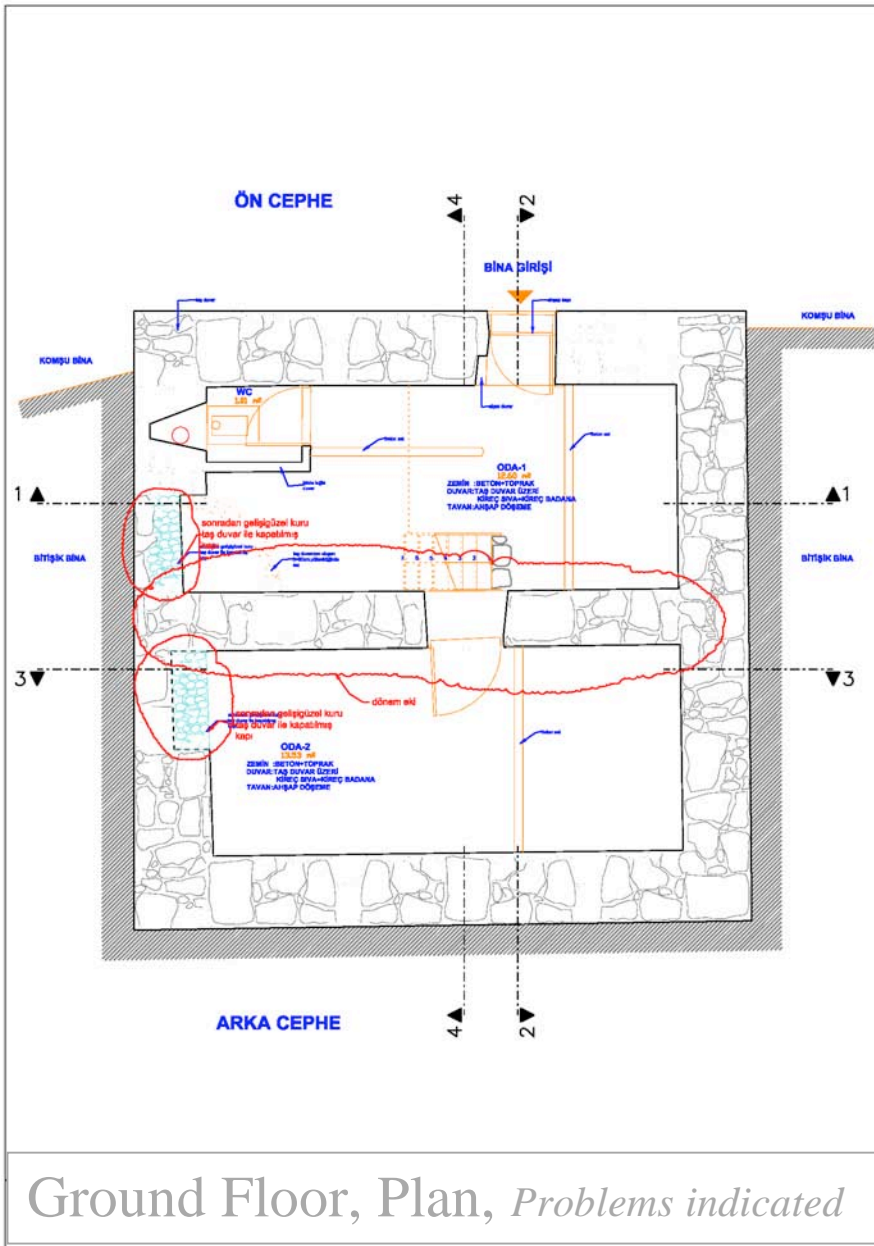
Ground Floor, Plan, *Problems indicated*

As observed, the space has been divided into two volumes with a stone wall after entering from the wooden framed door which was obviously built recently. This unoriginal entrance leads to the first space which has low ceiling and a lowered concrete floor as an obvious 20th century addition. The ceiling of the space built with wooden beams leaving a small hole for a narrow staircase on the right side. This ceiling in the first space has two variety of heights. The left half close to the entrance door is higher than the other half, which covers the top of the toilet area. In addition, the ceiling in the second volume is also at the same level with the lower one. Since the construction details reveal that the first half was elevated later, the lower level is probably be the original ceiling.

The staircase (obviously not original) is illogically located and almost in front of the opening connecting the first and the second spaces of the ground floor. It is next to the interior wall that separates the volumes from each other, and is directed towards the west facade. On the right, towards the west

- main door will be kept open to let the daylight in through the second set of glass doors.
- b. The concrete floor will be removed and additional height, which is especially needed for the entrance volume, will be obtained. This will also enable the construction of an even and continuous ceiling for the ground floor.

- c. A new staircase will be built along the entrance wall where there are two windows. This will enable some extra daylight to come into the ground floor.

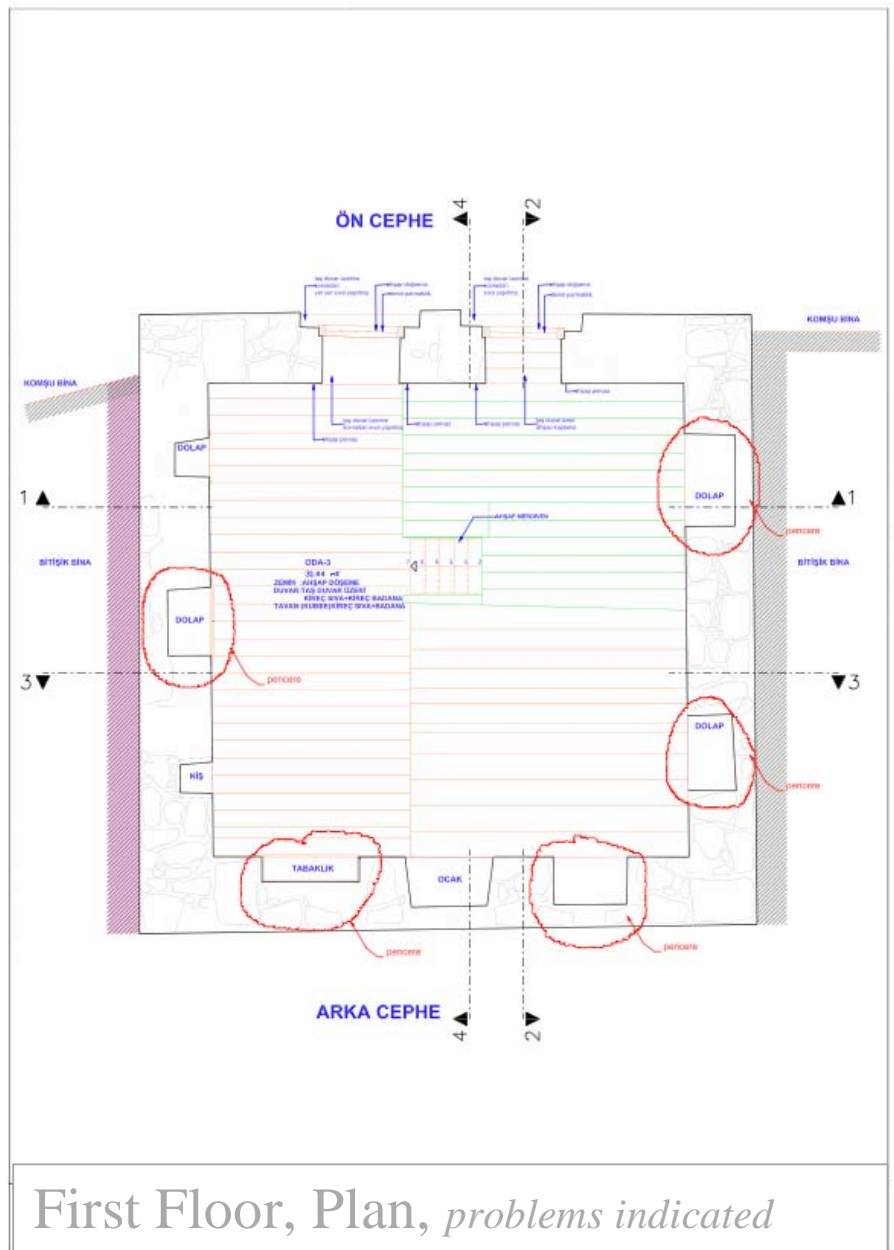
First Floor, Plan, *problems indicated*

On the upper floor, which is made of wood, the higher level, (north-east corner of the first floor level), can be observed clearly.

The east wall has two gaps with different dimensions. The first gap has a wooden frame and no shutters. The second gap is also wooden but there are two shutters on the each side. They might have been used as storage cupboards, but from the exterior which is totally closed by the neighbouring building, the unrevealed parts might tell more about the original form and functions in later studies.

- d. The first floor will have an even floor surface as a continuation of the original layout. The floorboards and some wooden beams will probably be replaced in accordance with the results of the analysis and experts' reports.
