SAN FRANCISCO LEARNING CENTER GABALDON CONSERVATION

THE DOCUMENTATION / CULTURAL HISTORIC VALUES

EXISTING CONDITION

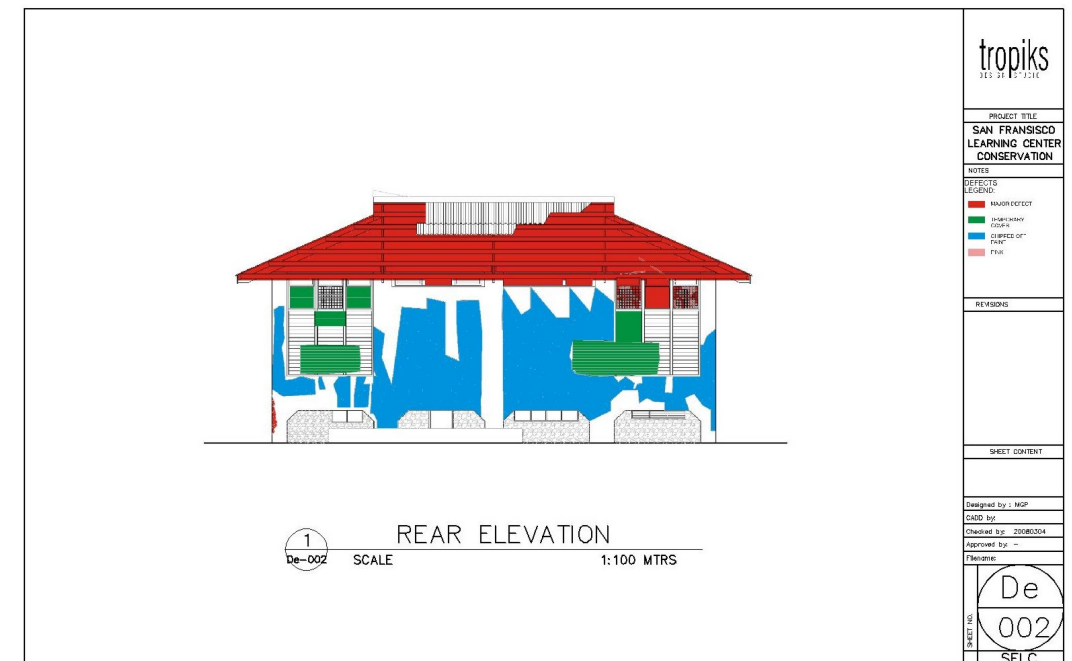
Fig. 4 Color Coding of Defects at the rear portion where it was damaged heavily by the typhoon

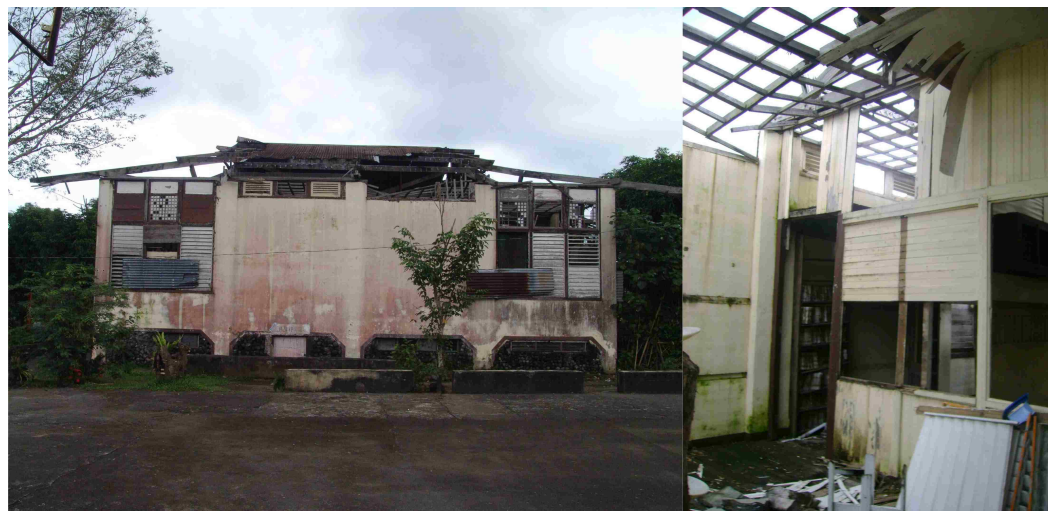
The building's condition can be summarized as a result of the damages caused by the typhoon. It caused the roofing to be ripped out & destroying half of the purlins & some parts of the end rafter. The damaged part is located at the rear portion as the wind came from the big open playfield. See Fig.7. Other parts destroyed due to the typhoon are the new ceiling eaves, half of the plywood ceiling w/ nailers & some capiz transom windows. Since then it was not repaired and when it was visited & studied last December of 2007, continuing deteriorations due to exposure to rains were found out. The most deteriorated one is the flooring & wood floor joists. Some floor joists are in wet condition making it soft leaving some floor areas sagging and

Fig. 7 (left) Back portion heavily damaged while interior (right) is exposed to weather.

hazardous to walk on. The wooden trusses are constantly exposed to rainwater making the joints where the bolts & wrought iron rods are located stagnated with water. The said metal parts became rusted too due to this condition. The basement walls & flooring became dirty & moist as rainwater end up on this lower floor. The concrete exterior & interior walls have molds due to the rainwater that drops directly to it without eaves. There are still some metal gutters in the end rafter that proves it has gutter before. This is supported by the evidence of the holes left by the downspout holders. See. Fig. 8 for building Materials Analysis.

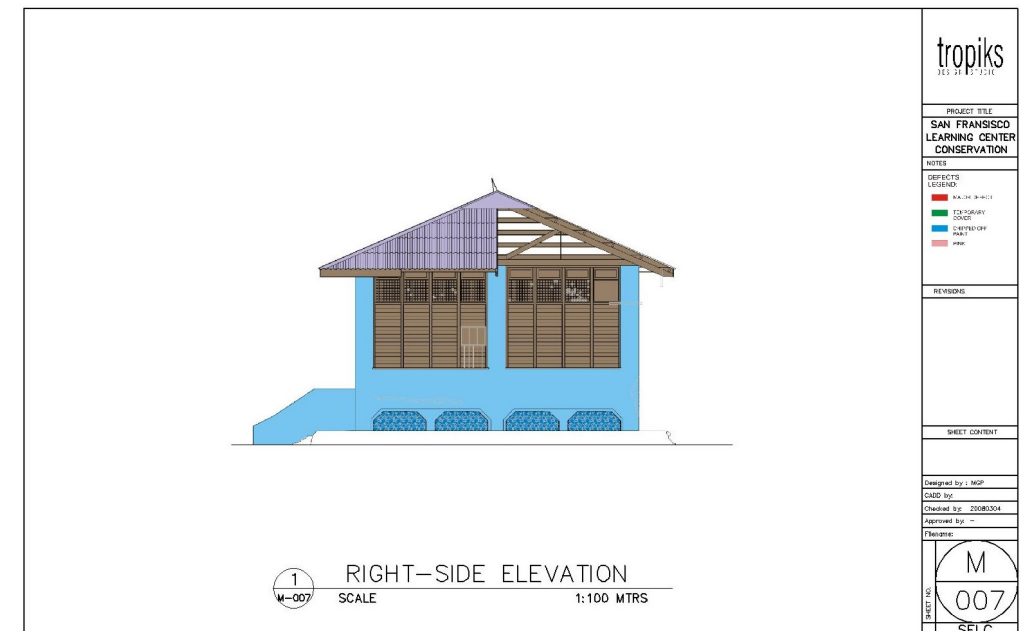
Fig. 8 Color coding of Materials

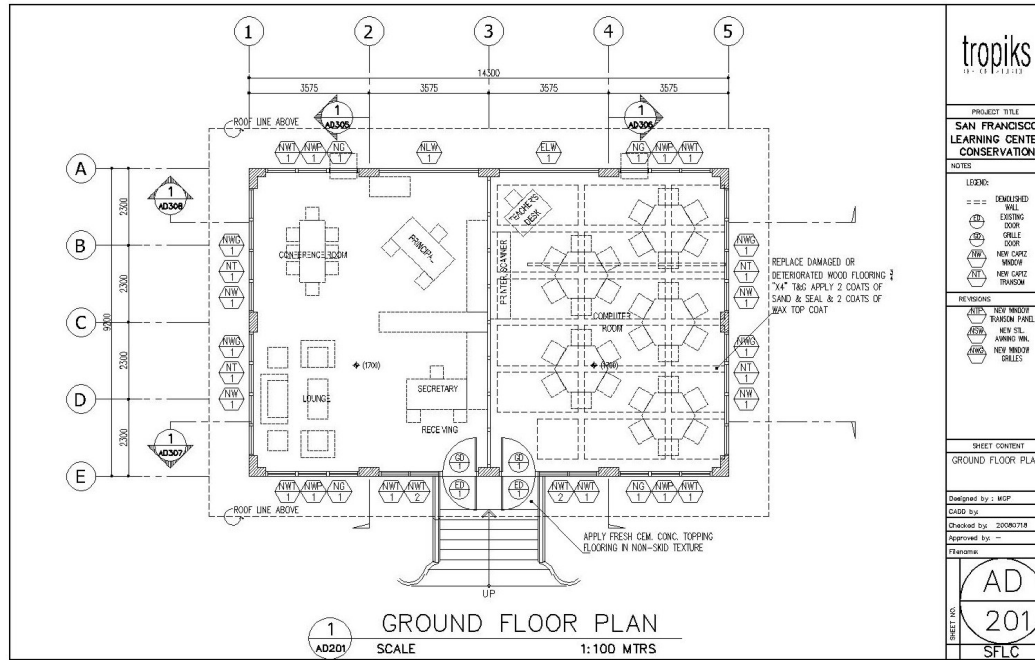
Fig. 13 Proposed Conservation Plan for the school

The first thing that was taken into consideration is the current interior condition of the rooms. Since the windows were replaced with wooden jalousies it became dark & air circulation is limited. In order to solve this, the reconstruction of the awning capiz windows is proposed. This will provide again good ventilation & pleasant atmosphere to the classroom thus making it conducive for studying again. This will bring back the fond memories of the Alumni who studied in a Gabaldon school. It will then be enjoyed & experienced also by future students of the school. But restoring the capiz windows is not an easy task as it is quite expensive to make. Local artisans will be tapped again to make this kind of windows thus reviving the industry as it will not be done only for this building but also to the thousands of other Gabaldon schools. Historically, it was part also in the students' workshop to repair a capiz window. So, it's an opportunity for the students to learn this craft at the same time strengthening the maintenance workforce of the building. But in order convince the people on the usefulness & effectiveness of the capiz window to ventilate a room, I have made a scientific of the airflow inside a classroom using capiz awning type windows. This will help convince the stakeholders to use again the capiz windows. To make it identifiable as reconstructed one, the interior side shall be stained natural finish while the exterior is semi-gloss painted as protection against dampness. See Fig. 13.

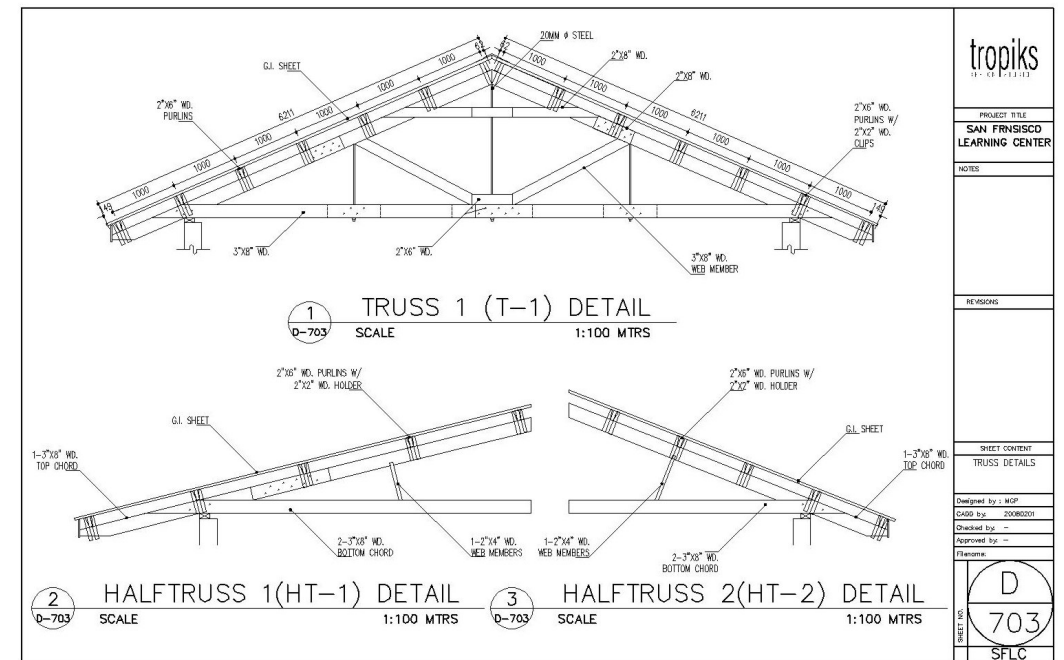
Fig. 14 Proposed truss repairs

Most of the repair works will be done on the wood. With prevention of deterioration first in mind, the repair of the trusses will be done first in order for the new roofing will be installed. See Fig. 14. A wood joint repair schedule was created so that there's a standard reference repair for wood and this will be useful also to other Gabaldon schools conservation. See Fig. 15. Missing wood purlins will be replaced with new ones & the destroyed end rafter will be replaced with a jointing system depending on the extent of the damage. It can be

then verified from the wood joint repair schedule. The trusses will be cleaned to see if there are deteriorations or termites especially in the joints where the Machine bolts are located. If these joints are found to be deteriorated, bolts will be unbolted & repair works will be done based on the extent of the deterioration. If there is only a stagnation of water in the joints, bolts will be unbolted then it will be dried up by blower & constant wiping of the interior to suck the water. After these, it will then be applied with 3 coats of preservative locally known as Solignum to protect it from termites. Once done, a thicker corrugated iron roofing sheets will be installed that is pre-painted & short-span instead of long span. Short-span roofing can be readily available if it will be replaced in the future. The new ceiling eaves will be removed as theorectically it might be also the cause why the roofing flew off, Instead of the wind passing through the roof interior, it just lifted the eaves together with the roofing as can be seen in the damage. Without the eaves, the air will flow directly inside the roof, blowing off hot air stored there. Historically, Gabaldon schools have no eaves and if there is it is made of wood strips spaced with big gaps to let the air to flow. New roof Louvers will be added in the left & right sides. The capiz panes shall be cleaned by using soft toothbrush with soap & water. The oldness will differentiate it from the new capiz panes.

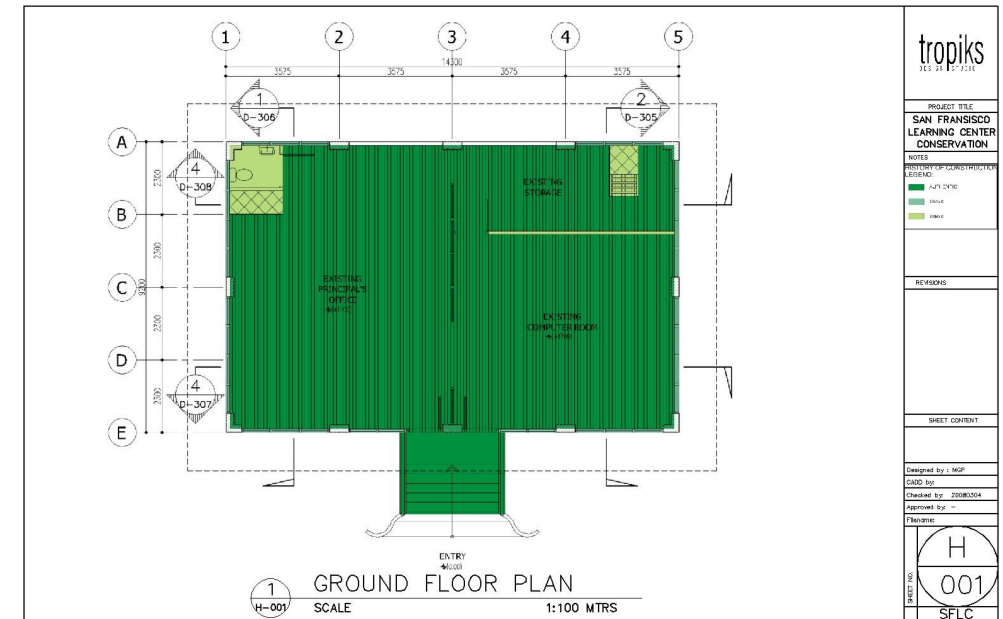
- Dark Green- the authentic T&G flooring of the classroom that needs some repair & replacement works due to rainwater deterioration. It has to be replaced with proper jointing layout in order to have a visually pleasant floor pattern when repaired. Verify floor pattern layout in repairing T&G flooring. The Area with the additional Toilet is assumed to be deteriorated.

- Green- replacement of windows to wooden jalousie when the original capiz windows were destroyed by the Typhoon in 1975.
- Light Green- in an unknown date, left classroom was converted into Principal's office with additional small Toilet, & the right-wing was converted into Computer Room with storage area & mezzanine addition. The mezzanine flooring added dead load to the structural wood frame making it vulnerable to weakening.
The semi-basement was excavated and converted into a Canteen. The Foundations were supported on the sides & bottom by retaining walls.

Fig. 20 Authenticity of Plan

- Light Green- additional rooms constructed in an unknown dates, these rooms are the Toilets, Storage & Mezzanine. These areas will have to be removed as the Toilet may further deteriorate the floor framing due to leaks & damage the floor joists. The mezzanine adds load to the floor framing which is not designed to accommodate the load at the same time, making the room warmer by reducing the air space & blocking the cross ventilation.
The semi-basement was dug & used as canteen the walls retaining the soil are only made of CHB. Reinforcements or solidification should be done on this wall. Observation should be done to check the movement if there are movements of the foundation.
