Methods and Strategies in the Rehabilitation of the Luneta Hotel

Rehabilitation and Adaptive reuse

John Joseph T. Fernandez, MSArch.

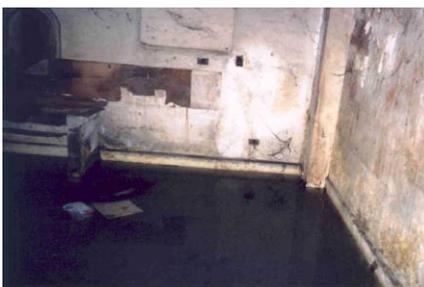
Inside the 2 level coffee shop an access stair is seen which leads to a semi-basement. (see figure 37) Unfortunately the basement has been flooded ever since the take over of the present owner, removal of the flood water was never made or attempted. From the lobby another stair is seen which gives access to the elevator lobby. (see figure 38) One can not ignore the changes in floor elevations in these areas. A difference of about .60M in elevation from the lobby floor to the elevator lobby signifies that the elevator was not an original part of the building. The kitchen and the service area are located at the left side of the rear of the building. (see figure 39) A driveway found at the rear of the property gave access to both delivery and services of these areas. Opposite of this area is the

Fig 21, Basement with stagnant water

As discussed earlier the entire basement of the building is flooded since the present owner had occupied the building. And due to this, there is a great possibility that salt migration is caused by this process.

1.1 Flooding of the basement - Since one of the major problems of the hotel is basement flooding, the expulsion or evacuation of stagnant water should be the first in order of thing. Once water has been evacuated from this part of the building, aeration of the basement should be done. This is to dry all moisture that has been stored in the basement wall due to the prolonged soaking in water. Determining the source of the flood water in the basement, will also alleviate the present condition. Possible sources of water in this case might be an open drain or some crack or fissure in the basement enclosure causing water to seep in. Once the source of flooding is determined and corrected, the area is allowed to dry for a period of time before waterproofing materials are installed. Since one source of flooding of the basement is the accumulated rain water from the road it will significantly prevent basement flooding if the ground floor is to be designed to serve as a coffer dam. An alternative method would be to completely fill in the basement so as to avoid further flooding. However in the later procedure, significant elements that maybe found in the basement of the hotel, will be completely wiped out.

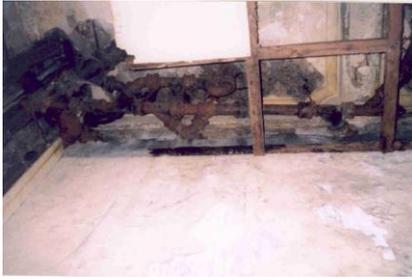
Another obtrusive element found in the ceiling of each room is the presence of soil pipes emanating from the upper floor. This however was covered up by creating a drop ceiling within the lower toilet. Again this proves the assumption that the toilets were later additions to the structure. (see figure 46)

Fig. 29 Drop Ceiling covering plumbing installation.

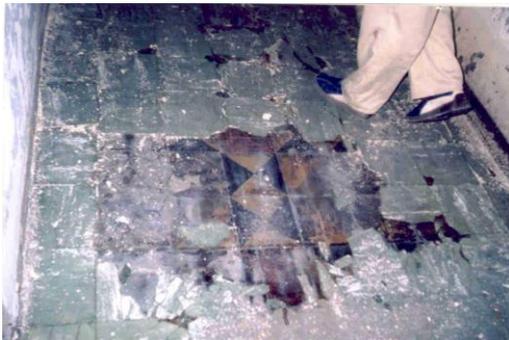
The flooring which is presently covered with vinyl tiles was also revealed. By peeling off the vinyl tiles along the hallway the original cement tiles or “baldoza” were exposed. (see figure 47) The tiles were of geometric patterns having different color of red, yellow and black. Some areas however with missing floor tiles were plastered with cement to level the floor. After which vinyl tiles were applied. These vinyl covering used were of the 60’s which are smaller compared to the 70’s where vinyl tiles were a lot bigger in dimension.

Fig. 30 Original Cement Tiles at Hallway

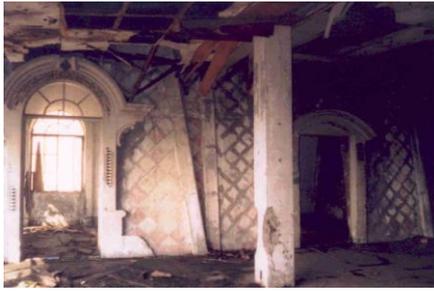
In the rear room another planted steel column could be seen, which carries the overhead water tank which supplies the entire building. The water tank was cleverly placed just beneath the roof to hide from view. As one looks above the elevator shaft, the machine room is seen and exposed.

Fig. 33 Planted Column on the 6th Floor

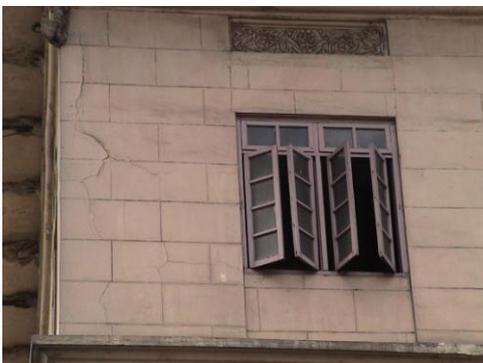
The water may also attack building materials directly, as opposed to damage resulting from efflorescence or subflorescence. If the water reaches interior plaster surfaces, the water will dissolve the gypsum, transport the dissolved plaster to the interior evaporative surface, and produce efflorescence on the interior of the wall. This sort of damage is characterized by bubbling and blistering of the interior plaster surface, and normally occurs below the painted surface. Unlike exterior efflorescence, which may well be the relatively harmless precipitation of transient salts, interior deposition of dissolved plaster indicates that the plaster is severely damaged and that the mechanism is still active. The mechanism may be active only during periods of rains, tide or other water inundation, and is, therefore, sporadic, but the damage is cumulative, the mechanism is continuous, and the damage is progressive. While the interior plaster may be in jeopardy only during periods of prolonged saturation, the damage that occurs is irreversible.

Fig. 35 Cracking of Plaster

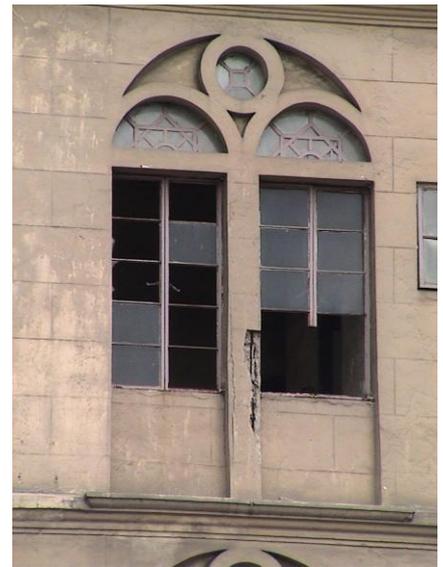
Fig. 36 Spalling of Cement

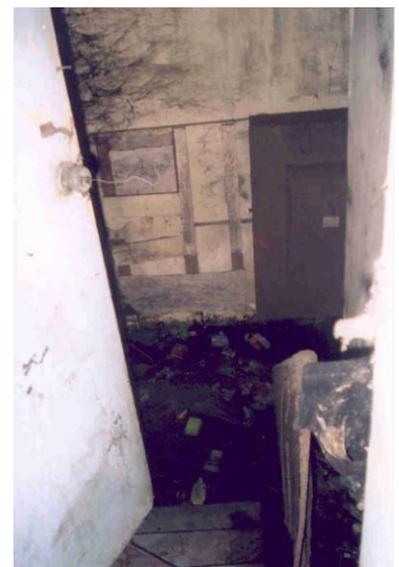
Fig. 37 Basement flooded with water

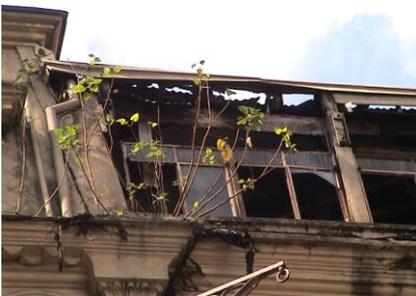
Fig. 38 Vegetation outgrowth

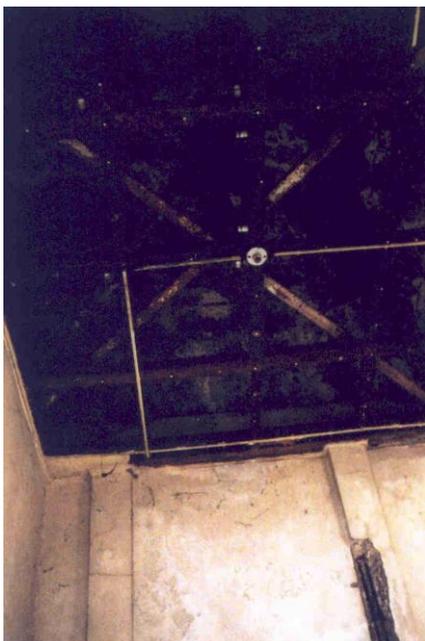
Fig. 39 Dark roof cause by fire.
