**Conservation and Maintenance plan for
Residential buildings within the
Main Dutch Fort of Matara
Matara, Sri Lanka**

**Presented
at
SIDA' s International training Programme
Conservation and Management of Historic Buildings
Phnom Penn, 20th February 2006**

**By
Ms. Shanthini Balasubhramaniam
University Of Moartuwa,
Sri Lanka**

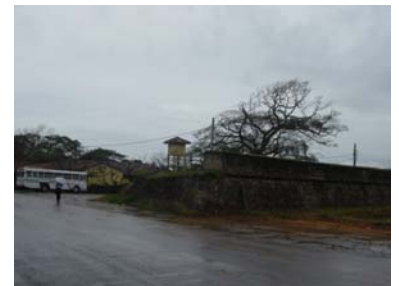
The rampart with its north bastion, central projection and gun embrasures remains same to date. They are in a fair state of preservation. However the half bastion in the south adjoining the sea has been demolished and a costal road built. Also it has been mentioned that there had been a ditch in front of the rampart and a draw bridge across the ditch at the gate. These had been dismantled in the early 19th century hence they no longer exist.

Fig. 12 The south bastion demolished.

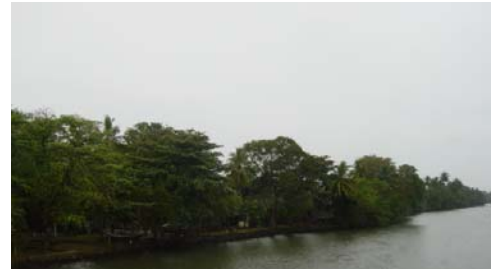
The sea front and the river front have been totally neglected. They have become garbage dumps. These need to be cleaned and revitalized to enhance the natural beauty. A well kept beach and river front would not only enhance the visual landscape but also help in income generation.

Fig.18. The underutilized river frontage

Hence these open space needs to be maintained at all cost. A landscape design for the sea and river fronts, open spaces and roads needs to be implemented and maintained.

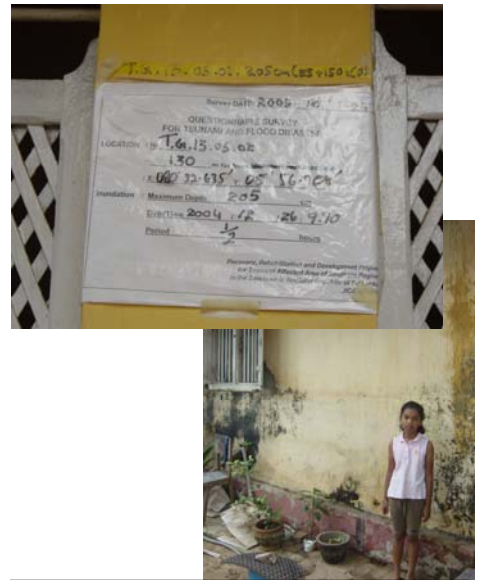
Fig. 27. Water marks indicating the water levels.

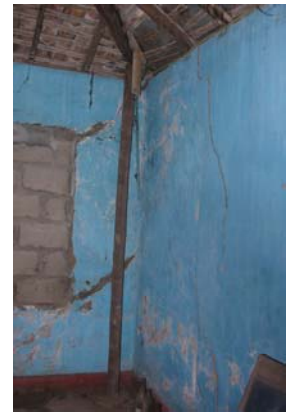
- Unstable walls and roofs were propped with materials such as bamboo, rubber timber or steel propos.
 - Cracks were visible on the floors and walls. These were checked and consolidated with an infill.

Fig. 37. Timber propos are used to stabiles the roof.

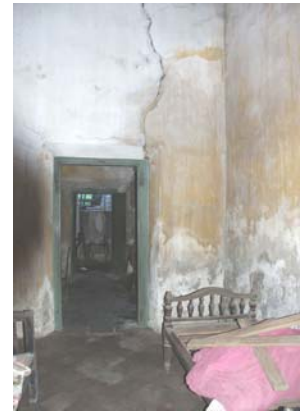
Fig. 38. Cracks infilled.

- Rectify wall cracks -wire mesh and use infill.
 - Timber work such as upper floor balcony timber work is to be rechecked for cracks and damages. New additions to be installed with timber of the same period and characteristics with a simplified workmanship.

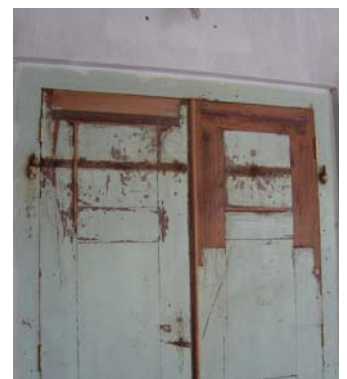
- All damaged doors and windows with temporary rectified with Materials such as damaged timber pieces or plywood and secured the dwelling.
 - Temporary materials such as water proof sheets were used to secure roof from water leakage.

Fig. 40. Secured door.

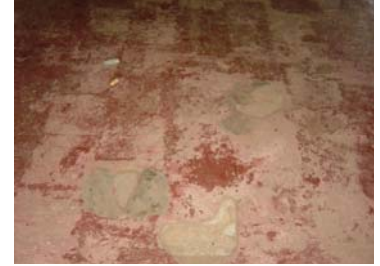
- Extensive damage is noticeable on floor. Relay ground floor with cement rendering or the tiles with similar characteristics. Water proofing and termite treatment is to be carried out.

Fig. 41. Damaged floor.

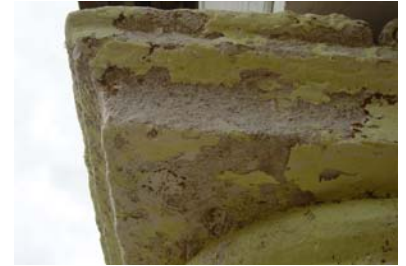
- Most of the plaster was damaged. They were cleaned with water and assessed for the extent of damage. If minimal lime plaster or cement plaster was used according to the existing plaster.

Fig. 42. Dutch lime plaster is peeling off due to salt.

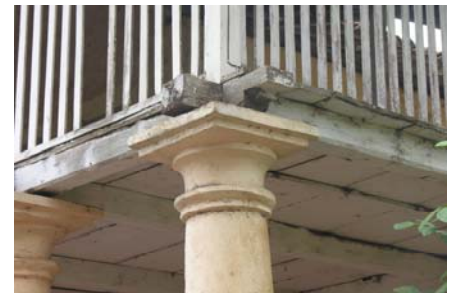
Fig. 43. A timber balcony with loose floor boards and missing elements.

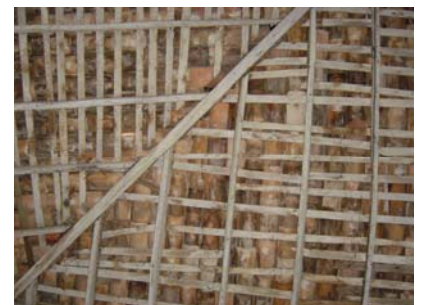
Fig. 44. Present conditions of most roofs.

- Roofs are of exposed rafter system with half round tiles. Major timber members are to be replaced or fiber jointed. Most owners have requested for ceilings. Hence a fiber bonded light weight ceiling has been recommended to certain areas.

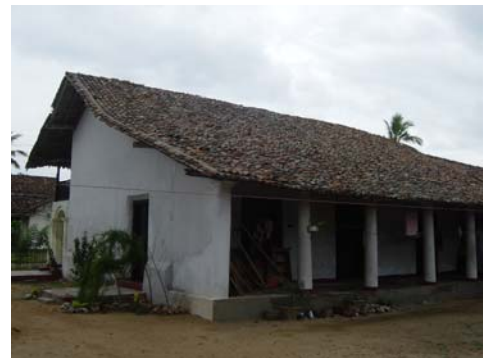
Fig. 46. Wijetunga walawwa after the tsunami . Note the building at the side has been destroyed.

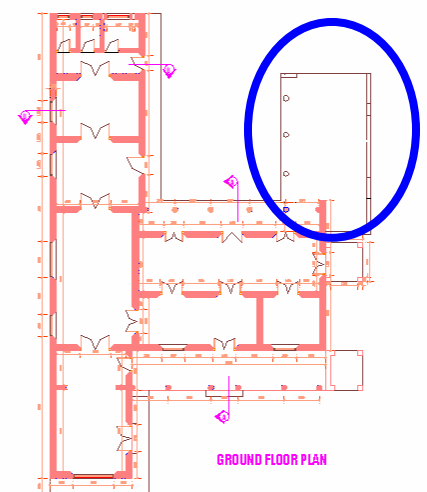
Fig. 47. The old destroyed unit to be rebuilt as a garage for cars.
