Advanced International Training Programme 2009/10

**CONSERVATION AND MANAGEMENT PLAN OF
SAO BAPTISTA FORT**

SAO BAPTISTA FORT

IBO Island

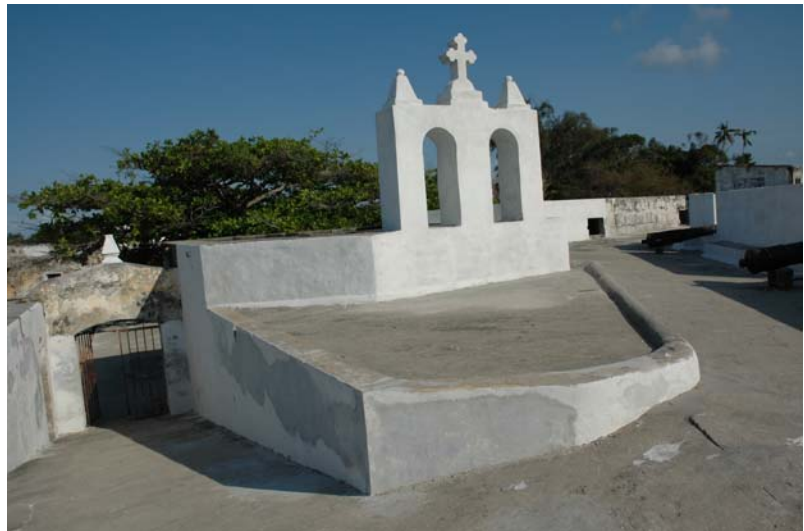
The walkway is 1500- 3000mm wide. The walkways are for defense purposes and therefore are embellished with mounted cannons directed through gun ports on the parapet walls at about 3000mm interval. - Battery. At the base of the parapet walls of the walkway are 50mm diameters galvanized waterspouts at two (2) meters centres. The walkway has deteriorated and the lime/cement/sand screed has developed cracks and water penetration into the core fill of the walkway is considerably high. On the southern section, over the main entrance area, the deterioration is so bad that the saturated and leached material used for filling between the two external walls has cracked and failed exposing the soil. Plants are growing in the exposed soils and water percolation into the structure is heavy. Vegetation growth found in cracks further accelerates widening of the cracks between the screeded surfaces. The permeability of the walkway is a progressive threat to the stability of the external walls. Immediate remedial action should be undertaken to arrest the possible collapse of this section.

Access to the walkway by a ramp between the church and kitchen buildings from the courtyard.

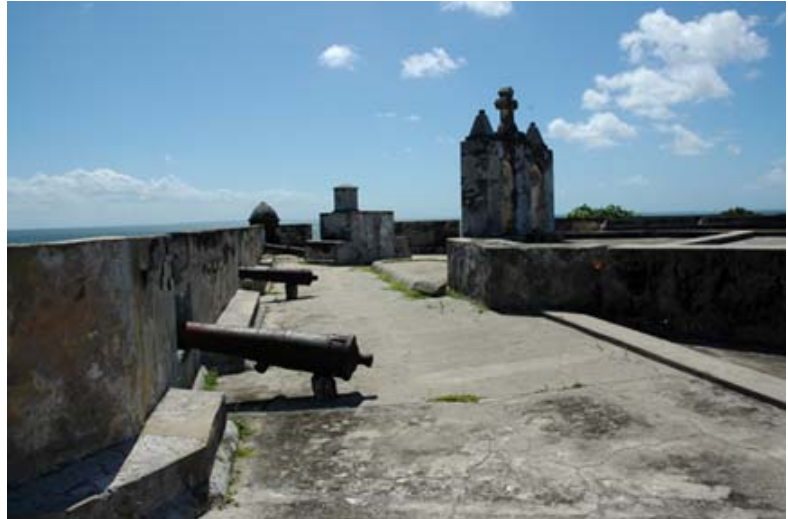
About twenty mounted cannons are in various stages of conservations. The two largest cannons are mounted on the front elevation on the opposite sides of the main entrance. The cannon balls are long missing and the timber carriages of only four are present. The remaining of the cannons rest on blocks or directly on the walkway and gun ports. The guns need regular maintenance and protection against the persisting rust to arrest the exfoliation of the cannon and the subsequent thinning.

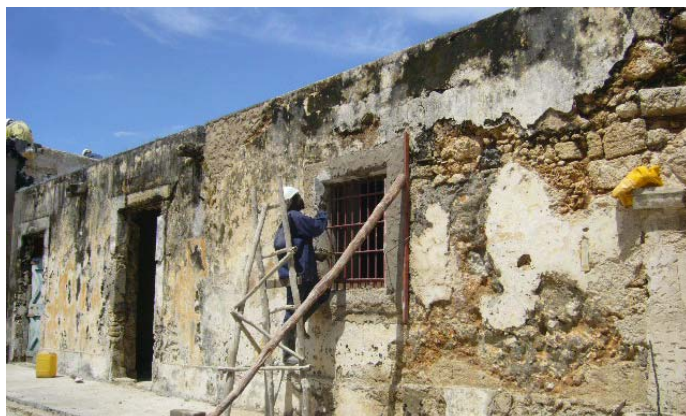
The walls are stout stable masonry constructions under attack from plants growing on and or into them destroying the building by the physical action of their roots, the storage of water, removal of minerals from the walls etc. Roots of larger plants on the walls have grown deep into the building caused cracks. The dead large plants have left in their aftermath huge voids in the masonry causing structural movement like subsidence.

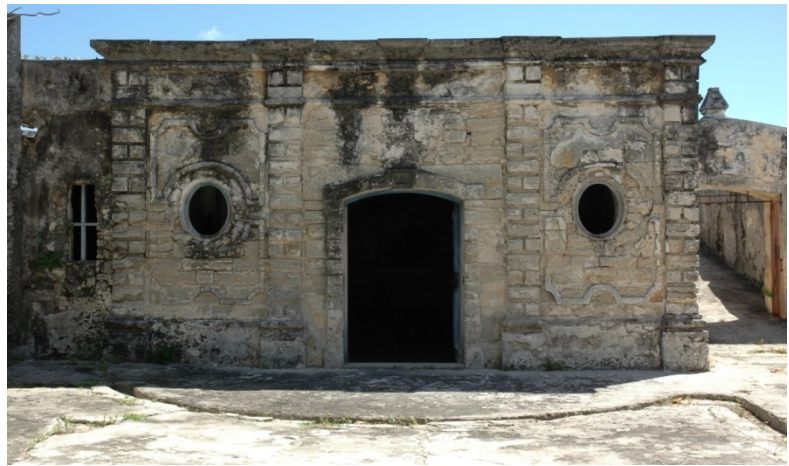
relief- pilasters et cetera. At the front façade, are two cut-coral stone pillars on each side of the arched medieval timber doorway and a beautiful pair of masonry abstract relief to the sides of the pilasters and the doorway. Along this front façade, next to the relief's is a pair of beautiful oval windows, probably they had stain glass in fills characteristic of church architecture of that period in Europe. Further to the oval window is a small slot to the extreme left of the facade with a timber crucifix. Once Inside the church, there is this bold and beautiful stout masonry alter located at the head of the room. About half way to the Masonry Alter is a roman arch on elaborate dwarf pillars of the kind found in the main exit from the courtyard through the main entrance lobby into the fort.

Front Elevation of the Chapel with Ramp to the Extreme Right (April 2006)

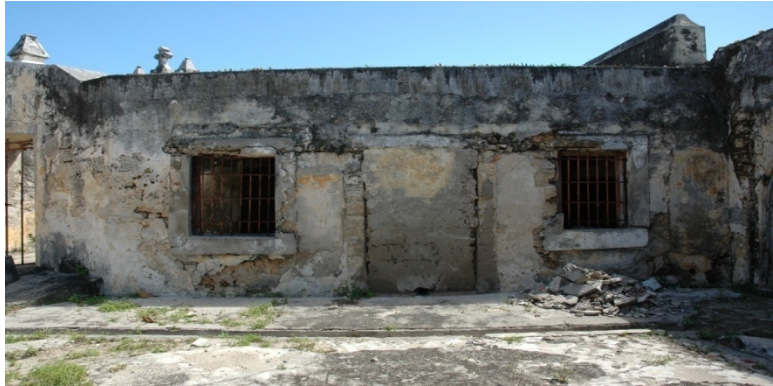
The Kitchen - The kitchen is located on the northern facade to the right of the ramp that leads on to the raised walkway from the courtyard. . The size of the kitchen is about 3000mm by 3000mm irregular room with two raised separate elongated rectangular (500 x 1500mm each) cooking fire places, two hoods and two separate flatten chimneys above. The kitchen floor is about 500mm below the courtyard floor level. The two window openings look into the courtyard but they are in a bad state of disrepair. A later doorway with a missing door is accessed from the side of the ramp and the earlier door from the courtyard is sealed. The walls and floors are damp and floor specially is cracked in some areas. The ceiling is false concrete

reinforced flat roof and the timber pools embedded in the soffit are missing. The roof leaks like a sieve and the ceiling is stained in several areas.

Elevation of the Kitchen from the Courtyard (With Sealed Doorway) April 2006.

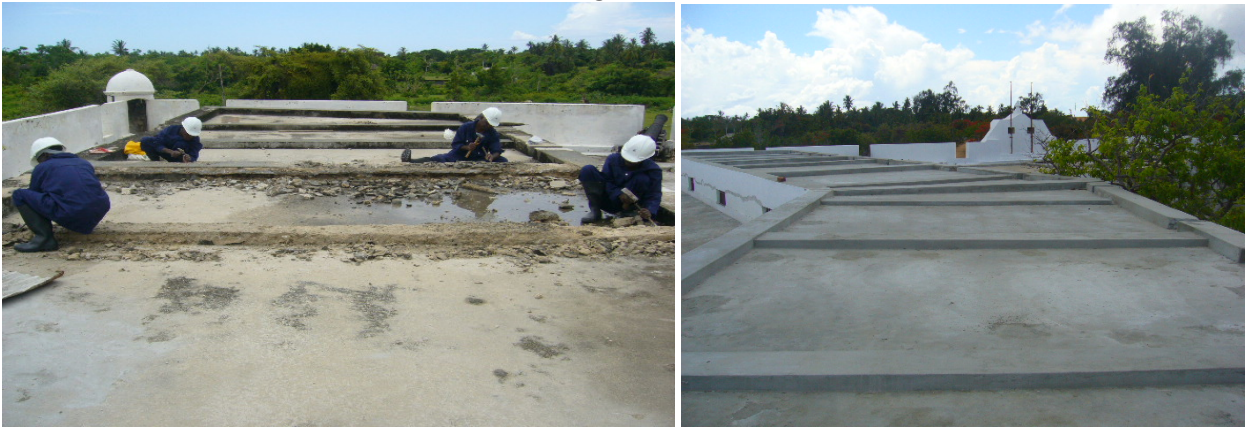
Roof – is currently a reinforced concrete flat roof. A close inspection of the roof from the walkway reveals the seriousness of the failing concrete slabs and beams.

The concrete flat roofs are laid in bays of about 3000mm by 5000mm between ribs of beams about 450mm thick by 500 deep. The slope of the flat roof is poor and some bays do not have spouts to discharge storm water during rains. To overcome this problem, some concrete slab bays are linked with others by drain pipes. The result is the pooling of the water on sections of the roof because of the poor gradient of the flat roof. The consequence of poor work and unacceptable repairs is this massive leakage through cracks into the rooms and structures below.

The Flat concrete roof - the intervention

Undertaking remedial repairs of roof leakages, boarding up windows and doors temporarily etc. to ensure that the building is watertight.

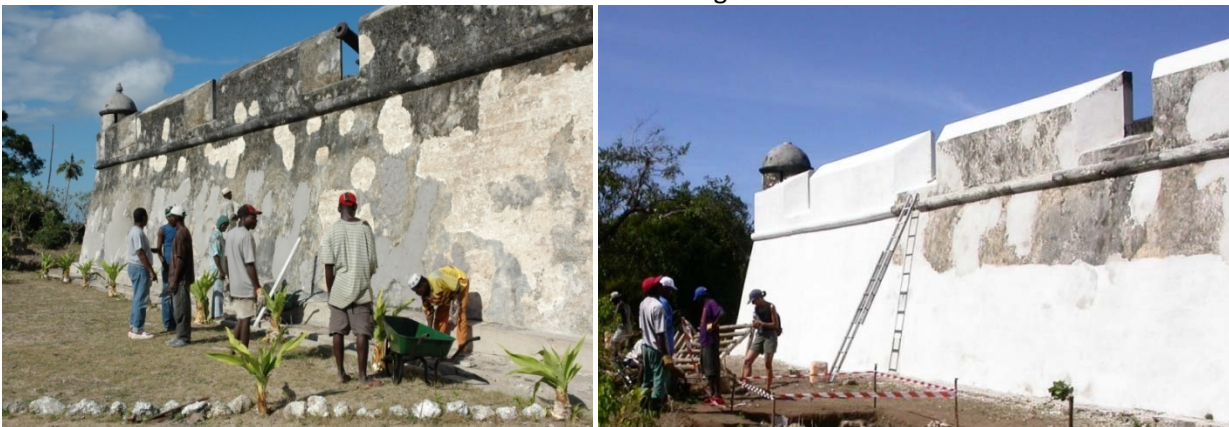
Repair works on external wall

Undertaking roof repairs including structure and roof finishes. Masonry repairs of walls, under pinning of foundation and foundation walls, repair and renewing plaster screed, etc to stabilize the building.

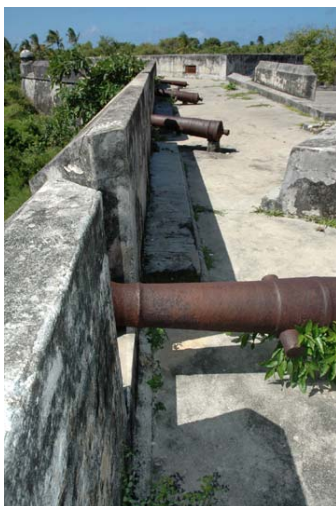
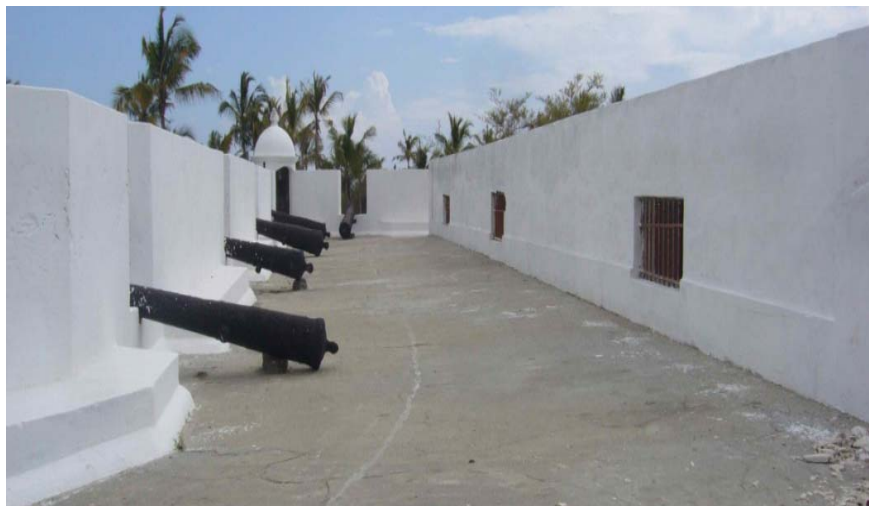
The canons on walkway before and after intervention

Paint architecture metals after applying three coats of ferrous oxide paint. Cannon, hinges and locks, bells, cresting, iron post etc

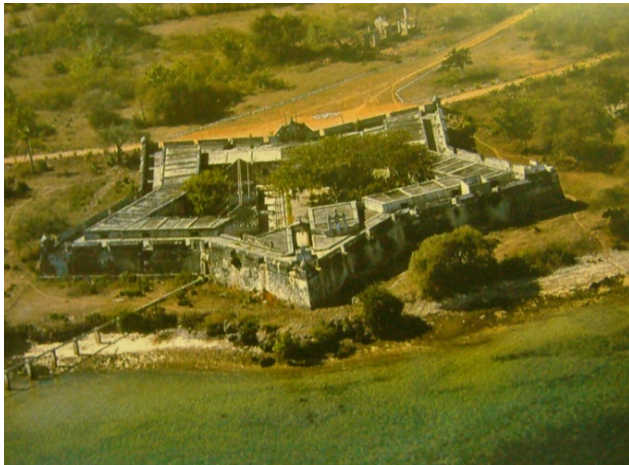
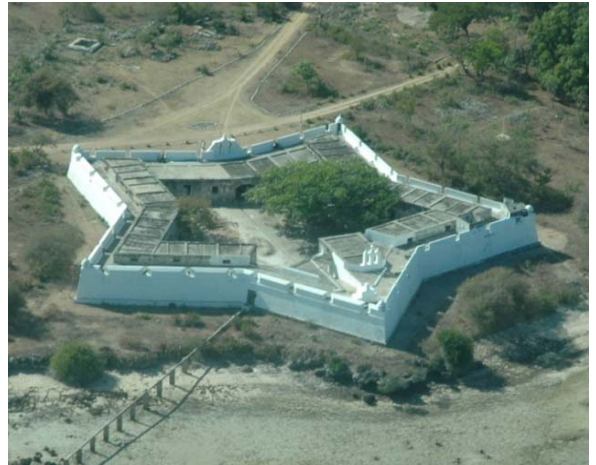
São João baptista Fort, Before Intervention(2006) and after intervention(2009)
