**A FINAL REPORT
ON
CONSERVATION OF 55 WINDOWS PALACE**

SUBMITTED BY:
AR. RAM GOVINDA SHRESTHA
HERITAGE SECTION
BHAKTAPUR, NEPAL
FEB. 2006

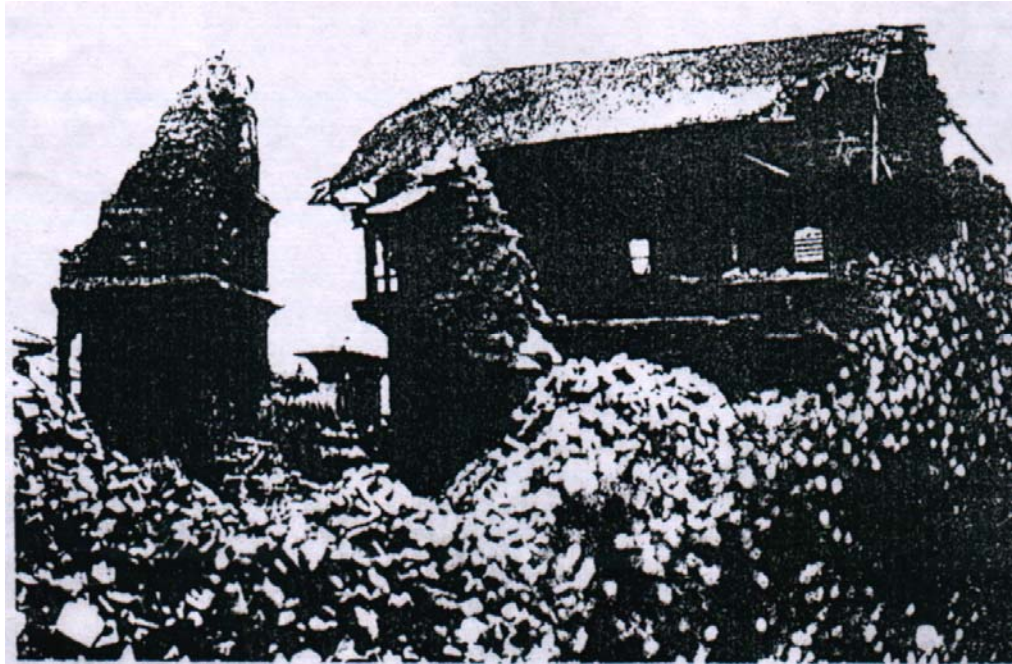
EAST VIEW OF 55 WINDOWS PALACE AFTER 1934 EARTHQUAKE

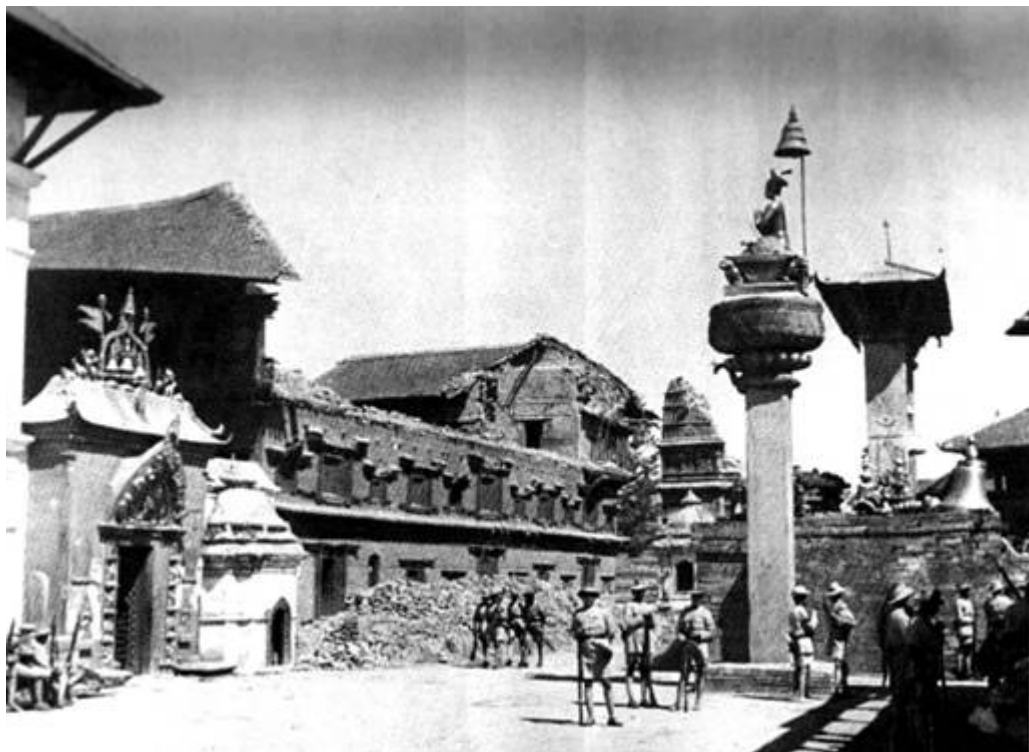
EAST VIEW OF 55 WINDOWS PALACE AFTER 1934 EARTHQUAKE

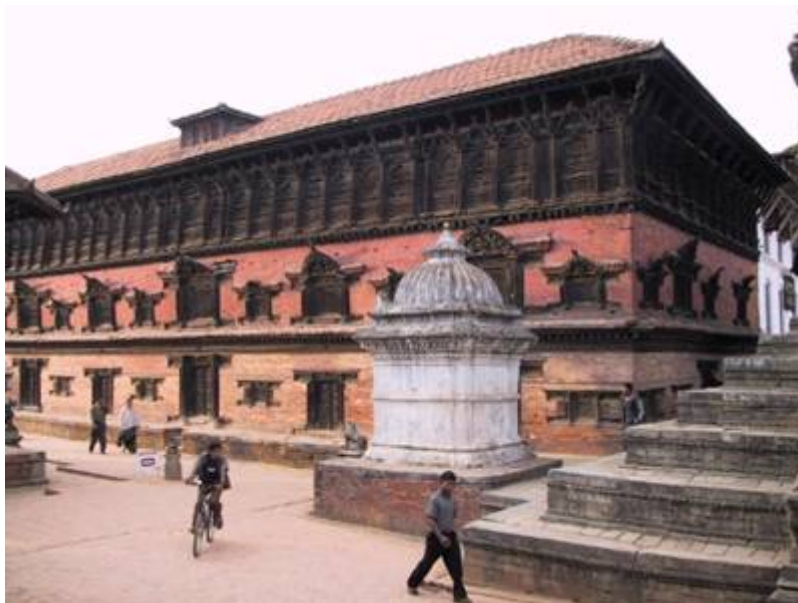
55 WINDOWS PALACE BEFORE RENOVATION

Beside the above mentioned deficiency in the post earthquake reconstruction, a number of other activities related with repair works in isolation must have aggravated the structural condition of the palace. The addition and removal of various structural elements in course of

time to suit the then occupancy of the palace is another major important parameter. In the Rana's regime, the then magistrate removed the southern cross wall to make the ground floor more spacious for his official purpose, and in late seventies (1978) the western cross wall was removed for the purpose of Museum. Such removals were done without proper study of the importance of the cross wall in the structural performance of the building.

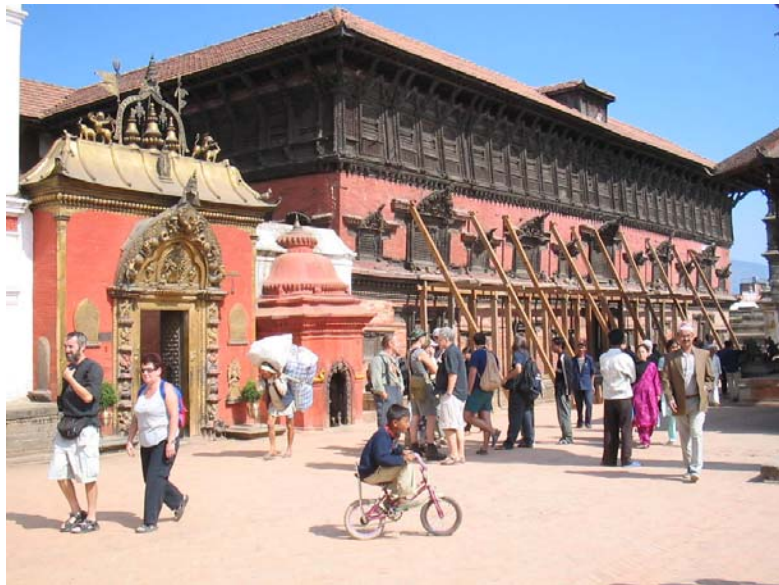
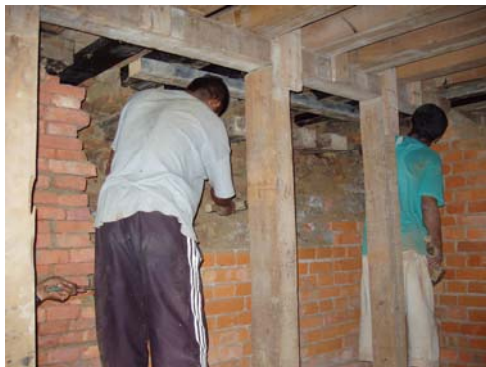
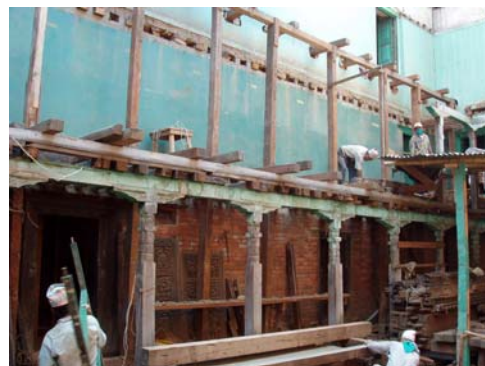
PHOTOS RELATED TO FIRST PHASE OF CONSERVATION WORK

- a. Dismantle ground floor's north and south wall and rebuild.
- b. To build southern wall in plum up to 2nd floor level.
- c. Inserting biteplate, beam and upright post into built up wall.
- d. Replaced old decayed ceilings
- e. Replaced lattice windows, doors and repairs.
- f. Protect Fresco painting
- g. Strengthen wall by providing wall plate.
- h. Replaced decayed wooden cornice.
- i. Remake floor.
- j. Remake gallery of courtyard.
- k. Build interconnection wall between south and north wall (4Nos).
- l. Replaced base of struts.

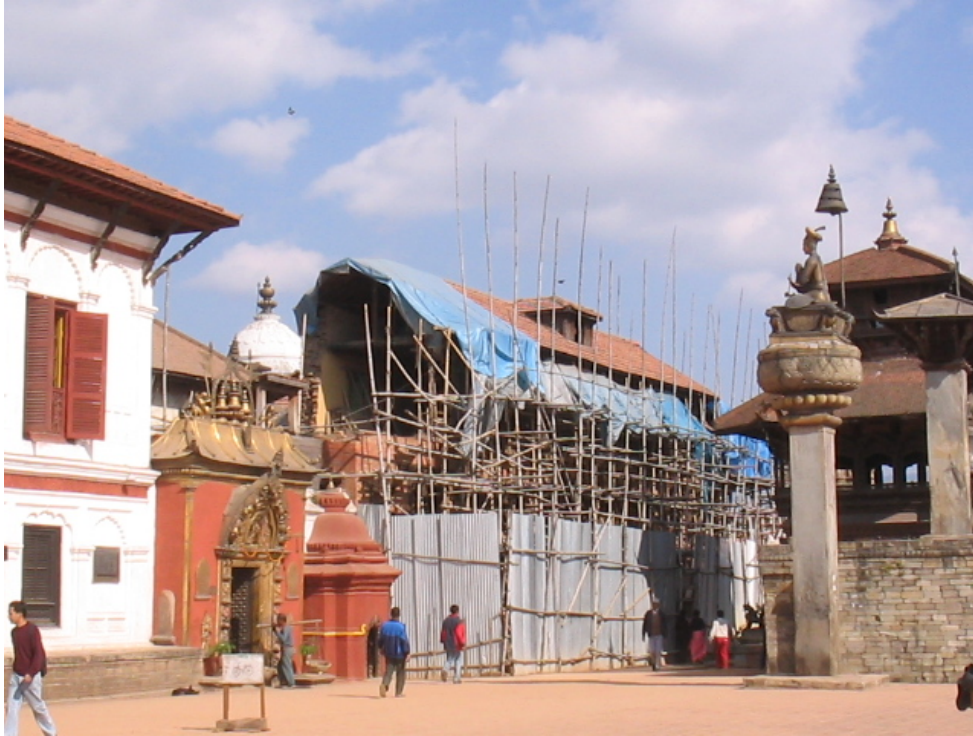
CONSERVATION WORK OF PALACE TOWARDS THIRD PHASE

- Dismantle of work from roof to 2nd floor level in south long.
- Replaced baseplate, beam and decorated post and *meth*.
- Replaced old decayed ceilings by new.
- Replaced bay windows of 55 , doors and repairs.
- Strengthen wall by providing wall Plate
- Replaced ceiling.
- Remake attic floor.
- Remake gallery of courtyard.
- Build interconnection wall between east and west wall (2Nos).
- Replaced base of struts.
- Repair old *sinkhwa*, *sardule* and making new *sinkhwa* and *sardule* for cornice over the 55 windows.
- Cantilever decoration.
