# Conservation and Management of the Far Eastern University Heritage Structures

## Focus on the FEU Nicanor Reyes Hall

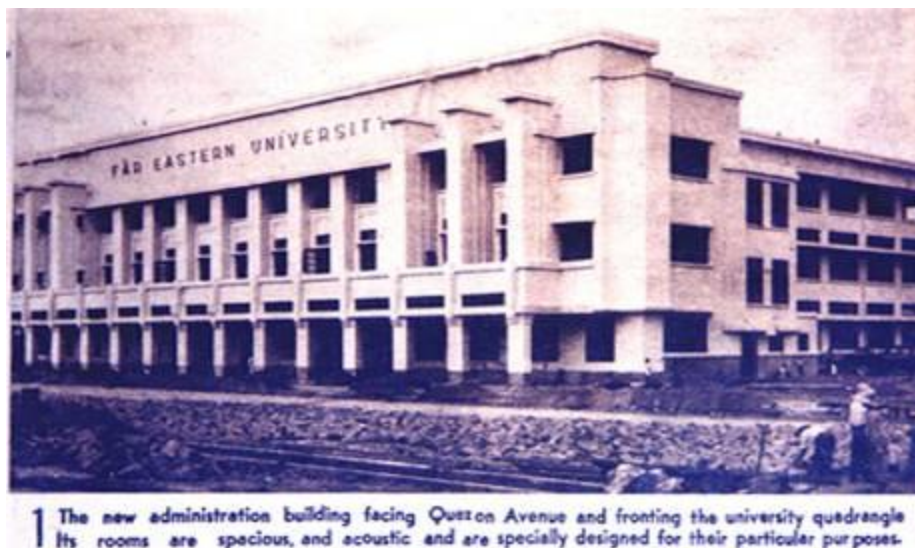
Fig. 1. An old photo of the FEU Nicanor Reyes Hall

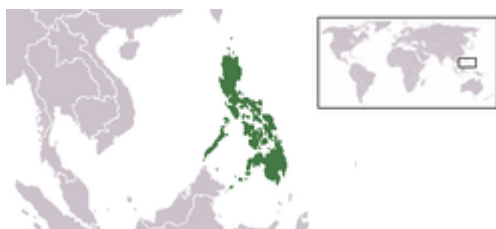
Fig. 2 Map of the Philippines

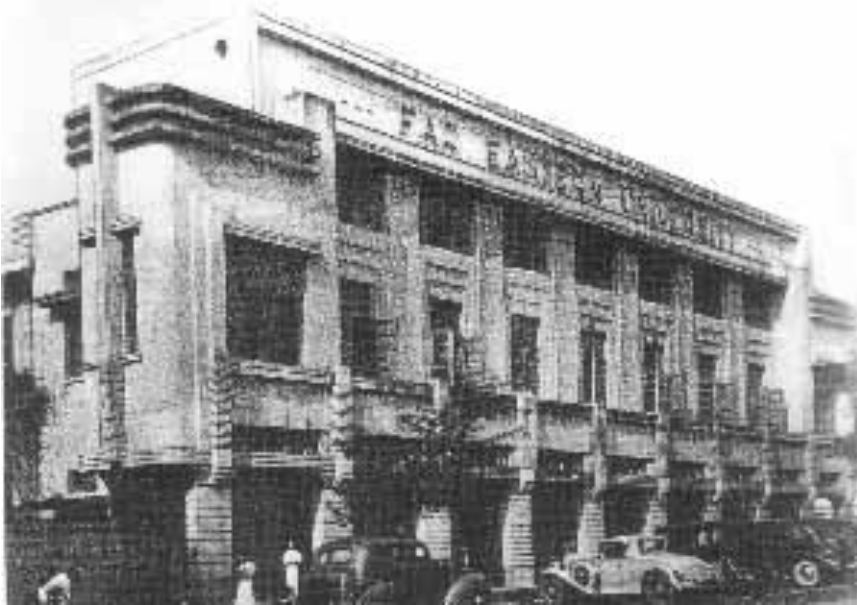
Fig. 6 The first Art Deco style FEU Main Building (2006 Azcarraga)

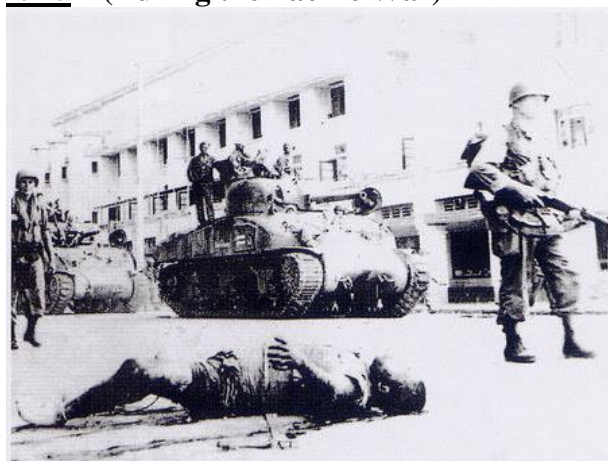
Fig. 9 The war ravaged FEU building (NRH) along Quezon Blvd.

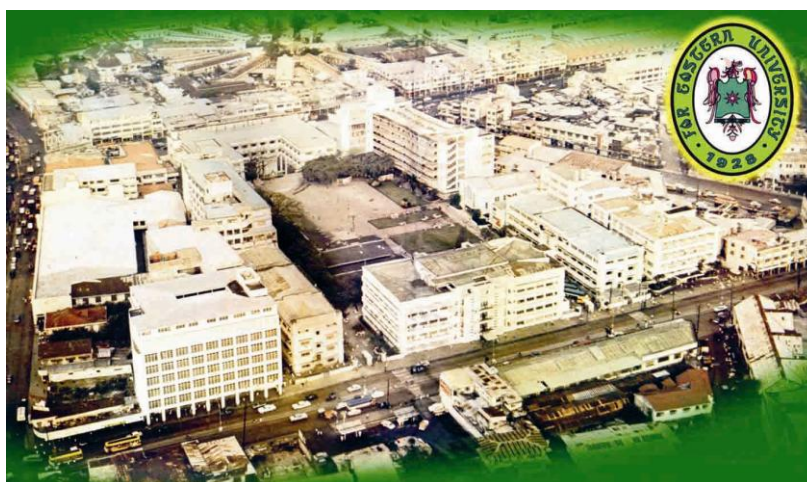
Fig. 12 FEU Campus – 1967

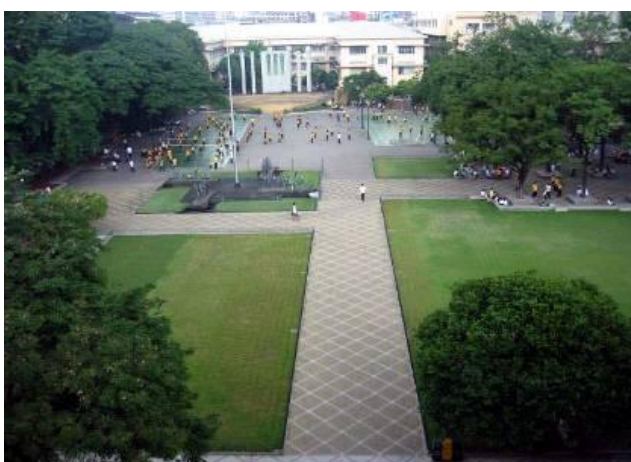
Fig. 15 The Nicanor Reyes Memorial Square. "One will sense the Founder's presence in the FEU campus. It was he who chose a modern architect for its heritage buildings, planted its trees and insisted an order and cleanliness."

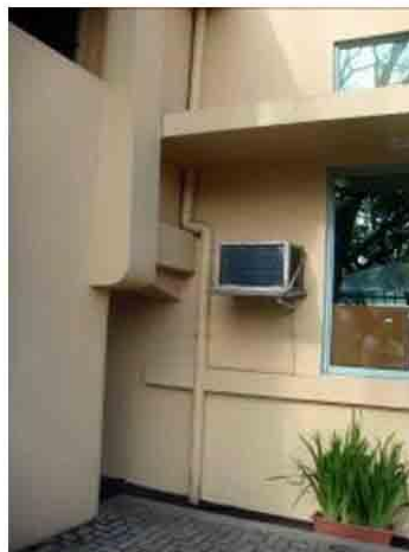
Photo 6. A WACU protrudes at the external envelope of the NRH. New awning glass windows replaced the old ones. **Should be covered with grille works to blend with the Art Deco grilles.**

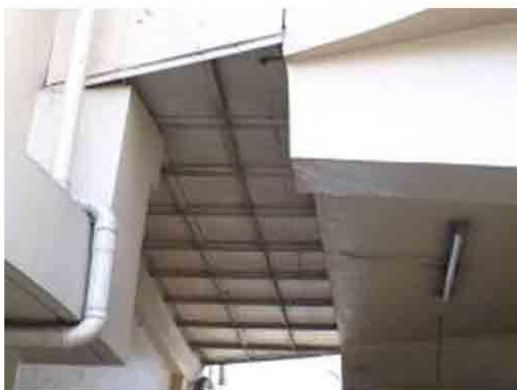
Photo 4. A closer view shows steel frame connector between NRH and Science Building. **Should be treated with aesthetic element.**

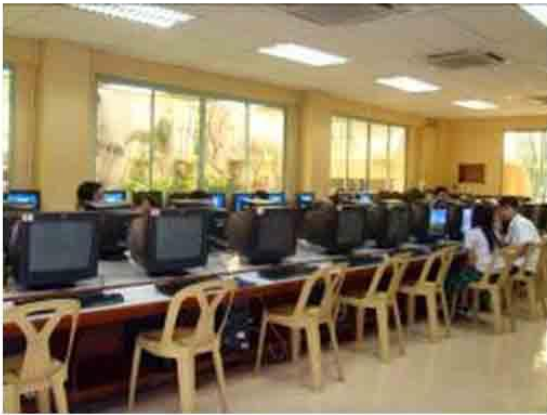
Photo 9. A Typing Laboratory Room (1980) is adapted to a Computer Laboratory Room. Air conditioning ducting and cabling were installed at the ceiling level externally affecting the internal aesthetics of the room. **Should be covered but accessed with openings for ease of installation and maintenance.**

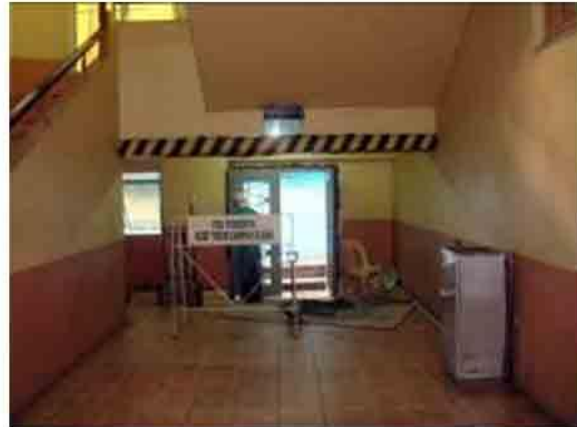
Photo 12. An original Art Deco side door entry being refurbished (Feb. 9'09). An overhead safety buffer (yellow and black stripes) was placed at the edge of the stairway landing because of the low height clearance of floor to stairway landing slab.

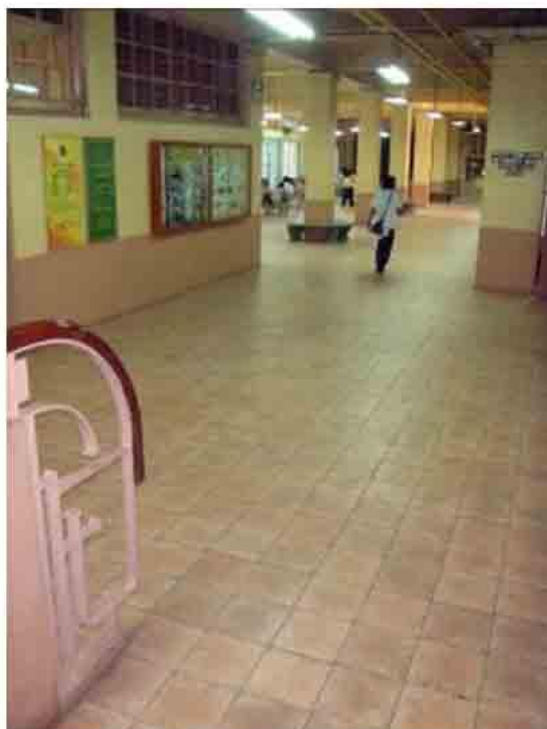
Photo 14. Ceramic floor tile finish replaced the old cement plaster finished flooring at the hallway leading to Study Area

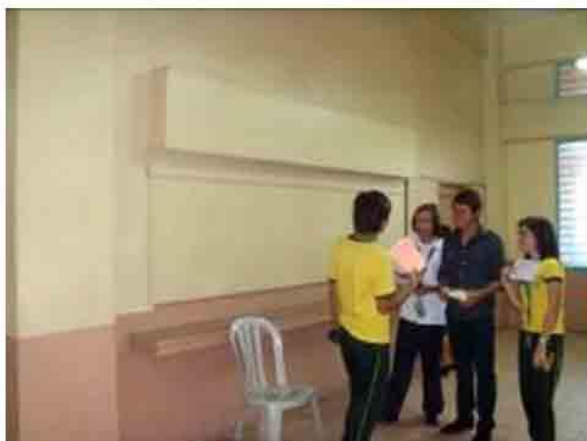
Photo 15. This space, used to be a Post Office, is now a storage room. An Art Deco grille work used at the counter before is covered with a painted plywood to match the color of the wall.

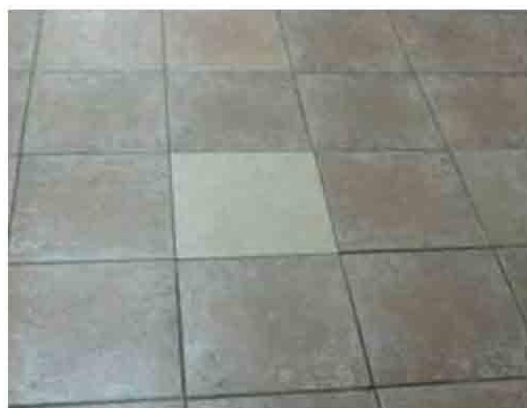
Photo 19. Incompatible color of tile used as replacement

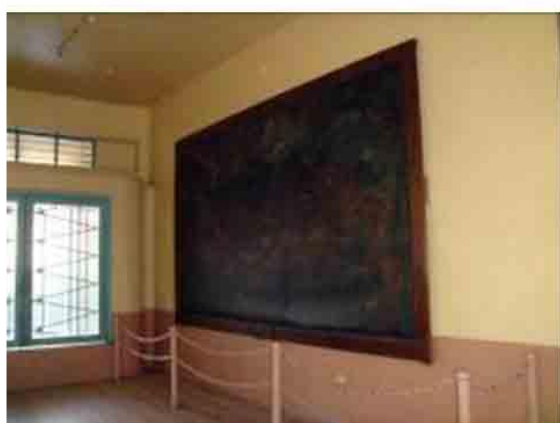
Photo 17. A 1947 painting entitled "Our Malayan Heritage" by Simon B. Saulog hangs lifelessly at the left side of the NRH Study Area. Steel chains on steel posts serve as a safety barrier for the painting. Track light at the ceiling is not functioning. **Should be given emphasis.**

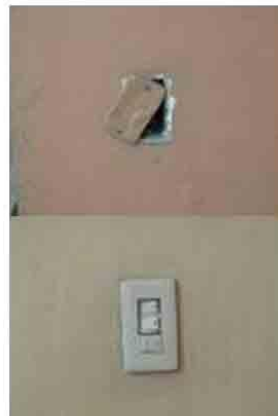
Photo 24. Busted electrical box and electrical switch. **Should be repaired or removed if not operational.**

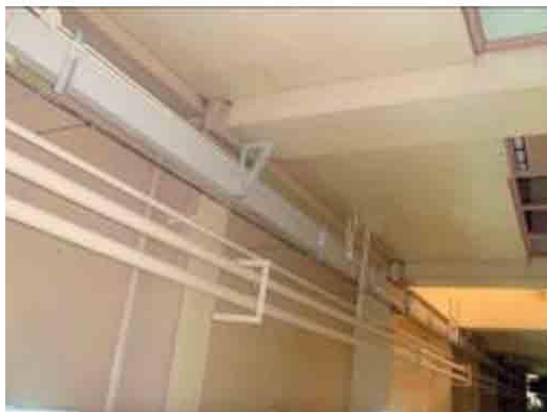
Photo 22. Electrical raceways and air conditioning ducts align the GF ceilings of NRH.

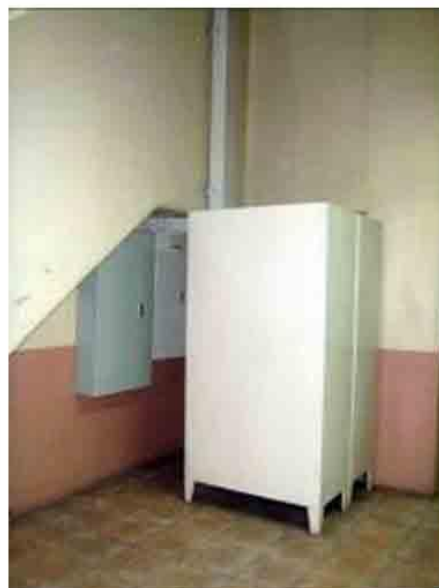
Photo 25. Utilitarian equipments placed indiscreetly near stairway. **Should be covered from view.**

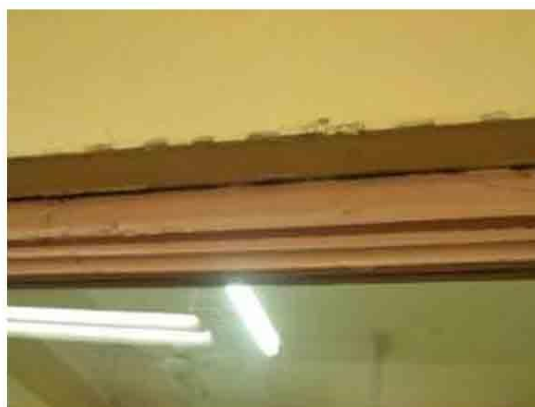
Photo 29. Close-up view of chipped plaster finish. **Should be repaired.**

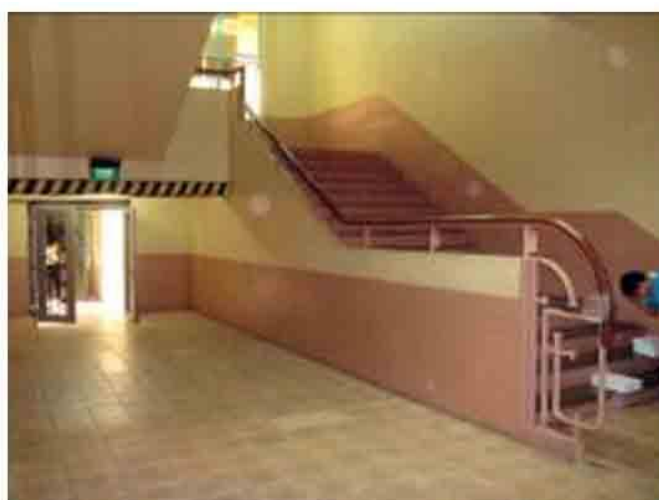
Photo 30. Left wing side stairway is a replication of the right wing side stairway showing symmetry in the planning of NRH.

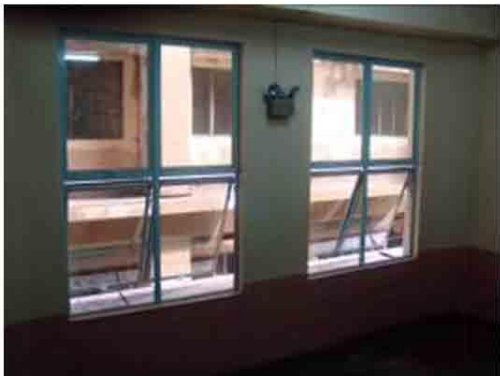
Photo 31. Newly installed awning glass windows at the stairway landing replaced the old ones.

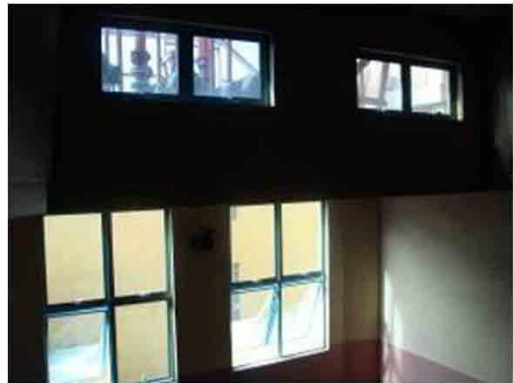
Photo 33. Heat exchanger pipes installed outside

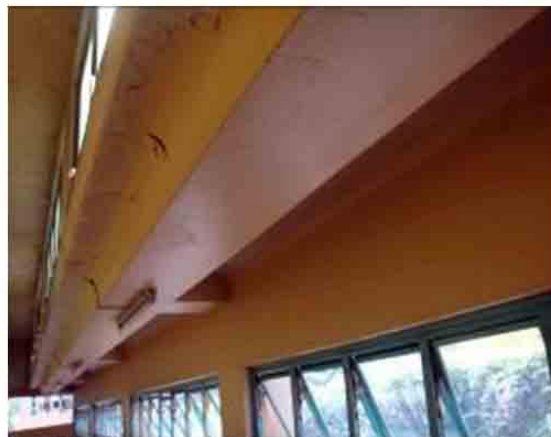
Photo 38. Paint cracks and peels at the bridge way ceiling

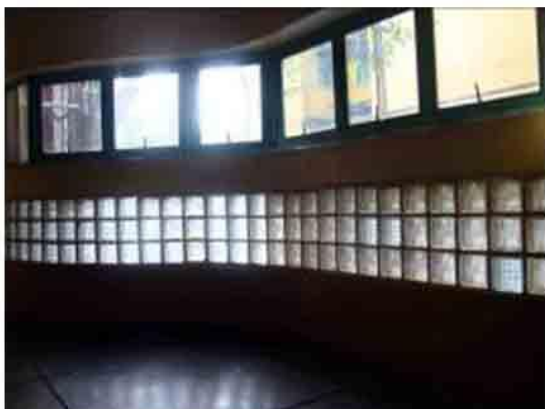
Photo 36. Original Art Deco glass blocks placed along bridge way

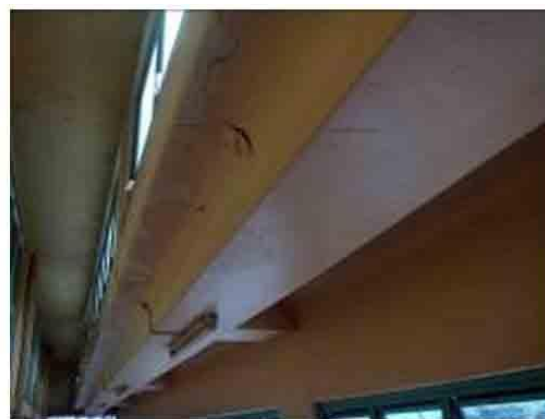
Photo 39. Close-up view of existing cracks and peels. **Should be restored.**

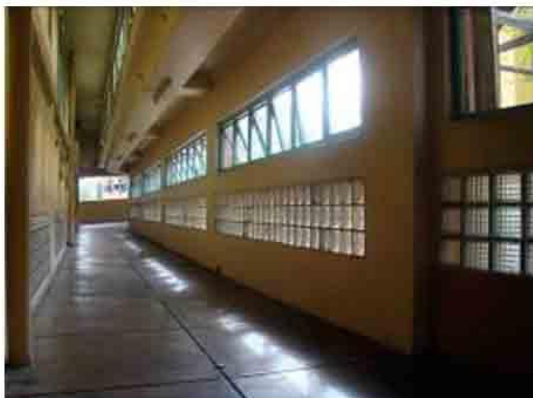
Photo 37. The bridge way with original flooring, glass blocks, and with newly installed awing glass windows

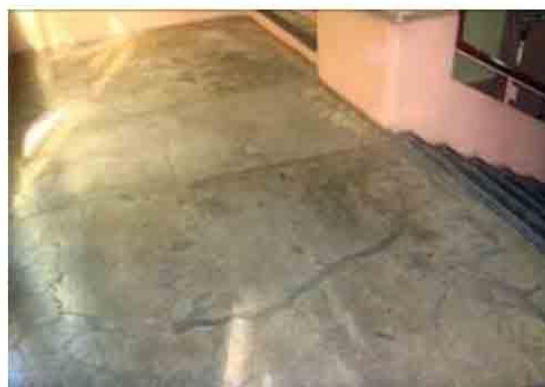
Photo 40. Original cement plaster finish of stairway landing shows remedied patches of cracks.

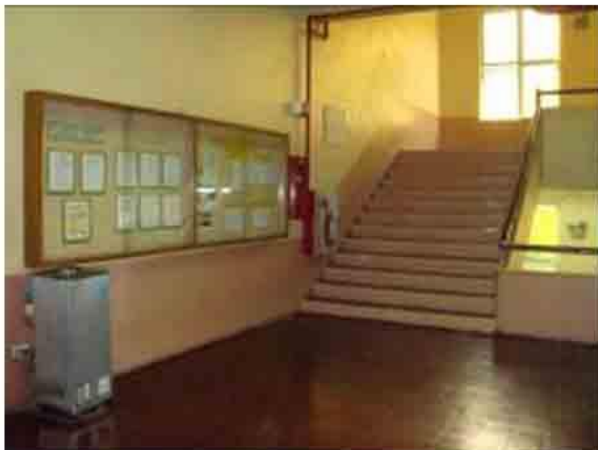
Photo 41. Right wing stairway leads to 3F. Note of the presence of utility pipes (fire sprinkler) for fire mitigation.

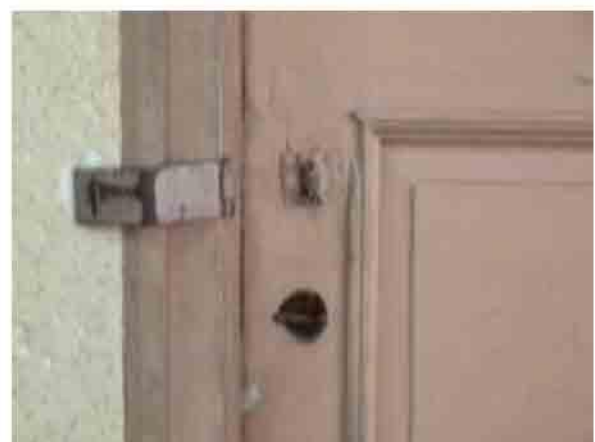
Photo 46. Present condition of an original wooden panel door of one of the classrooms. **Should be restored.**

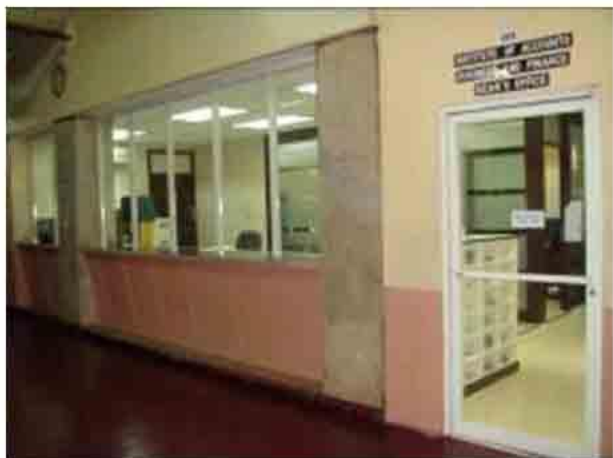
Photo 47. Newly refurbished IABF Dean's Office at second floor

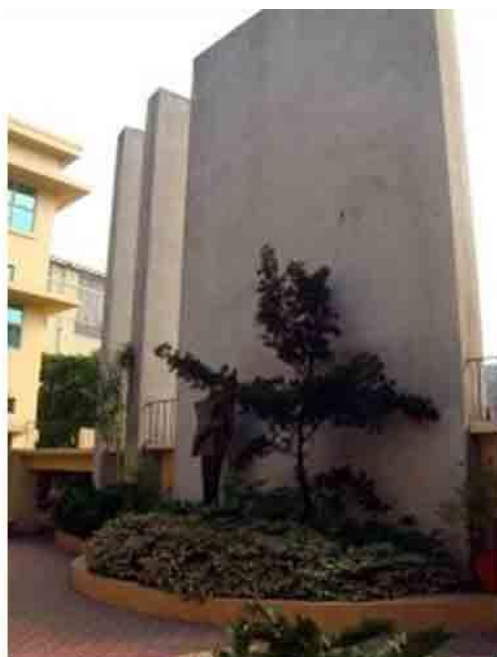
Photo 68. Back of the Grandstand adjacent to the commemorative garden. A sculpture of the university founder, Nicanor Reyes, Sr. stands isolated and flanked with plants. **Should be given more dignity and emphasis.**

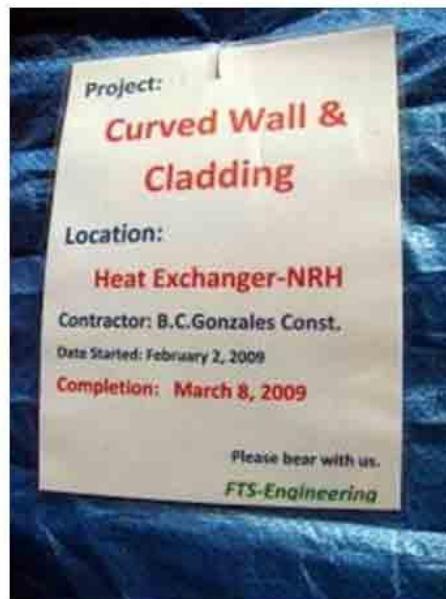
Photo 69. A signage is placed at the ongoing project at NRH.

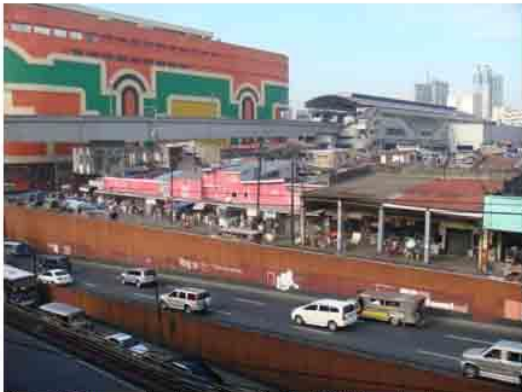
Photo 73. Quezon Boulevard fronting the NRH Facade shows blighted condition of neighboring vicinity.

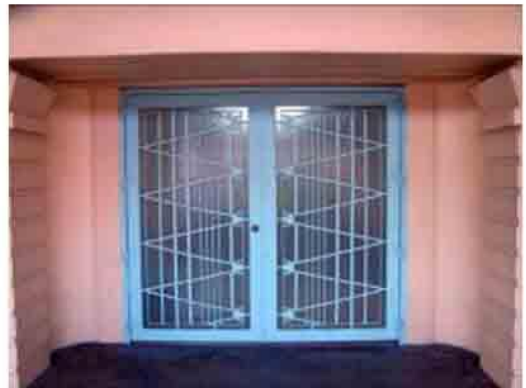
Photo 76. The main entrance door (center) at NRH facade is no longer being used for access. **Accent lighting should be placed.**

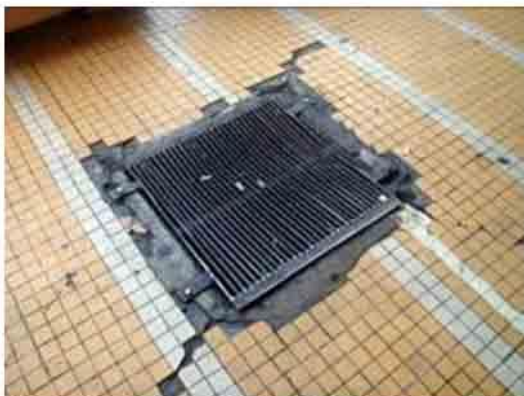
Photo 78. An area drains catch basin. **Tiles abounding drain should be replaced and repaired.**

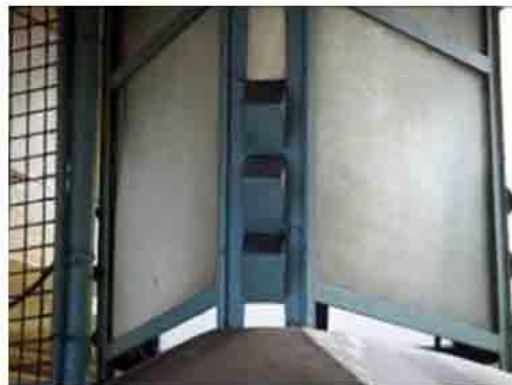
Photo 80. Original Art Deco lamp post no longer being used located at the entrance gate of FEU. **Should be revived and emphasized.**

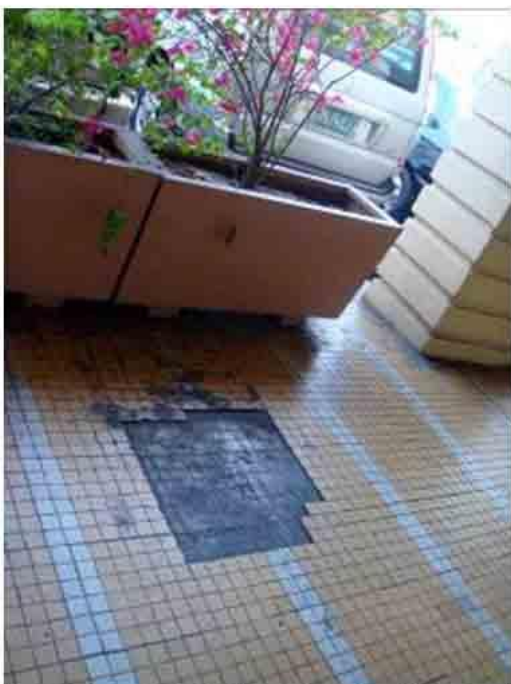
Photo 79. A neglected part of the arcade flooring with original tiles missing. Note also of wooden plant boxes lined along the arcade sidewalk. **Should be replaced.**

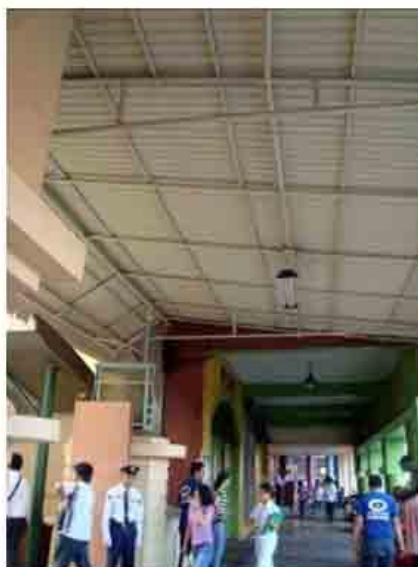
Photo 81. A steel corrugated roof canopy covering gate entrance. **Should be replaced with Art Deco style covering to blend with aesthetic style of NRH facade.**

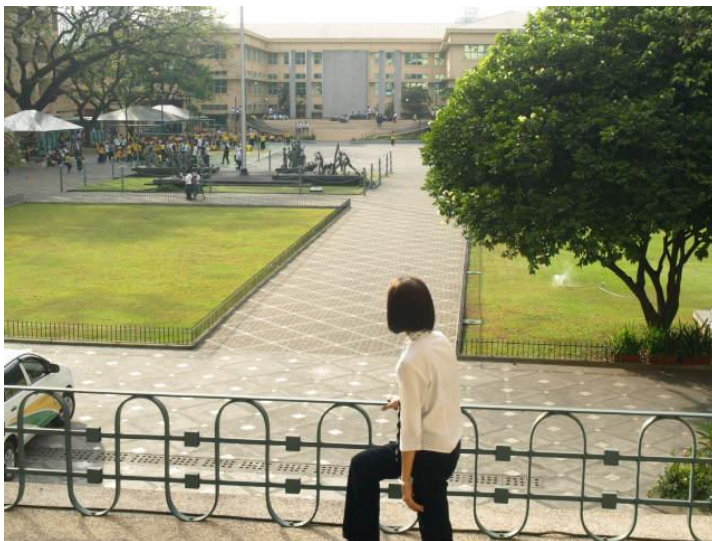
Fig. 20 The author looking at NRH from the Administration Building
