The Great Hammam in Prishtina

Conservation, Restoration and Re-Functionalizing Project

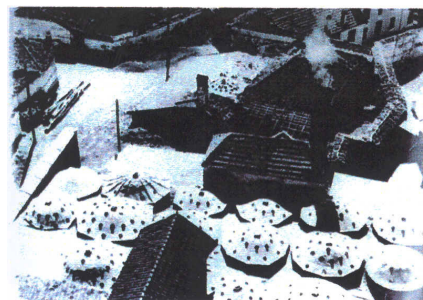
Photo from the above of the Hammam, Year 1955

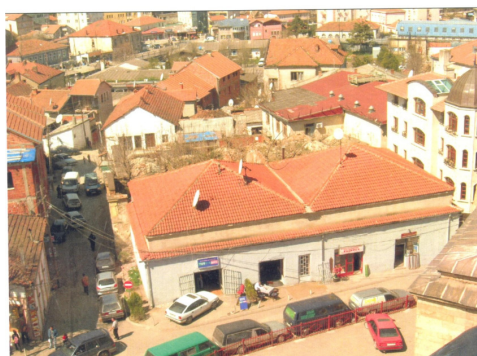
View of the building just before the restoration

Since 1989 no maintenance work has been carried out despite the building's status as one of the oldest Ottoman structures in the historic part of Prishtina and a rare and valuable example of public architecture of this type. During this time the building has been used as a storage for construction materials, and partially, the main entrance halls were adopted as a shops. In year 1995 the shops, the eastern part of the building, has burned down. In this occasion the main entrance halls have suffered a lot, where the walls were the rebuilt walls and together with the roof covering were done in very unprofessional and improper way. This part of the building continued to be used for shops until recently, when the first conservation activities have been started, in year 2007, while the other part of the building was left to ruins.
