Conservation and Management of Historic Buildings
Advanced International Training Programme

Conservation of Shakhari Bazar

Md. Bahauddin
Executive Engineer
Public Works Department
Bangladesh

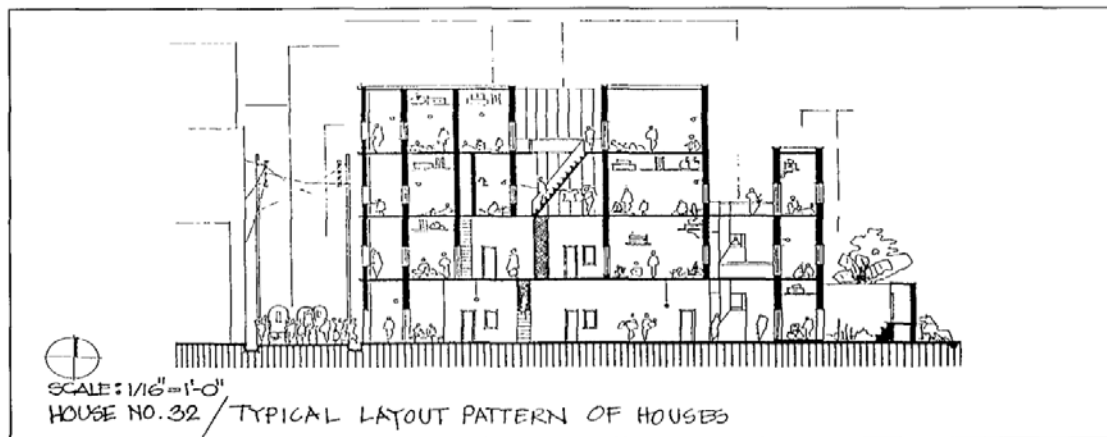
Section through a typical house showing height and disposition of rooms Each house is occupied by many families

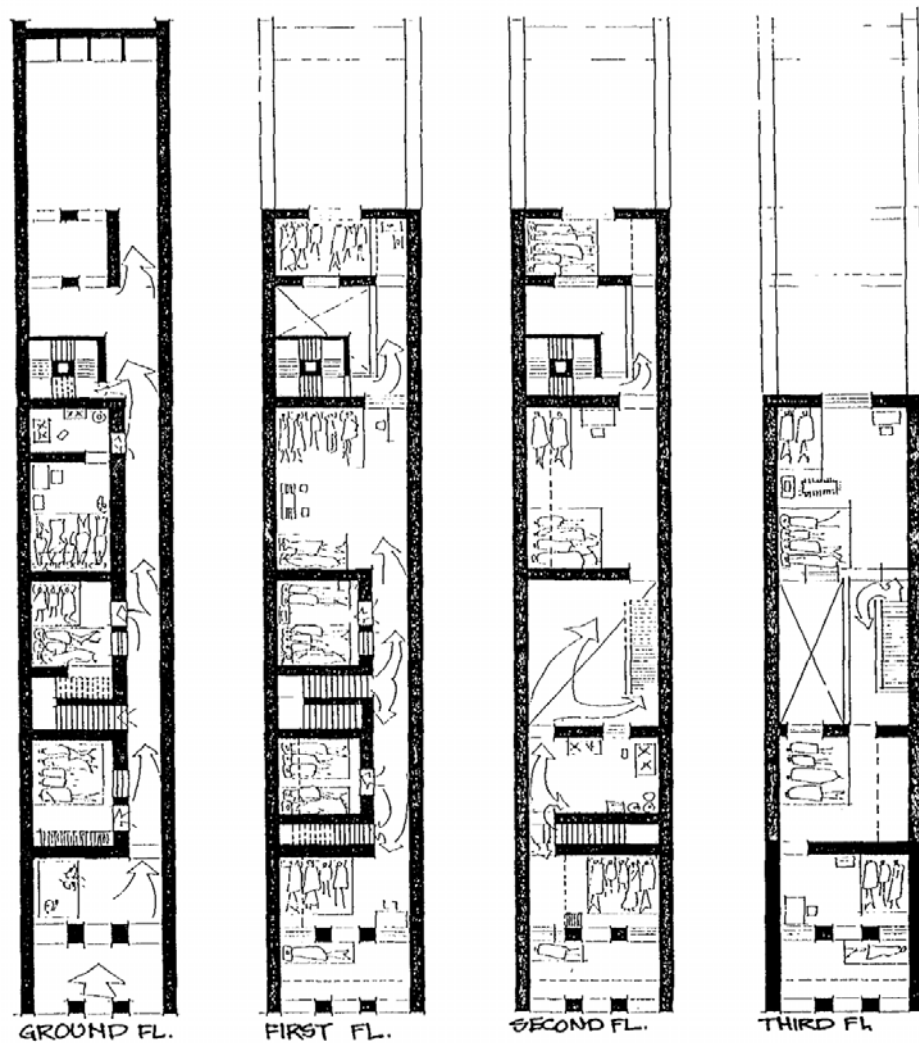
Plan of the interior

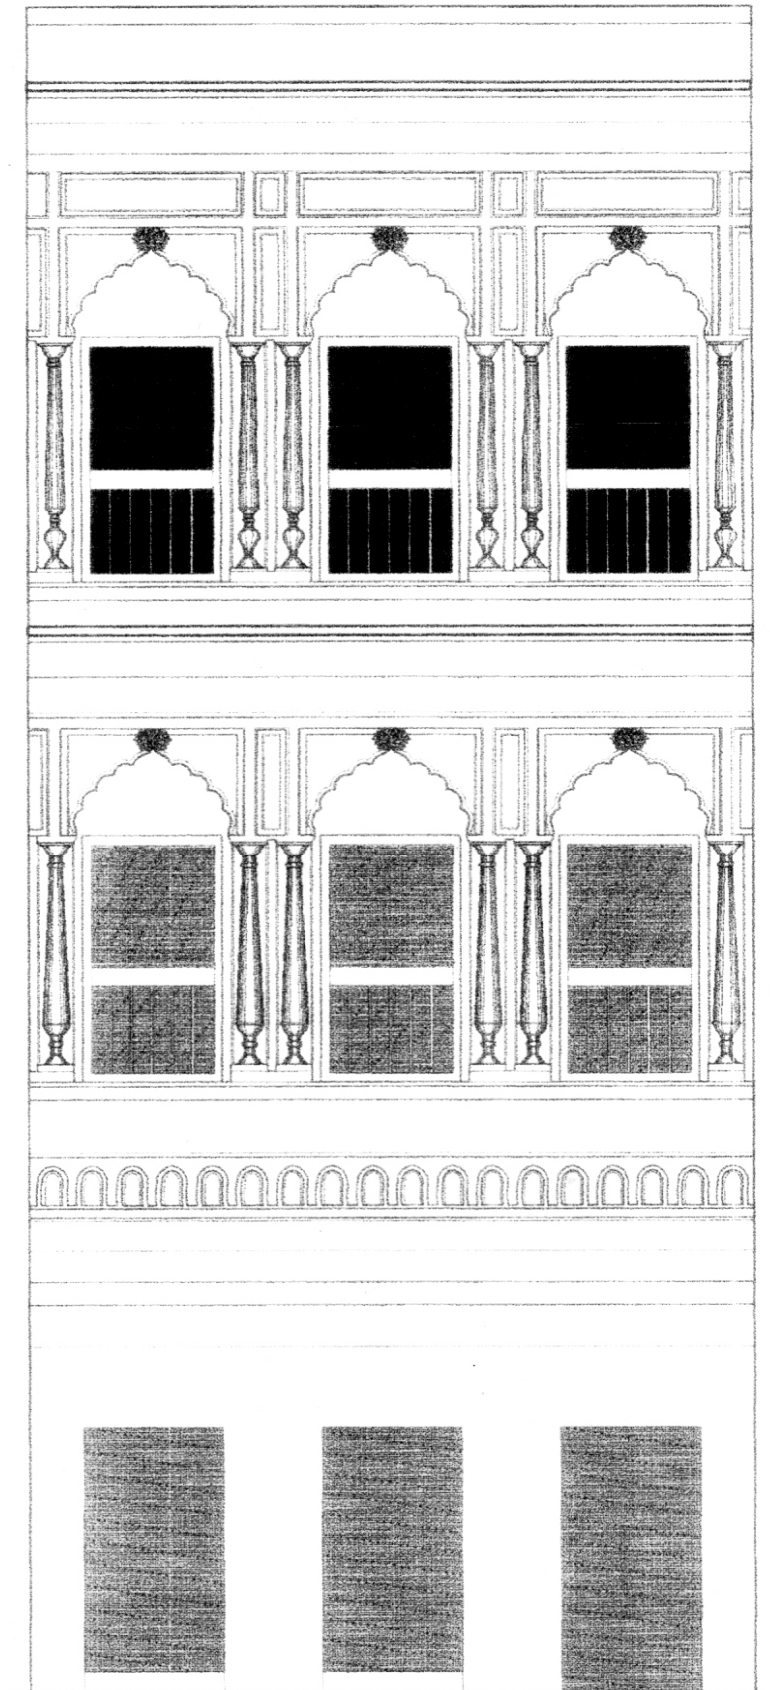
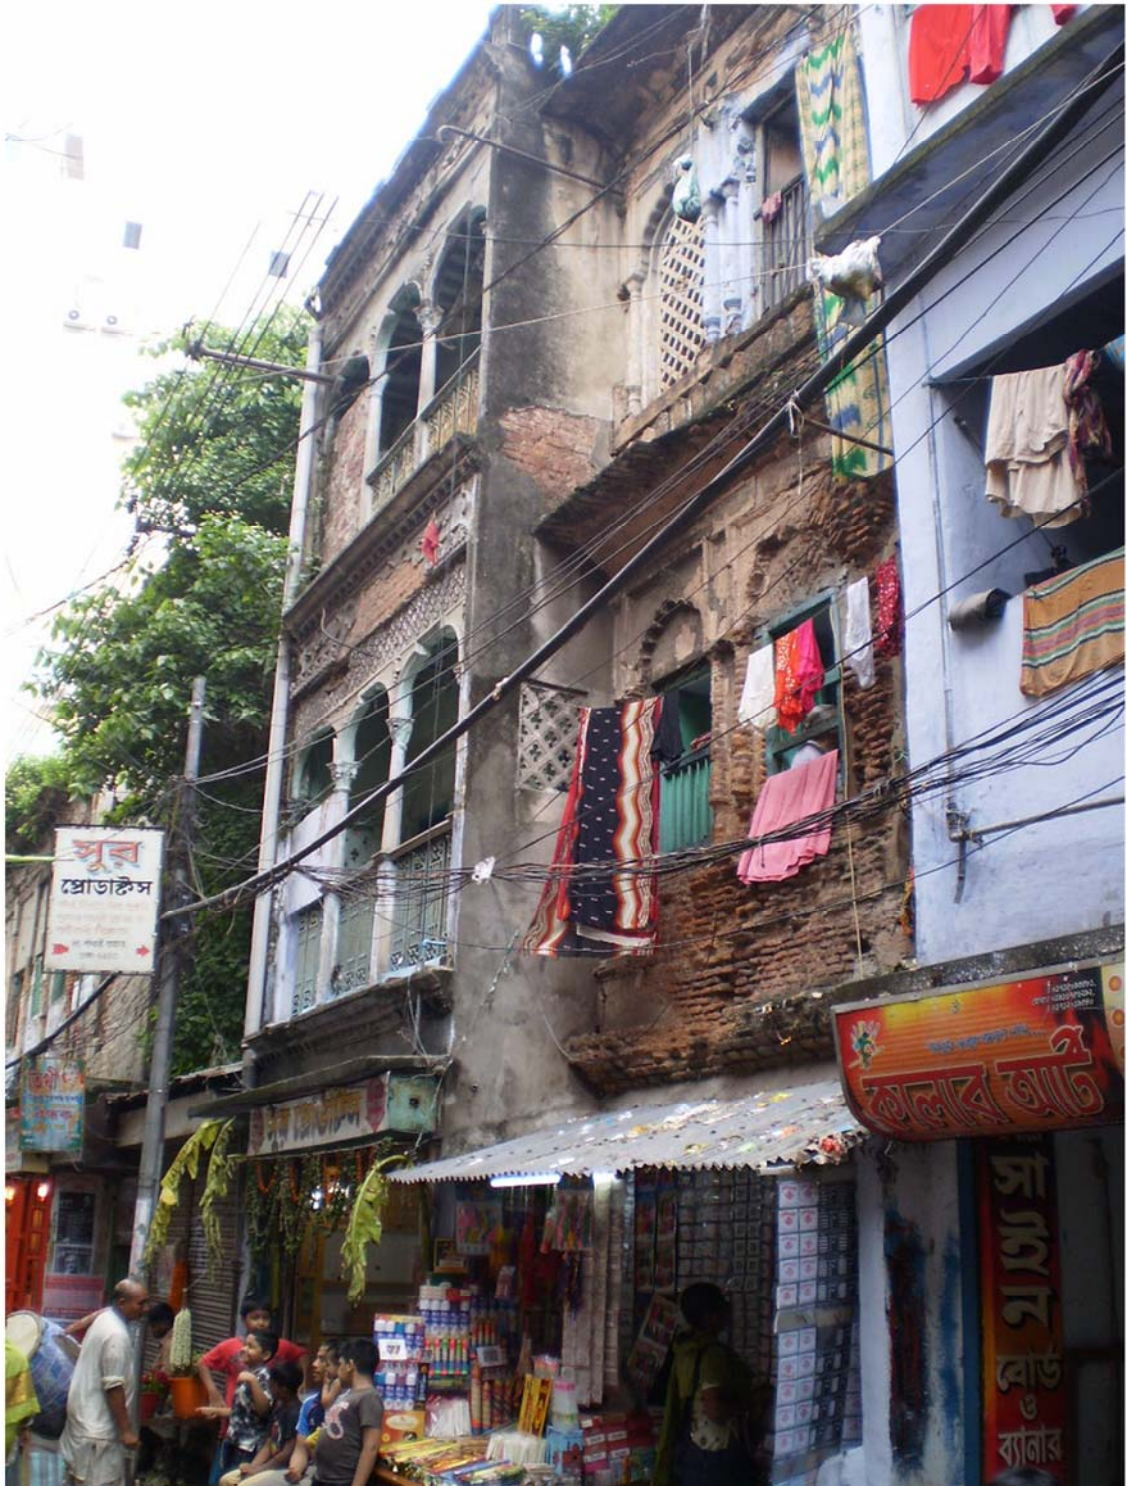
Proposed for Restoration House # 61, House # 62

The front façade of house no 61 is badly degraded but it is possible to restore the previous façade by employing well-experienced mason under precise supervision of architect & engineer.

The elevation of the front façade of the building after the restoration work will be of the following shape.

The house no-62 is apparently in good shape particularly the front façade for both of the buildings interior work is limited within the removal of damaged plaster in wall & ceiling, brick work, RCC work, new plastering work in the damaged area, renovation of sanitary, water supply line & lime washing only. The estimated cost for the restoration work of house no-61 is US \$ 9,682.00 and house no-62 is US\$ 7,858.00 respectively (Engineer's Estimate in the Appendix-2, 3).

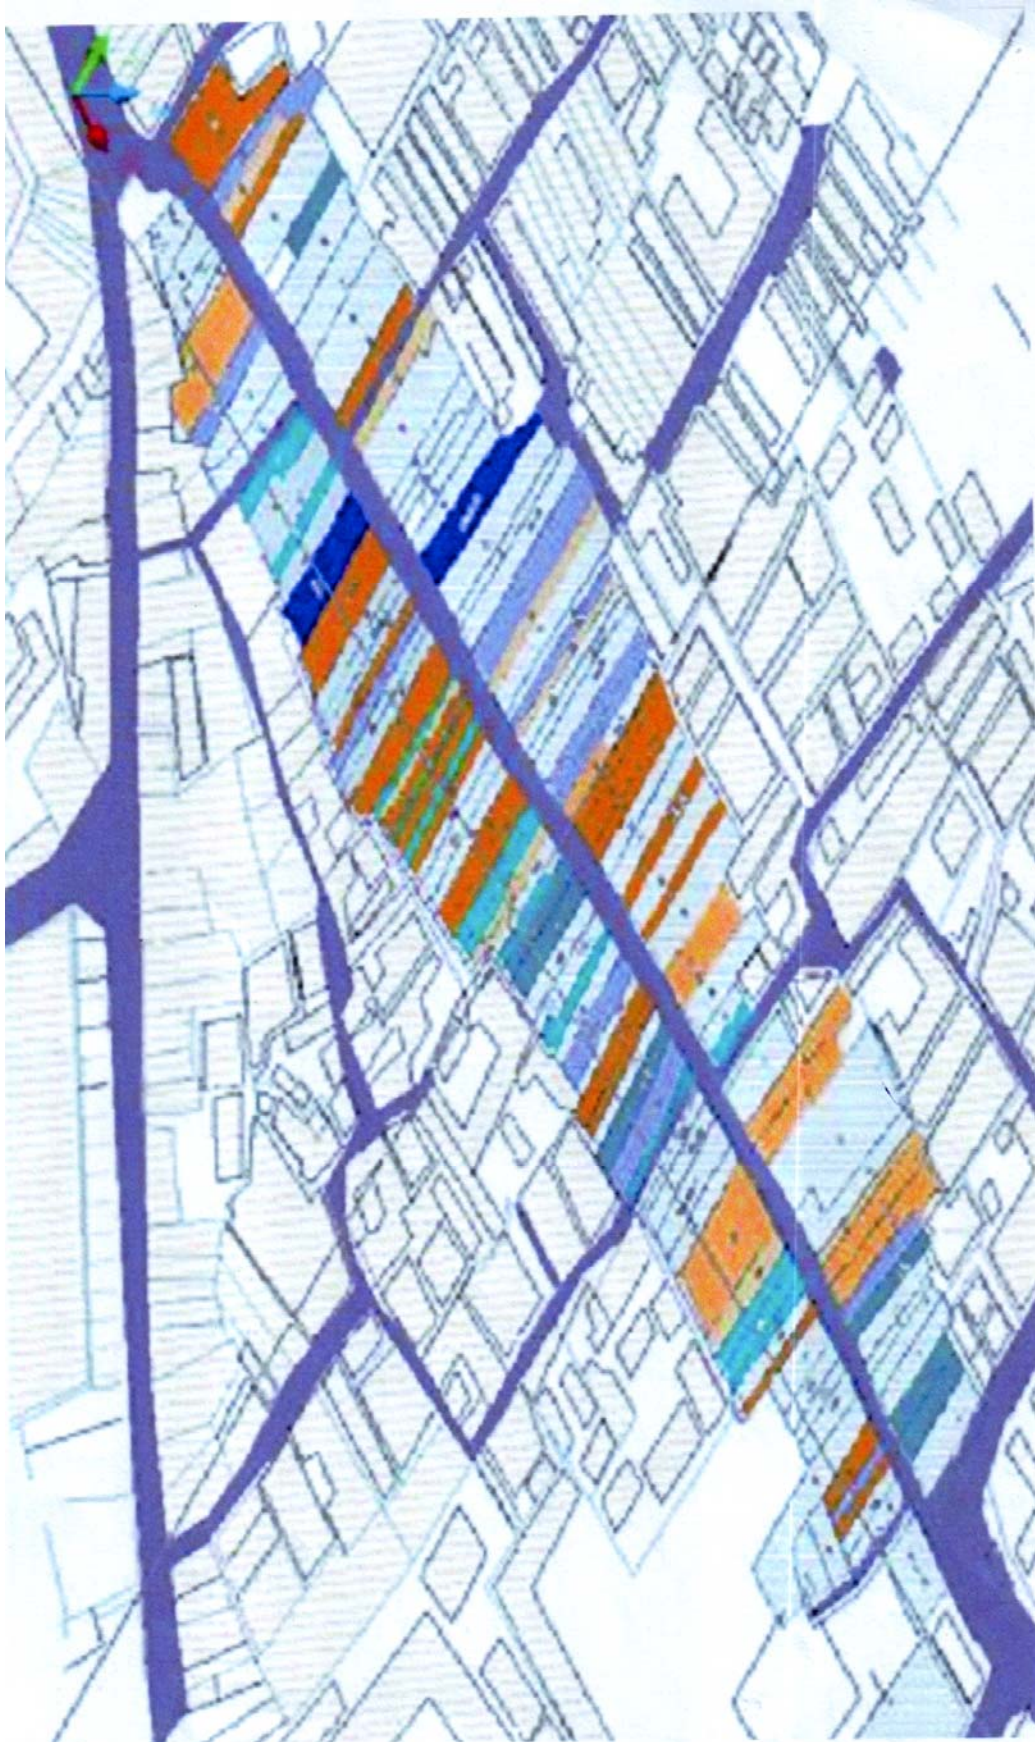
Proposed walk way at Shakhari Bazar

The objective of this is also to promote and manage tourism in ways that respect and enhance the heritage and living cultures of the host communities. to provide the conservation area a well managed opportunities for tourists the accessibility in to the area should be enhanced. For this purpose a multi-storied parking space is proposed for facilitating the parking space of the tourist's vehicle of Main Street of Shakhari bazar in to pedestrian walkway to extend an experience for the tourist who is enjoyable, respectful and educational. It is found that the Plot # 56 is currently lying vacant which is now used for community festivals. It is proposed for a parking space for the vehicles of the tourist. The parking space will be provided in a multistoried building and festivals of the community may be accommodated in the top 2-story of the building. The settlement at Shakhari bazar has grown along a narrow road 14'-0' wide connecting Islampur road with Nowabpur road, along a distance of

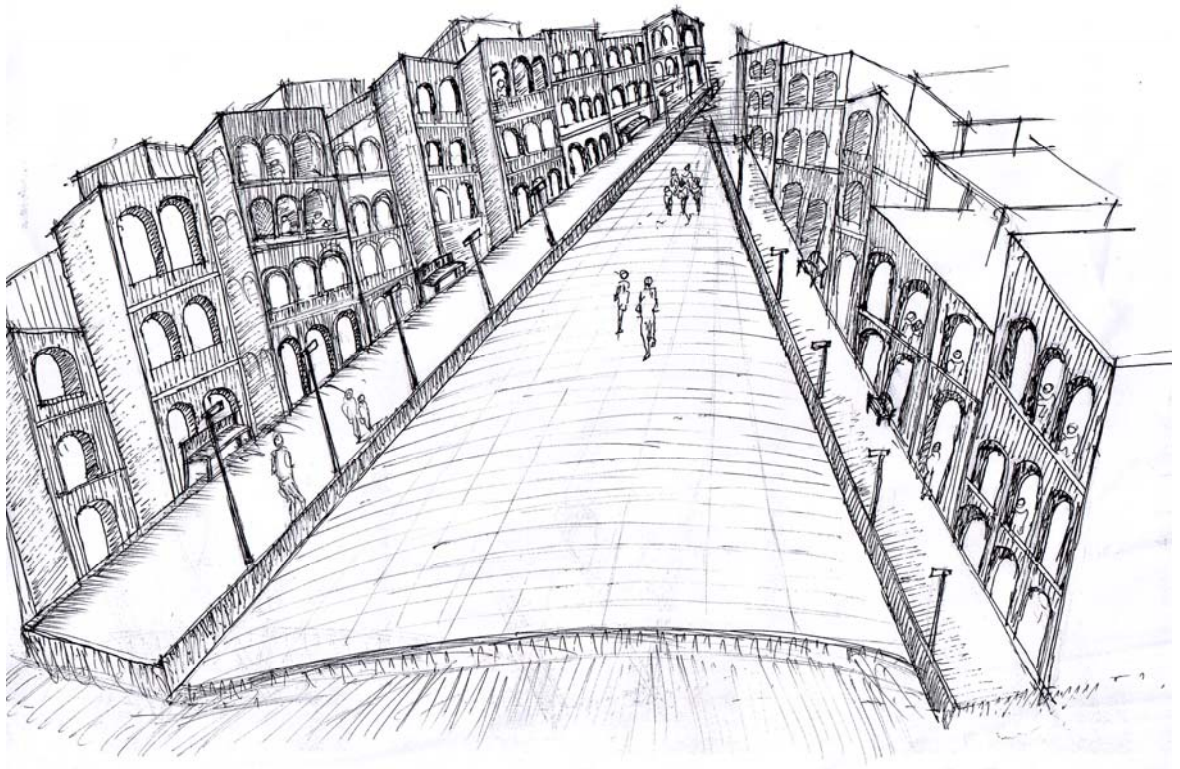
Proposed walk was (no vehicular traffic is permitted)

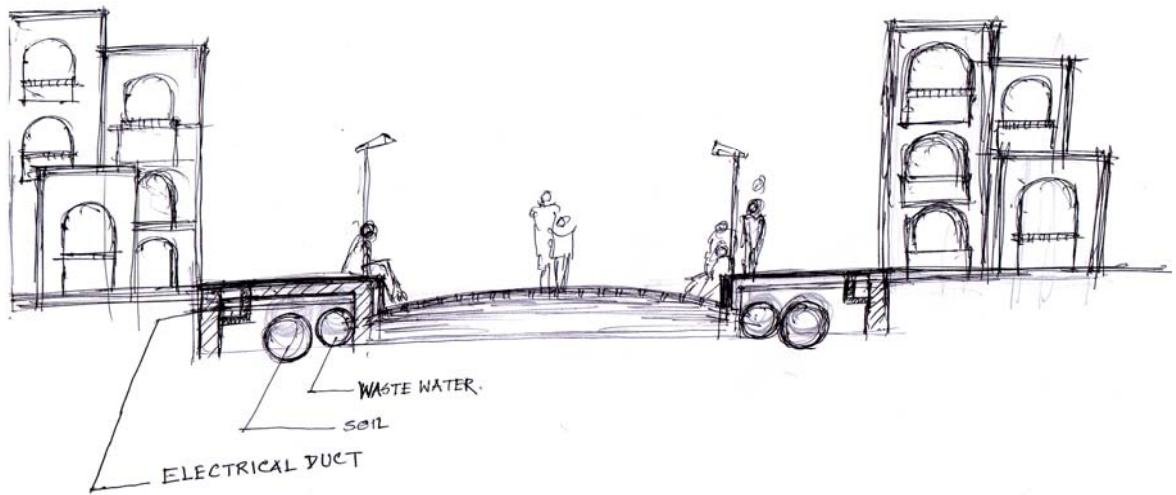
X- section of the proposed walkway showing the underground utilities provision

Overhanging telephone and electrical cable: The T&T and electrical cables are overhanging along and across the building. The overhanging cables undermine the aesthetic view, heritage image of the area. So there should not be any cables overhanging the buildings rather the cables should be concealed under the main walkway.

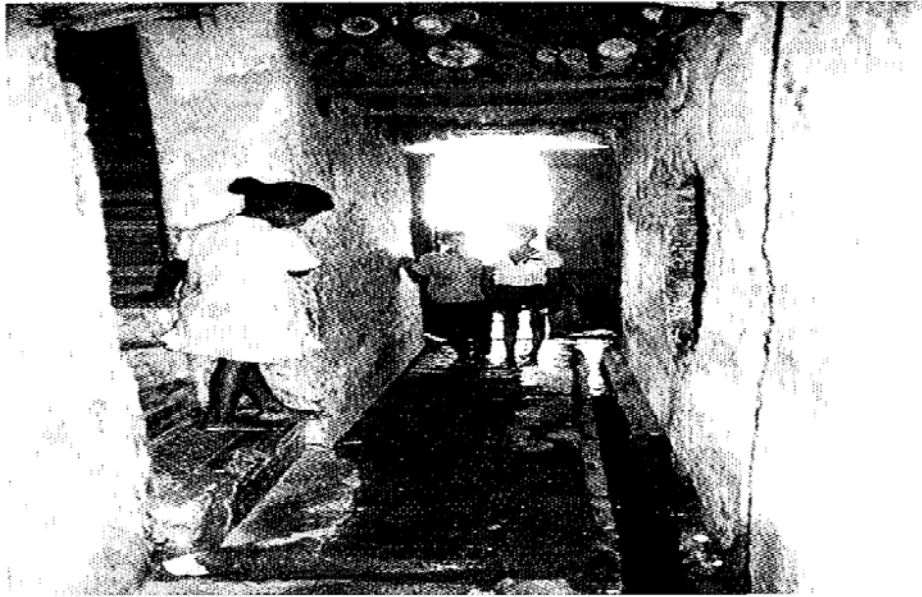
Corridors are narrow but usually provide private access to all of the many families occupying these sub-divided dwellings

2. Access to the inner part of the house is through a corridor placed at the side of the house. Corridors are usually divided by a party wall to provide access to other rooms and to upper floors through stairways. Corridors ultimately terminate to service areas at the rear.
