Conservation in Pueblito Archaeological Site.

Tayrona National Natural Park, Colombia.

A Proposed Maintenance Plan.

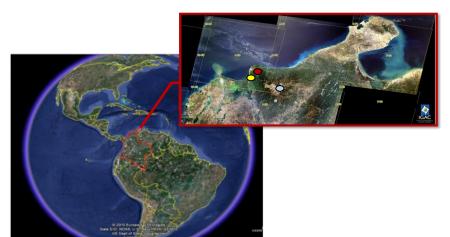
Figure 1. Localization of Colombia in South America. The figure shows the North region of Colombia where is located Pueblito (red point), Santa Marta City (yellow point) and Sierra Nevada de Santa Marta (blue point).Sources:google earth (global) and Instituto Geográfico Agustín Codazzi.

The archaeological site of Pueblito, also known as Ciudad Chairama, is located in the north region of Colombia, in the country sides of Santa Marta city , inside the Tayrona National Natural Park (Figures 1 and 2). The altitudinal variation, between 0 meters to 900 meters high above the sea level, make it one of the most biodiverse places in South America, giving it also an incredible range of ecological diversity represented by more than 100 species of mammals, 300 species of birds, 60 of reptiles and 50 species of amphibians (Figure 3). Some of these species are found nowhere else on the planet. The temperatures range from 16°C to 28°C and humidity can reach levels of 90 per cent or more due to the abundant rainfall.

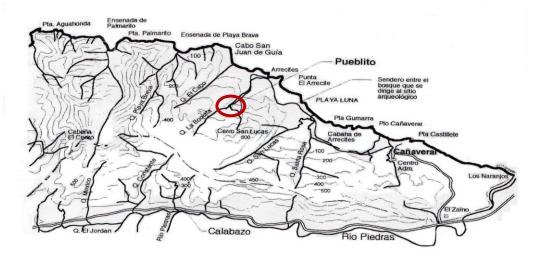
Throughout the 16th century, multiple governors tried, and failed, to Christianize and subjugate the indigenous population to Spanish rule. The Spanish only ruled over the immediate area around Santa Marta Figure 2. Localization of Pueblito, inside the Tayrona National Natural Park. Map taked and adopted of Zuluaga (1996:160)

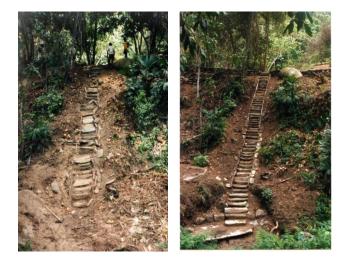
Figure 6. Cadavid photos of phase II (1988) before and after the intervention.

- Compile, organise and digitalise the existing conservation information about the area produced by Cadavid during the phases between 1987 y 1993 (Figure 6).
- Evaluate the main characteristics and behaviour of visitors (age, origin, site usage).
- Analyse and identify the major problems affecting the structures whose walls had collapsed.
- Identify and analyse the type of stone of the structures and type of biological mechanisms that are affecting them.
- To intervene the collapsed wall and those at risk of collapsing.

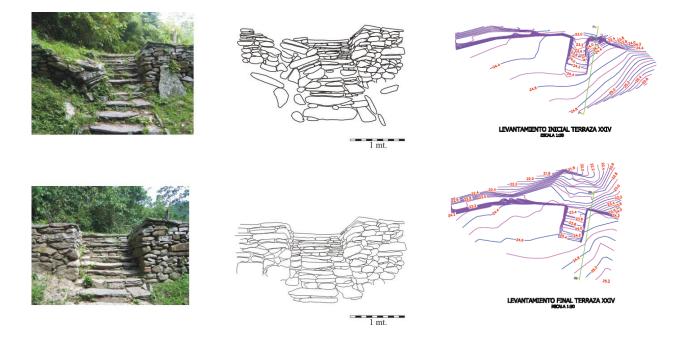
Figure 7. Type of documentation produced in the 2008 intervention: photos, drawings and topography

• Develop detailed documentation on the intervened structures before and after the intervention that includes topographical surveying and sectional drawings (Figure 7).
