Conservation and Management of Historical Buildings Advanced International Training Program 2009-2010 Lund University SIDA

Restoration and Maintenance Plan of Alfred Ilg's Residence

Abnet Gezahegn Berhe

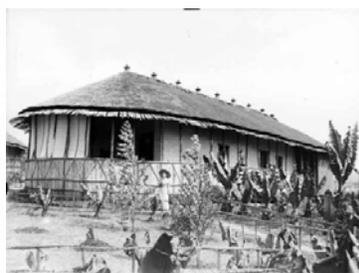
Figure 1: Left: View from Alfred Ilg's Residence to the grand palace, Right: Alfred Ilg's residence in 1900

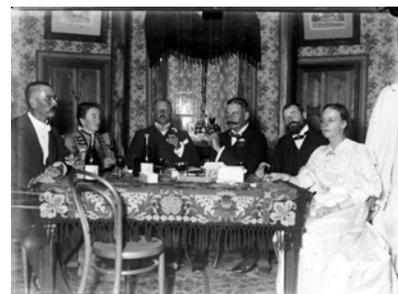
Originally, the house had a rectangular plan. The veranda running around the entire plan was oval and the oval roof on timber posts was covered with thatch. The interior of the house was furnished in a European fashion with imported wallpaper and, a supreme luxury, a decorated fireplace. The Compound was landscaped with different indigenous trees, a fish pond was also found in the compound to the left of the house using the natural spring water.

Figure 3: Left: Mrs. Ilg in the compound with the children around 1904, Right: Living Room of the house in 1900

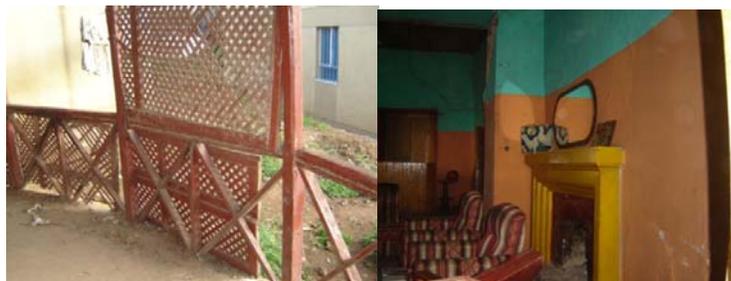
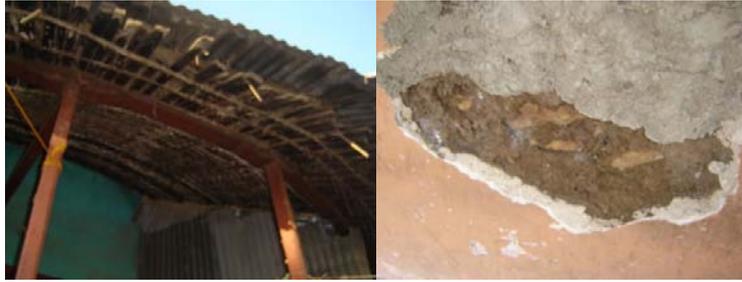
Figure 4: Expected needs of repair: top Left - hand rails on the veranda, top right -fire place
bottom left- reed ceiling, bottom right-crack on walls due to the introduction of Cement mortar.

Expected needs of repair and maintenance: Sanitary fixtures, Kitchen, floor parquets and external tiles, wooden door and window frames, glassing, bed room furniture, wooden beam in the living room, external plastering, electrical cables and fixtures, the fire place.

Conservation, restoration: the fish pond to be reconstructed as it was but this time at the centre of the compound. The only reference obtained about the type and position of the fish pond is based on the interview with the recent tenant of the house and the neighbourhood elders. The reed ceilings, the thatch roof, paint, wall paper, replacement of the mortar plaster with the original lime plaster. New functions: Phone lines and internet networking, technical equipment.

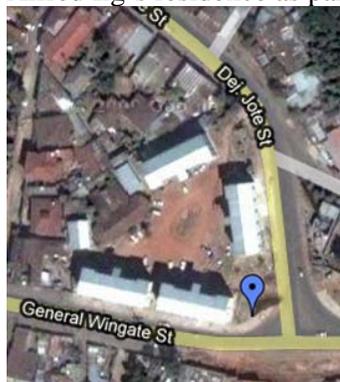
Figure 6: Satellite map of Alfred Ilg's residence and Compound

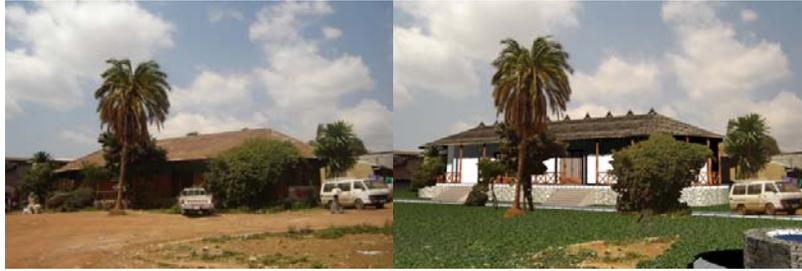
Figure 7: Left: Alfred Ilg's Residence in its current situation, Right: The Proposal

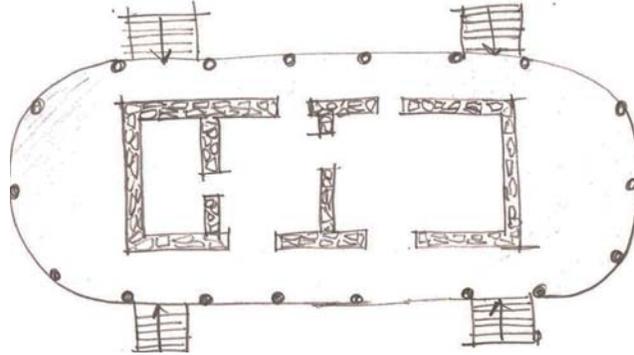
Alfred Ilg's Plan in the 1890's

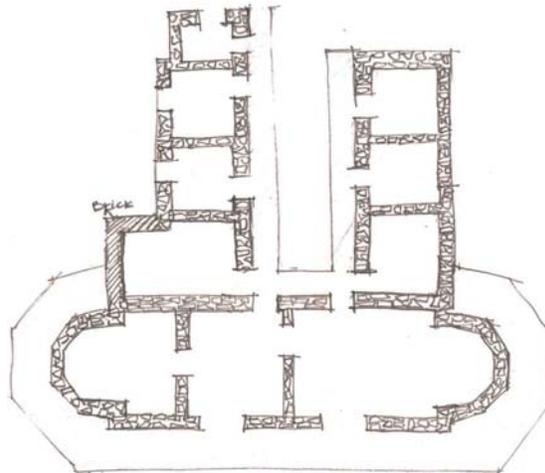
Addition of the rectangular blocks in 1935

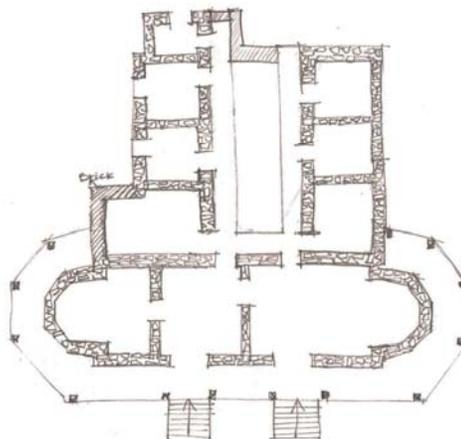
Courtyard Covered with roof and wall constructed connecting the two rectangular blocks in 1974

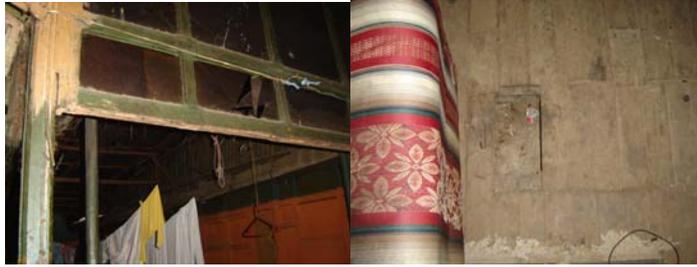
Left: Courtyard Covered , Right: Damaged part of the Parquet floor

- Floor: damaged terrazzo floor finishes to be repaired. Polish and varnish existing parquet floor.
- Roof: removal of the corrugated iron sheet and thatched roof, varnish the truss members, replace worn out trusses and reconstruct the roof with corrugated iron sheet under the thatch roof for protection against leakage. Thatch roof to be constructed by known local craftsmen.

- Glassing to be replaced and provided to all windows.
- Removal of the roof over the courtyard and replanting greenery.
- Furnishing: The Original bed, mirror, cupboard in the Master bed room to be mended. The painting in the steam bath room should be cleaned up.

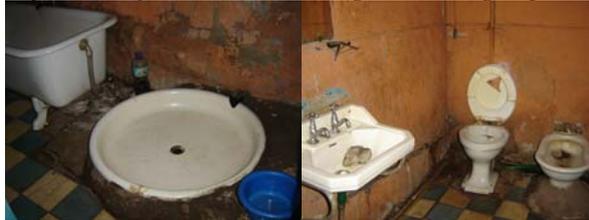
Sanitary fixtures to be replace and mended in the bath rooms

- The fireplace though still functional to be cleaned.
- Electrical: Cables to be reinstalled, TV and satellite dish wiring to be installed.
- Sanitary lines and Fixtures: Plumbing should be redone, sewerage pipes should be replaced, bath tub, WC and Bidet should be replaced shower tray, HWB, to be repaired.

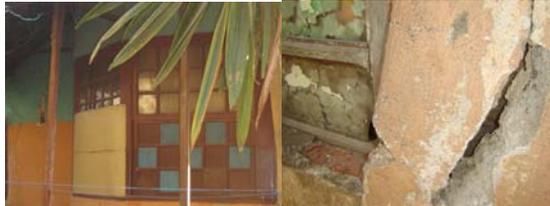
Left: Broken glazing on windows replaced by wooden and card oards

Right: Brick wall combined with wood frame with mud on the rectangular extensions of the house

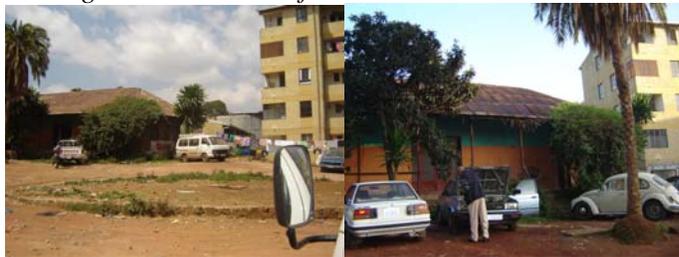
Left: No Architectural relationship between the residence and the new Apartments, Right: Currently, Cars parked very close to the house

1. Since all the low cost apartments have used the compound as parking, the house should be protected by a vegetation buffer of young trees which will be introduced between the historic residence and the parking space in memory of the demolished trees. This space can also be used as a playground for the children living in the apartments.

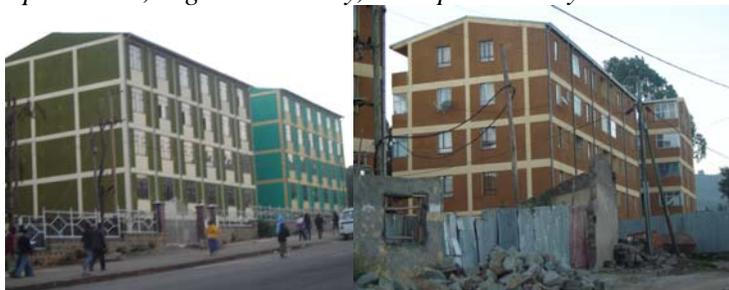
Low cost apartments similar in different parts of Addis Ababa- No site adaptation and response to particular site conditions
