ANNEX 5

File inventory of the collection (valuable goods)

Universidad Católica Sedes Sapientiae		CHURCH OF ST. PETER OF CARABAYLLO	
		INVENTORY OF PIECES	
		SEQ Code	PC-001/93
		INC Code	V-2,1/B-56/6 - INC
LOCATION		UCSS Code	01-001
Precedence		IDENTIFICATION	
Collection	Church of St. Peter of Carabayllo	Name	Eternal Father
Location (former)	Baptistry	Typology	Sculpture
Location (actual)	Unknown	Date	XVIII c.
IMAGES

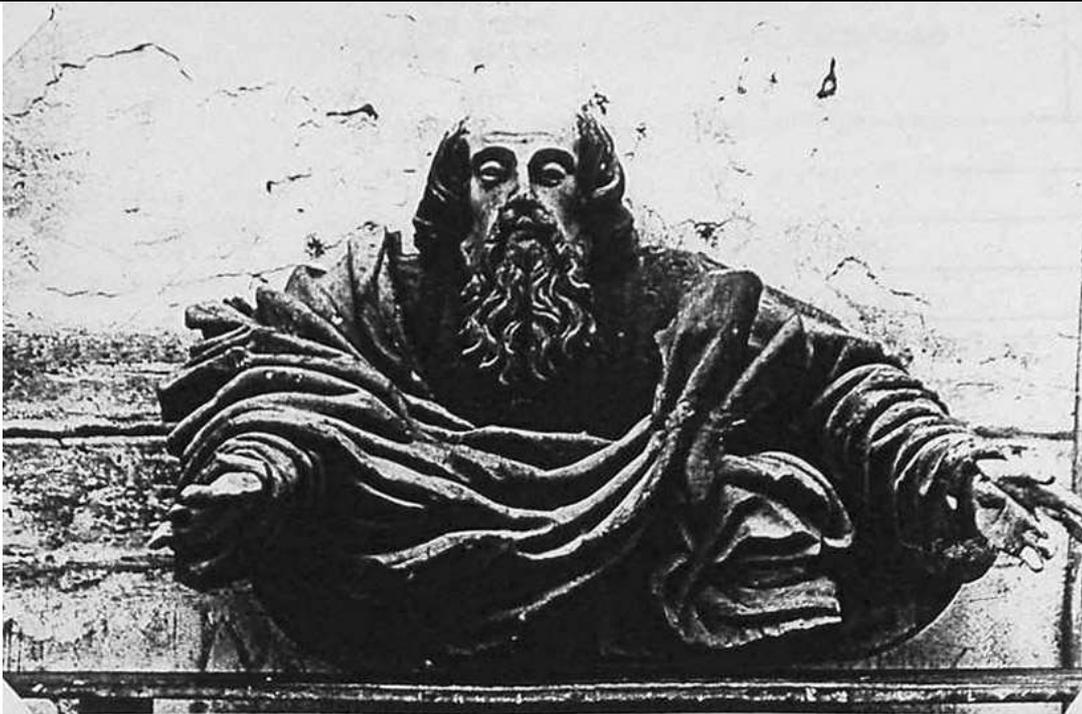
Frontal view			
DESCRIPTION			
Carved in wood, detached hands, which lacks the fingers (thumb, the ring finger and part of the little finger of the right hand; and the middle finger in the left hand)			
HISTORICAL INFORMATION			
Author(s)	Anonymous	Style	Baroque
Donor	Unknown	School	
TECHNICAL INFORMATION			
Height	0.75 m	Material	Wood
Width	1.02 m	Support	Wood
Length		Technique	Carved
Diameter		Finishing / Technique	Paint / Stewed (Estofado)
Weight		FRAME	
STATUS		Material	----
Conservation Status	Bad	Form / Style	----
Integrity	Incomplete	Finishing / Technique	----

Last date of inventory	1993		
OBSERVATIONS			
The backside is very deteriorated, moth-eaten and presents bugs impregnated			
The pictorial layer present cracks, decay, total dry out, a little loss of the primer and pictorial extracts			
SOURCE OF INFORMATION			
Ediciones e Investigaciones Sequilao Proyecto Multidisciplinario Histórico – Arqueológico - Iglesia de San Pedro de Carabayllo

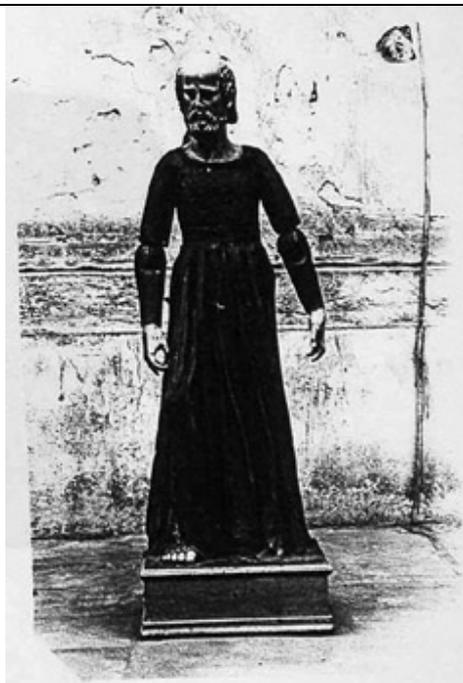
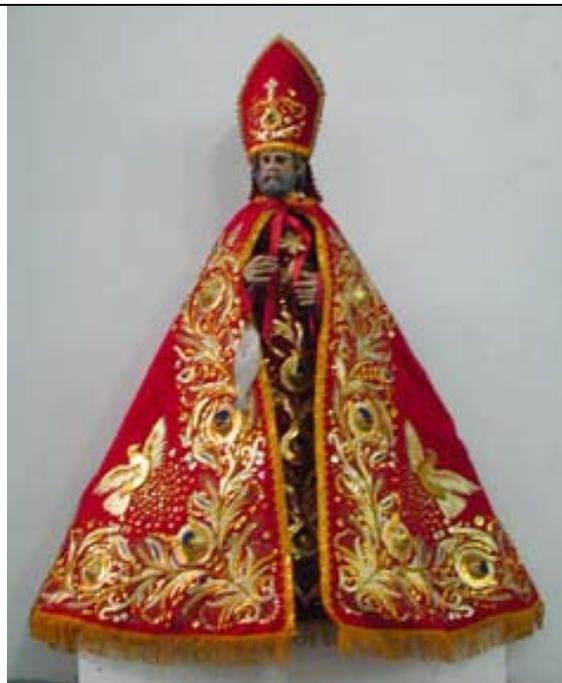
Without clothing

St. Peter on the altarpiece

Carved in wood, body in glued fabric, glass eyes.
The upper extremities are articulated and detached.
The sculpture is stood by a squared wooden pedestal

Repainted in the face and upper extremities
The original halo, cane and the fish, artifacts that identify St. Peter are lost
Dressed with a new white tunic, a red embroidered chest, cape and a bishop's mitre

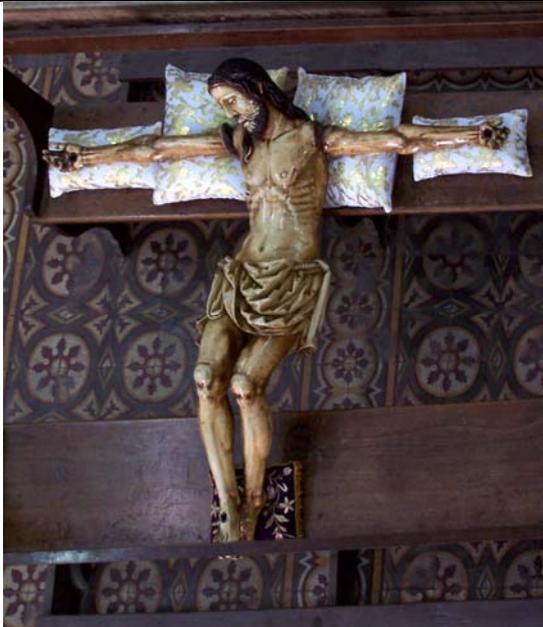
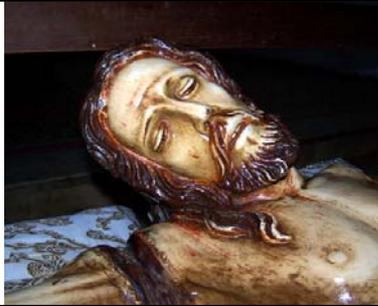
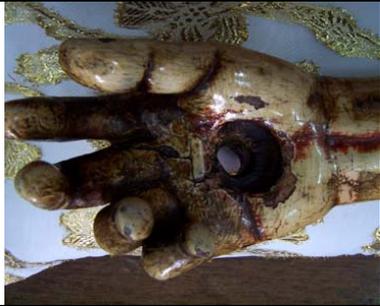
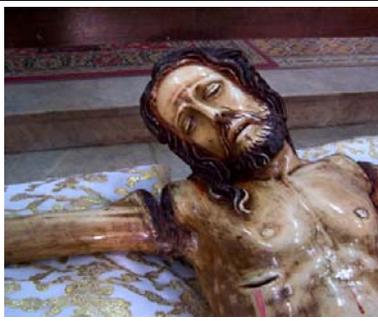
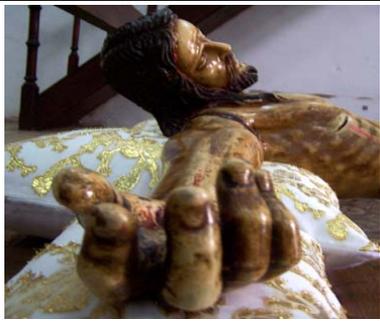
DESCRIPTION			
Carved in wood, body in glued fabric, glass eyes. The upper extremities are detached and articulated using leather straps, and has holes, where the nails pass through, in order to be hang in the cross The torn crown is made of rope and painted in green			
HISTORICAL INFORMATION			
Author(s)	Anonymous	Style	Baroque
Donor	Unknown	School	
TECHNICAL INFORMATION			
Height		Material	Wood & linen
Width	1.50 m	Support	Wood
Length	0.67 m	Technique	Carved
Diameter		Finishing / Technique	Polychrome Painting

Weight		FRAME	
STATUS		Material	----
Conservation Status	Regular	Form / Style	----
Integrity	Complete	Finishing / Technique	----
Last date of inventory	2006		
OBSERVATIONS			
Is take in procession with the cross, on holly week; an in the. Sepulchre day Is located inside a glass case below the closed lateral door threshold Part of a sculptural group with the (green) cross that use to be hang in a cross, above the mail altarpiece - Repainted in different parts Is named " Christ – Calvary" in the INC inventory (30 October , 1980) and "Lord of the Help" in the inventory made by Ediciones e Investigaciones Sequilao, 1993			
SOURCE OF INFORMATION			
Proyecto Multidisciplinario Histórico – Arqueológico - Iglesia de San Pedro de Carabayllo

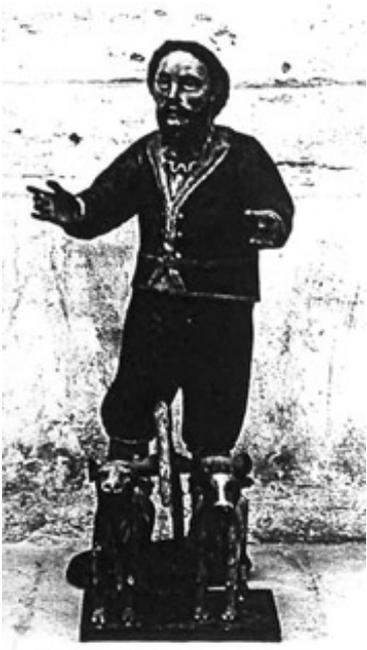
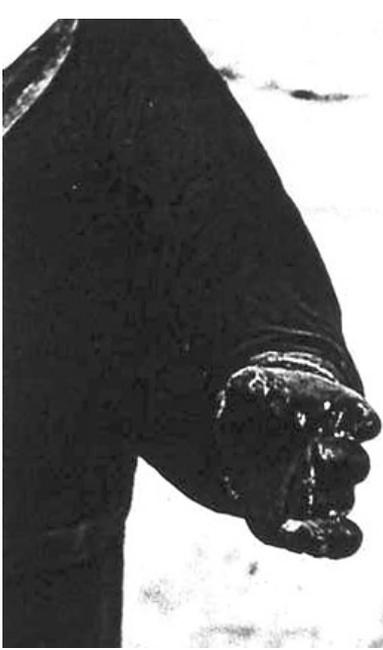
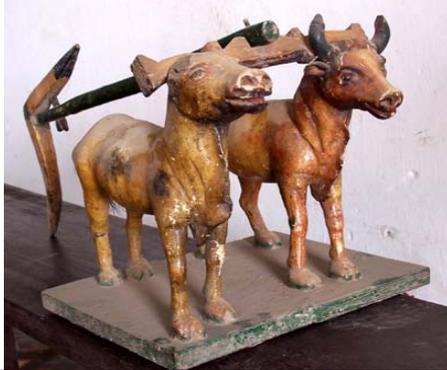
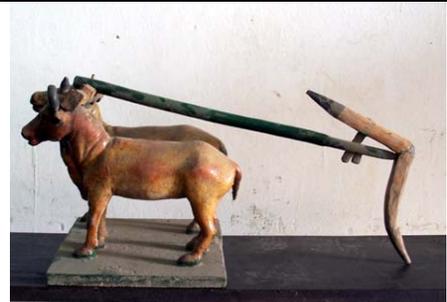
St. Isidore

The oxen	
DESCRIPTION			
Carved in wood, body in fabric The upper extremities are articulated and detached. The sculpture is stood by a squared wooden pedestal			
HISTORICAL INFORMATION			
Author(s)	Anonymous	Style	Baroque
Donor	Unknown	School	
TECHNICAL INFORMATION			
Height	1.68 m	Material	Wood & linen
Width	0.84 m	Support	Wood
Length		Technique	Carved & glued fabric
Diameter		Finishing / Technique	Polychrome Painting & varnished
Weight		FRAME	
STATUS		Material	----
Conservation Status	Bad	Form / Style	----
Integrity	Lost	Finishing / Technique	----

Last date of inventory	1993		
OBSERVATIONS			
The Inventory of 1993 describe the status: <i>Repainted in the clothing with rusting varnish. Insects excrement in the surface. 3 fingers lost in the left hand. The pedestal is broken and moth-eaten</i> Only the oxen still stand			
SOURCE OF INFORMATION			
Ediciones e Investigaciones Sequilao Proyecto Multidisciplinario Histórico – Arqueológico - Iglesia de San Pedro de Carabayllo

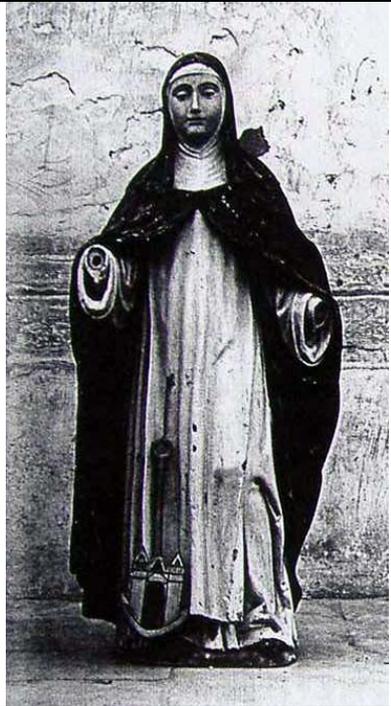
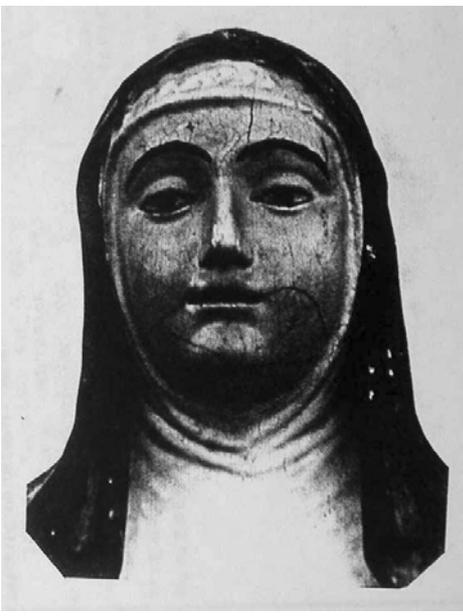
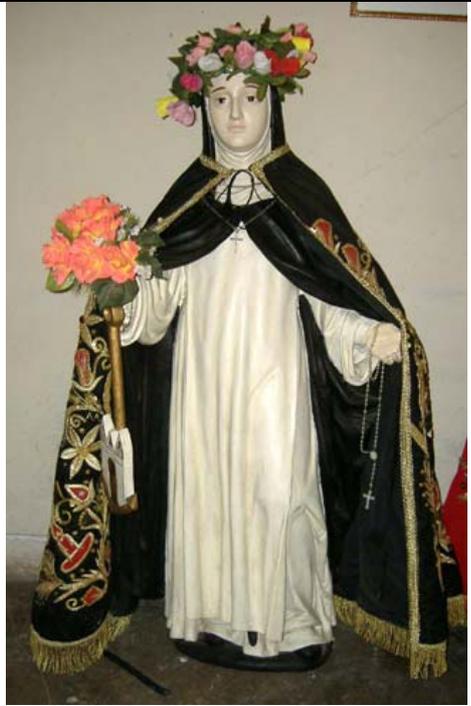
DESCRIPTION			
Carved in wood, body in fabric. Shawl stewed in gold Presents hole in the arms where the hands are fixed In lower part has an anchor with the image of a temple			
HISTORICAL INFORMATION			
Author(s)	Anonymous	Style	Baroque
Donor	Unknown	School	
TECHNICAL INFORMATION			
Height	1.30 m	Material	Wood
Width	0.63 m	Support	Wood
Length		Technique	Carved
Diameter		Finishing / Technique	Paint / Stewed (Estofado)
Weight		FRAME	
STATUS		Material	----
Conservation Status	Regular	Form / Style	----
Integrity	Incomplete	Finishing / Technique	----

Last date of inventory	2006		
OBSERVATIONS			
Presence of repainting in the face Total dry put and dirt impregnated en the face Partial detachment of the pictorial layer Dressed with a black Dominican embroiled cape. Her attributes are a crown of roses and a rosary			
SOURCE OF INFORMATION			
Ediciones e Investigaciones Sequilao Proyecto Multidisciplinario Histórico – Arqueológico - Iglesia de San Pedro de Carabayllo

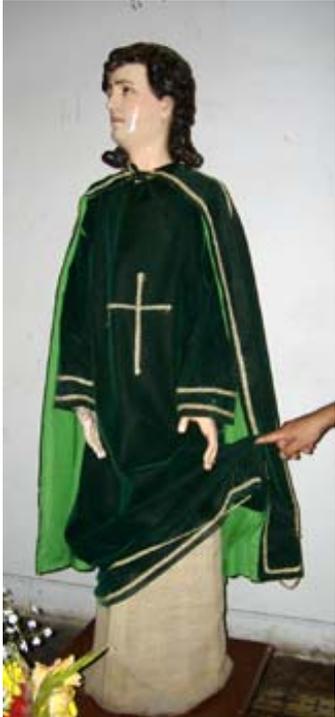
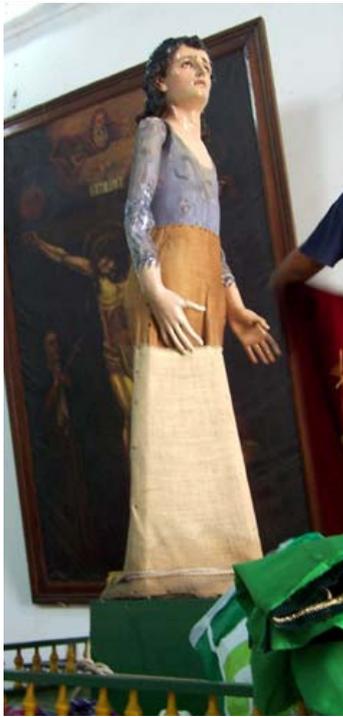
Frontal view			
DESCRIPTION			
Carved in wood, body in fabric The upper extremities are articulated and detached. The sculpture is stood by a squared wooden pedestal			
HISTORICAL INFORMATION			
Author(s)	Anonymous	Style	Baroque
Donor	Unknown	School	
TECHNICAL INFORMATION			
Height	1.68 m	Material	Wood & linen
Width	0.43 m	Support	Wood
Length		Technique	Carved & glued fabric
Diameter		Finishing / Technique	Polychrome Painting
Weight		FRAME	
STATUS		Material	----
Conservation Status	Regular	Form / Style	----

Integrity	Incomplete	Finishing / Technique	----
Last date of inventory	2006		
OBSERVATIONS			
Is named " St. John – Calvary" in the INC inventory (30 October , 1980) Sometimes is called erroneously St. John The Baptist Totally repainted in the face; The clothing are not original			
SOURCE OF INFORMATION			
Ediciones e Investigaciones Sequilao Proyecto Multidisciplinario Histórico – Arqueológico - Iglesia de San Pedro de Carabayllo

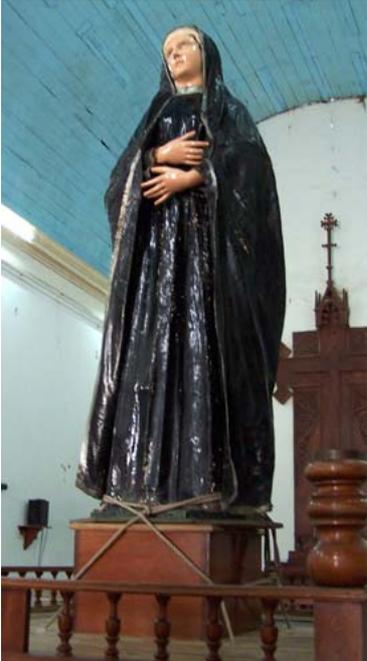
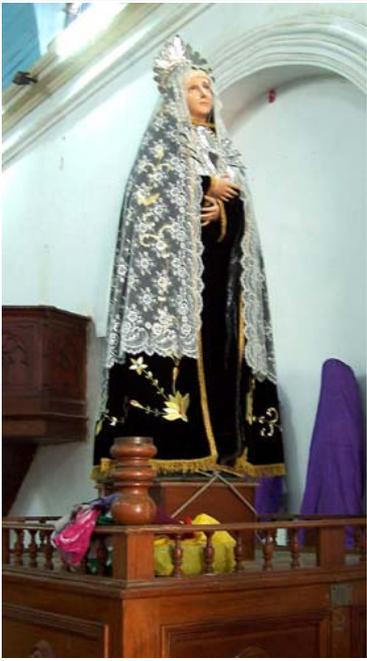
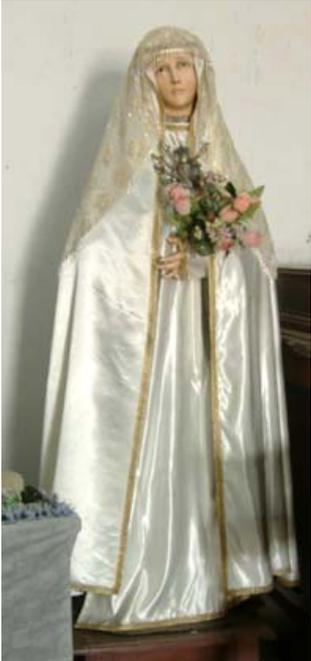
Frontal view			
DESCRIPTION			
Carved in wood, body in fabric The upper extremities are articulated and detached. The sculpture is stood by a squared wooden pedestal The clothing is made of glued fabric finished in golden stew (estofa)			
HISTORICAL INFORMATION			
Author(s)	Anonymous	Style	Baroque
Donor	Unknown	School	
TECHNICAL INFORMATION			
Height	1.66 m	Material	Wood & linen
Width	0.56 m	Support	Wood
Length		Technique	Carved & glued fabric
Diameter		Finishing / Technique	Polychrome Painting

Weight		FRAME	
STATUS		Material	----
Conservation Status	Regular	Form / Style	----
Integrity	Complete	Finishing / Technique	----
Last date of inventory	2006		
OBSERVATIONS			
Is named "Virgin Mary - Calvary" in the INC inventory (30 October , 1980) Totally repainted in the face, the hands and inn the clothing, over the golden stew (estofa) The pictorial layer, deteriorated, cracked with little loss of primer and pictorial finishing Has a cape, a white shawl and roses in the hands. Also a metallic heart with the sorrows			
SOURCE OF INFORMATION

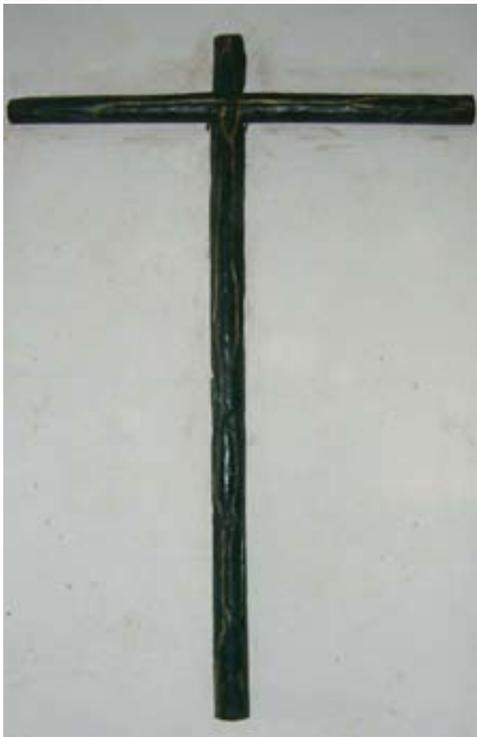
Frontal view			
DESCRIPTION			
Painted in green with golden in the shape of a tree			
HISTORICAL INFORMATION			
Author(s)		Style	
Donor		School	
TECHNICAL INFORMATION			
Height		Material	Wood
Width		Support	Wood
Length		Technique	
Diameter		Finishing / Technique	Painted
Weight		FRAME	
STATUS		Material	
Conservation Status	Regular	Form / Style	
Integrity	Complete	Finishing / Technique	
Last date of inventory			
OBSERVATIONS			
Painted in green with golden in the shape of a tree Part of a sculptural group with the Dead Christ lying Used to be hanged in the Main altar Common shape of the crosses in all the Peruvian churches

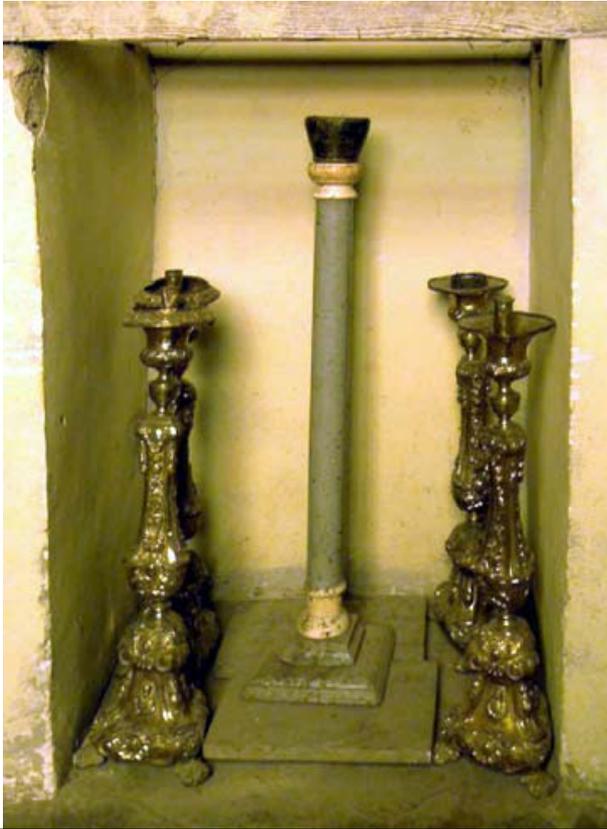
Frontal view			
DESCRIPTION			
The tripod base represents 3 faces, of Christ, Virgin Mary and St. Peter In the top has a candle stick			
HISTORICAL INFORMATION			
Author(s)		Style	Neoclassical
Donor		School	
TECHNICAL INFORMATION			
Height	0.87 m	Material	Alloy of brass & gold
Width		Support	brass & gold
Length		Technique	Cast alloy
Weight		Finishing / Technique	
Units	04	FRAME	
STATUS		Material	----
Conservation Status	Regular	Form / Style	----
Integrity	Complete	Finishing / Technique	----
Last date of inventory	2006		
OBSERVATIONS			
Only use in special religious ceremonies and in funeral services

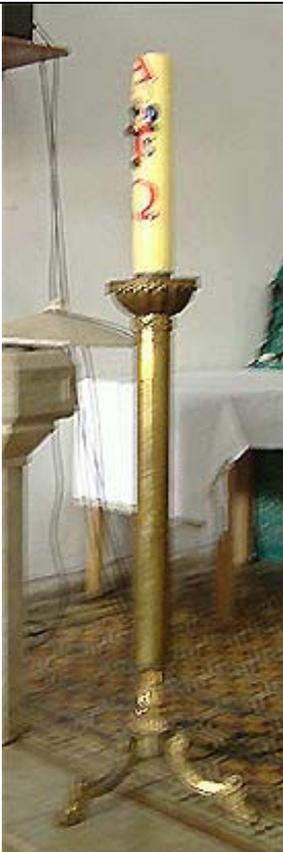
Frontal view			
DESCRIPTION			
Cast brass candelabrum In the top has a candle stick			
HISTORICAL INFORMATION			
Author(s)		Style	Neoclassical
Donor		School	
TECHNICAL INFORMATION			
Height	1.10 m	Material	brass
Width		Support	brass
Length		Technique	Cast alloy
Weight		Finishing / Technique	
Units	01	FRAME	
STATUS		Material	----
Conservation Status	Regular	Form / Style	----
Integrity	Complete	Finishing / Technique	----
Last date of inventory	2006		
OBSERVATIONS			
SOURCE OF INFORMATION

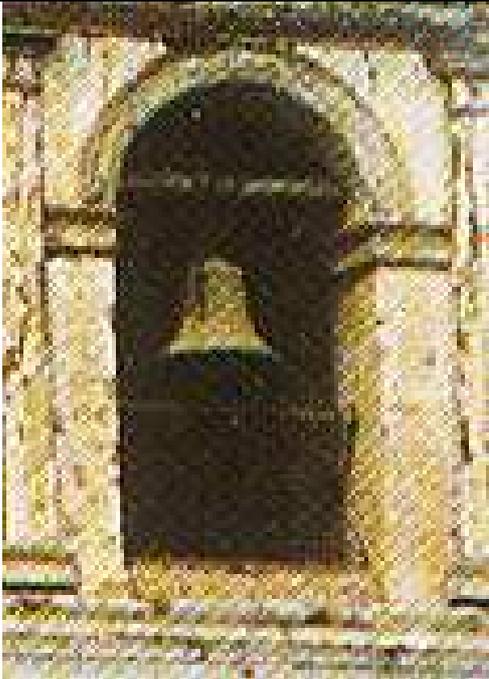
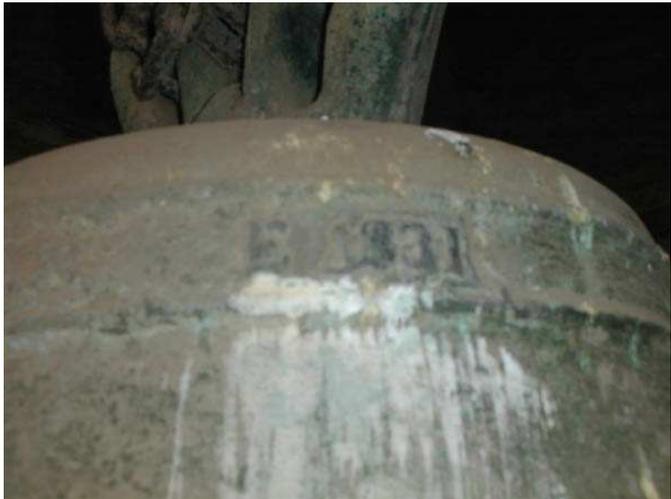
Original location		Date	
DESCRIPTION			
<p>Has the current inscription in the base: <i>me dio Julian Marquez para nuestro amo únicamente</i> (given by Julian Marquez to our master only) , and I the cup: <i>me hizo José Ochoa año de 1831</i> (made by Jose Ochoa the year of 1831)</p> <p>In the middle has a relief of a rose-shaped cross</p>			
HISTORICAL INFORMATION			
Author(s)	José Ulloa	Style	
Donor	Julian Marquez	School	
TECHNICAL INFORMATION			
Height	0.61 m	Material	Brass
Width		Support	Wood beam
Length		Technique	Cast brass
Diameter	Cup: 0.25 / Base: 0.66 m.	Finishing / Technique

Weight		FRAME	
STATUS		Material	----
Conservation Status	Regular	Form / Style	----
Integrity	Incomplete	Finishing / Technique	----
Last date of inventory	2006		
OBSERVATIONS			
The clapper had disappeared, and had been moved to the middle of the space			
SOURCE OF INFORMATION			
Arkinka 121, December, 2005

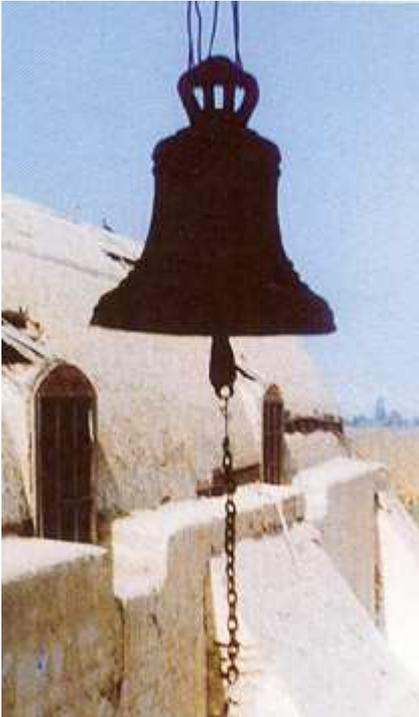
Frontal view			
DESCRIPTION			
Cast brass bell			
HISTORICAL INFORMATION			
Author(s)		Style	
Donor		School	
TECHNICAL INFORMATION			
Height	0.61 m	Material	Brass
Width		Support	
Length		Technique	Cast brass
Diameter	Cup: 0.25 / Base: 0.66 m.	Finishing / Technique	
Weight		FRAME	
STATUS		Material	----
Conservation Status	Unknown	Form / Style	----
Integrity	Lost	Finishing / Technique	----
Last date of inventory			
OBSERVATIONS			
Last seen on the pictures taken in 1987			
SOURCE OF INFORMATION			
Arkinka 121, December, 2005

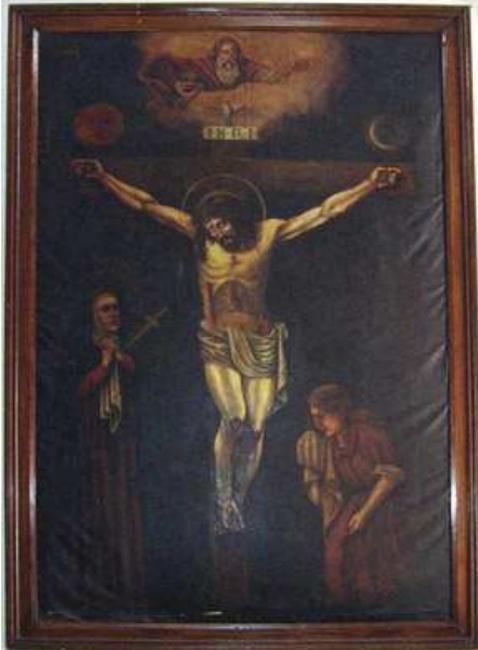
Frontal view			
DESCRIPTION			
Oil over canvas Crucified Christ in the shape of the Lord of the Miracles.			
HISTORICAL INFORMATION			
Author(s)	Castillo	Style	
Donor		School	
TECHNICAL INFORMATION			
Height	312 cm (frame) / 184 cm. (paint)	Material	Oil and wood
Width	210 cm (frame) / 282 cm. (paint)	Support	Canvas
Length		Technique	Oil painting
Diameter		Finishing / Technique	
Weight		FRAME	
STATUS		Material	Wood
Conservation Status	Regular	Form / Style	Squared
Integrity	Complete	Finishing / Technique	Varnish
Last date of inventory

OBSERVATIONS			
Crucified Christ in the shape of the Lord of the Miracles, forming the Holy Trinity (Father, Holy Ghost and the Son); the sun and the moon in each side. Bellow, virgin Mary with the dagger of the sorrow in the left side, and St. John the Evangelist in the right side.			
SOURCE OF INFORMATION			
Ediciones e Investigaciones Sequilao Proyecto Multidisciplinario Histórico – Arqueológico - Iglesia de San Pedro de Carabayllo

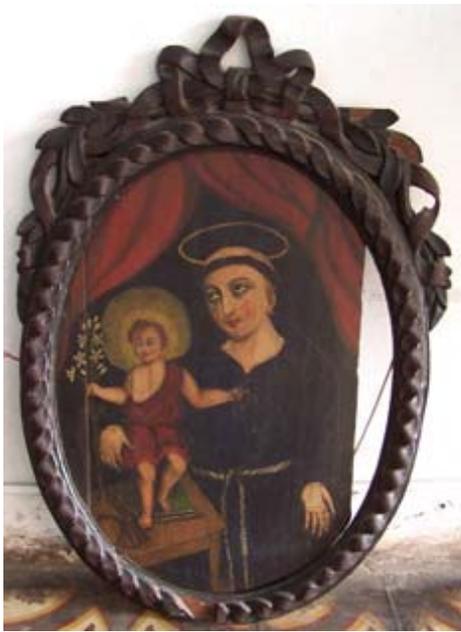
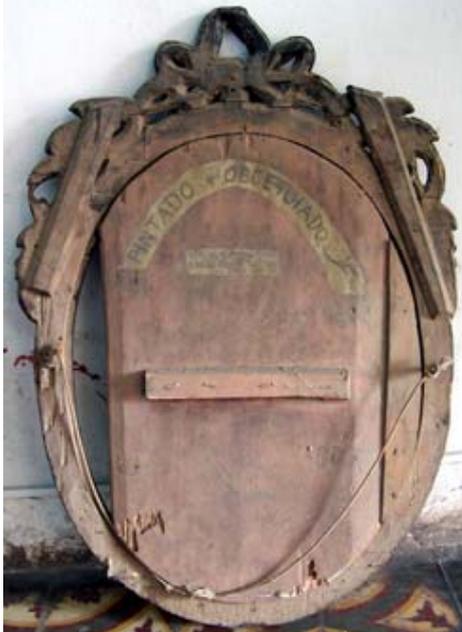
Frontal view		Back view	
DESCRIPTION			
Oil over wood table made of three pieces of wood Frame carved with laces around the top Has inscription: Pintado y obcequiado pot Castillo – Carabayllo Octubre 1884 (<i>Painted and gave by Castillo Crabayllo October 1884</i>)			
HISTORICAL INFORMATION			
Author(s)	Castillo	Style	
Donor		School	
TECHNICAL INFORMATION			
Height	84 cm (frame) / 63 cm. (paint)	Material	Oil and wood
Width	55 cm (frame) / 47 cm. (paint)	Support	Wood
Length		Technique	Oil painting
Diameter		Finishing / Technique	
Weight		FRAME

STATUS		Material	Wood
Conservation Status	Regular	Form / Style	Oval
Integrity	Complete	Finishing / Technique	Enamel
Last date of inventory		Finishing / Technique	Carved
OBSERVATIONS			
One of the pieces of the support is lost, and is slightly moth-eaten in the back The pictorial layer present dry outs, dirt and insect excrement Stained varnish			
SOURCE OF INFORMATION			
Ediciones e Investigaciones Sequilao Proyecto Multidisciplinario Histórico – Arqueológico - Iglesia de San Pedro de Carabayllo

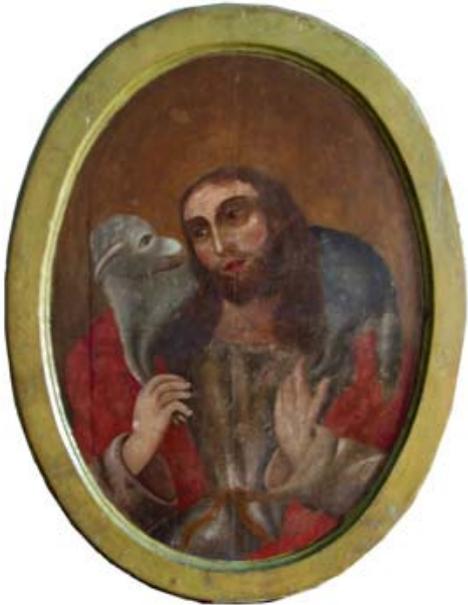
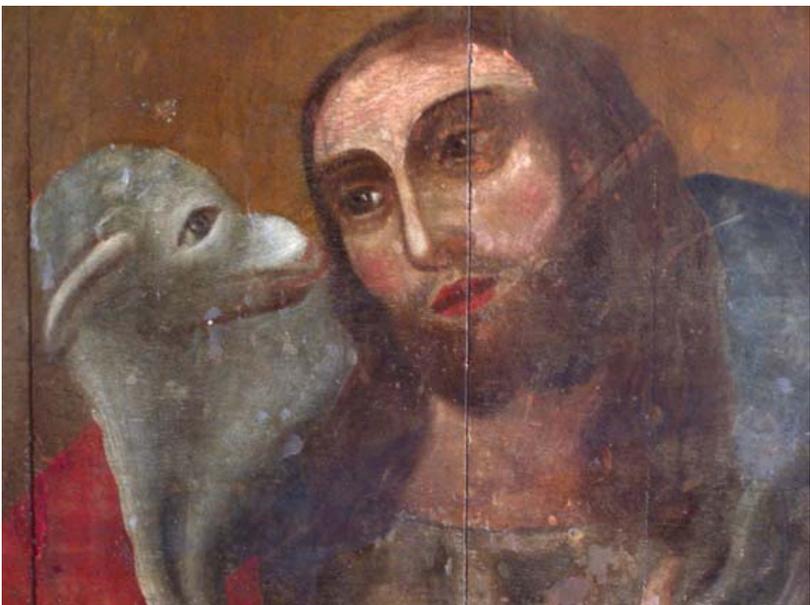
Frontal view		Detail	
DESCRIPTION			
Oil over wood			
Table made of five pieces of wood			
The frame is oval and enameled			
HISTORICAL INFORMATION			
Author(s)		Style	Neoclassical
Donor		School	
TECHNICAL INFORMATION			
Height	97 cm (frame) / 83 cm. (paint)	Material	Oil and wood
Width	63 cm (frame) / 48 cm. (paint)	Support	Wood
Length		Technique	Oil painting
Diameter		Finishing	Varnish
Weight		FRAME	
STATUS		Material	Wood
Conservation Status	Regular	Form / Style	Oval
Integrity	Complete	Finishing	Enamel
Last date of inventory	1993		
OBSERVATIONS			
Lightly moth-eaten in the back

The pictorial layer present dry outs, dirt and insect excrement			
Enamel stains, and minimal loss of pictorial extracts			
Stained varnish			
SOURCE OF INFORMATION			
Ediciones e Investigaciones Sequilao			
Proyecto Multidisciplinario Histórico – Arqueológico - Iglesia de San Pedro de Carabayllo

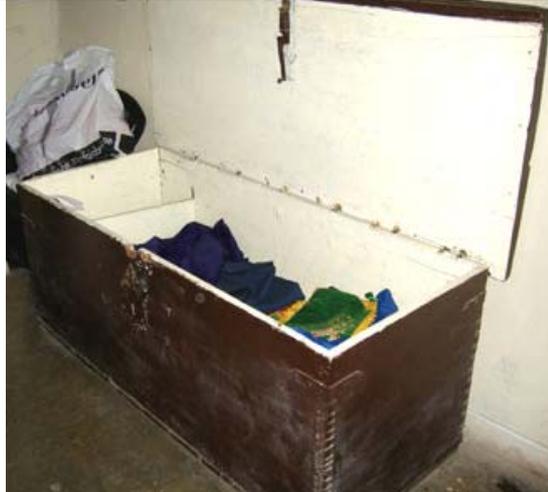
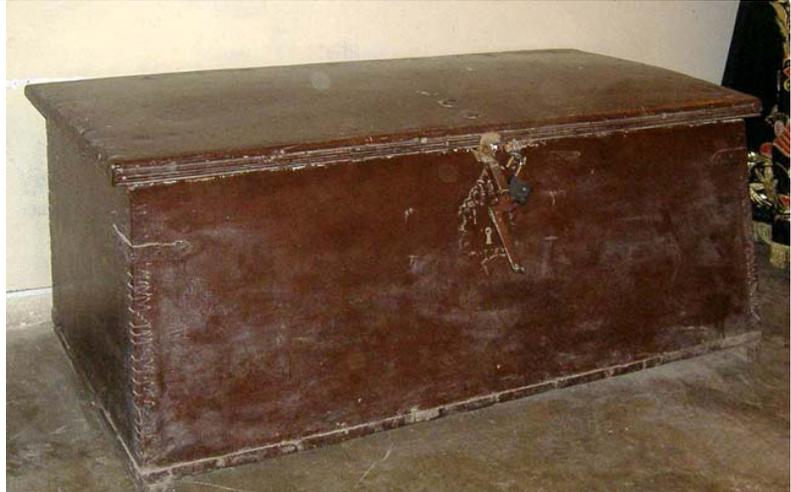
Open		Closed	
DESCRIPTION			
Wooden trunk Has its original lock and hinges			
HISTORICAL INFORMATION			
Author(s)		Style	
Donor		School	
TECHNICAL INFORMATION			
Height	0.67 m.	Material	Wood
Width	1.43 m.	Support	Wood
Length	0.62 m.	Technique	
Diameter	.	Finishing / Technique	Varnish
Weight		FRAME	
STATUS		Material	
Conservation Status	Regular	Form / Style	
Integrity	Complete	Finishing / Technique	
Last date of inventory	2006		
OBSERVATIONS			
Use to save the Eucharistic garments & artifacts			
SOURCE OF INFORMATION

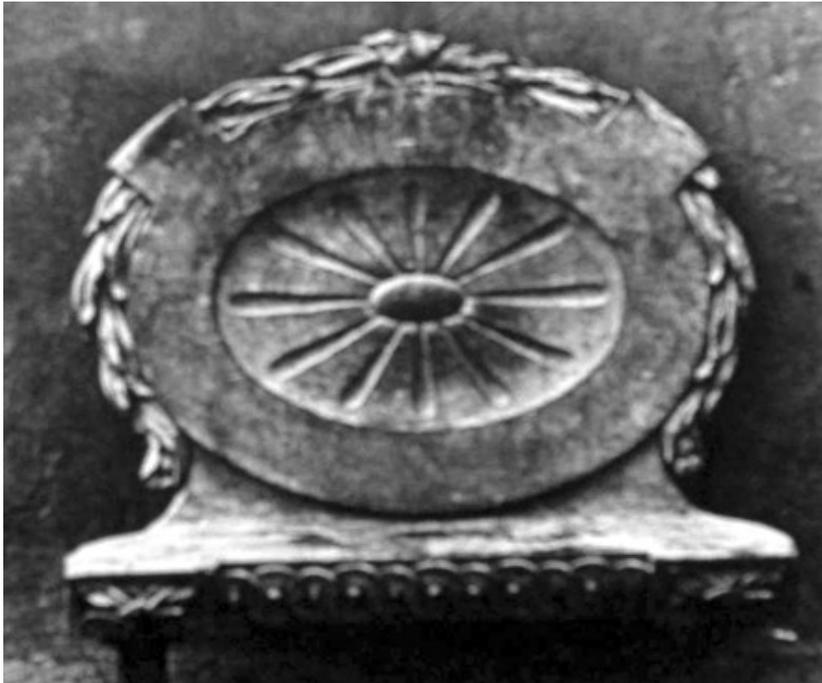
Frontal view			
DESCRIPTION			
Elliptical shape with a border of bay leaves carved around A low relief of an stylized sun in the middle			
HISTORICAL INFORMATION			
Author(s)		Style	Neoclasical
Donor		School	
TECHNICAL INFORMATION			
Height	0.43 m.	Material	Wood
Width	0.42 m.	Support	Wood
Length		Technique	Carved
Diameter	.	Finishing / Technique	Varnish
Weight		FRAME	
STATUS		Material	
Conservation Status	Lost	Form / Style	
Integrity	Incomplete	Finishing / Technique	
Last date of inventory	1993		
OBSERVATIONS			
Not seen since the last inventory, 1993			
SOURCE OF INFORMATION

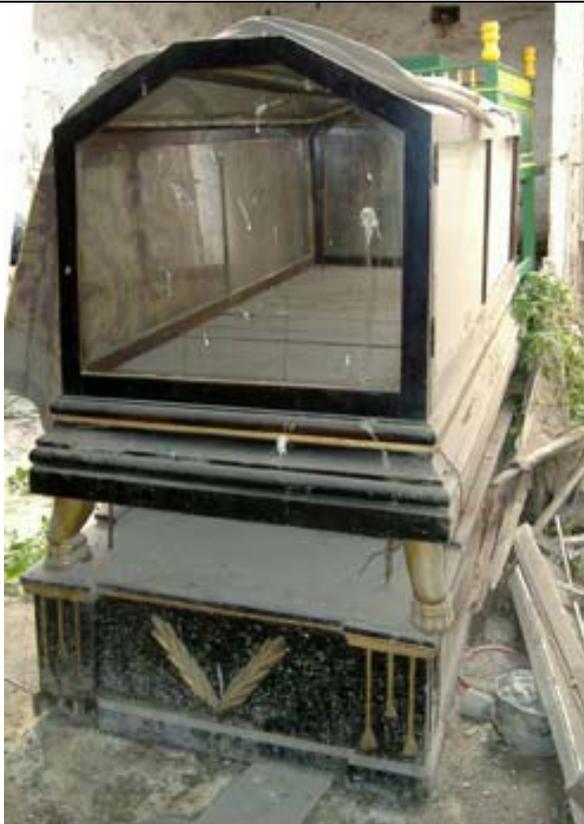
Frontal view			
DESCRIPTION			
Wood & glass case that used to host the Dead Christ Lying sculpture			
HISTORICAL INFORMATION			
Author(s)		Style	
Donor		School	
TECHNICAL INFORMATION			
Height		Material	Wood & glass
Width		Support	Wood
Length		Technique	
Diameter		Finishing / Technique	Brown & gold paint
Weight		FRAME	
STATUS		Material	
Conservation Status	Regular	Form / Style	
Integrity	Complete	Finishing / Technique	
Last date of inventory	2006		
OBSERVATIONS			
Was replaced by a brand new one few years ago Presents dirt, insect's excrements and moth holes

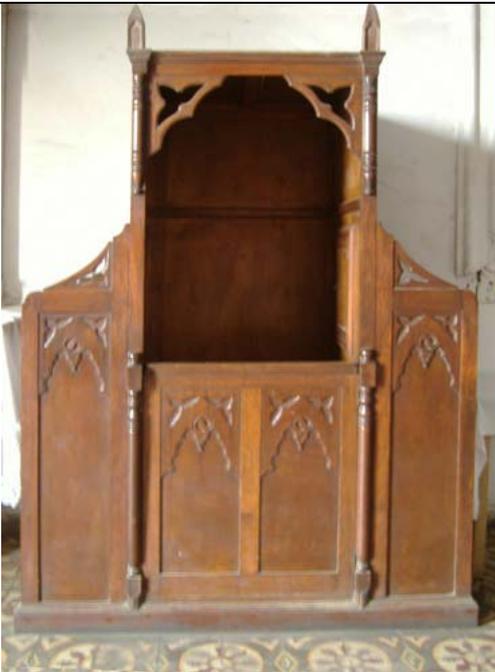
Frontal view			
DESCRIPTION			
HISTORICAL INFORMATION			
Author(s)		Style	Neo gothic
Donor		School	
TECHNICAL INFORMATION			
Height	1.53 m.	Material	Mud , cane & plaster
Width	2.10 m.	Support	cane
Length	0.80 m.	Technique	Mud & cane
Diameter	.	Finishing / Technique	Water paint
Weight		FRAME	
STATUS		Material	
Conservation Status	Good	Form / Style	
Integrity	Complete	Finishing / Technique	
Last date of inventory			
OBSERVATIONS			
Presumably made at the same time as the main altarpiece & the pulpit			
SOURCE OF INFORMATION

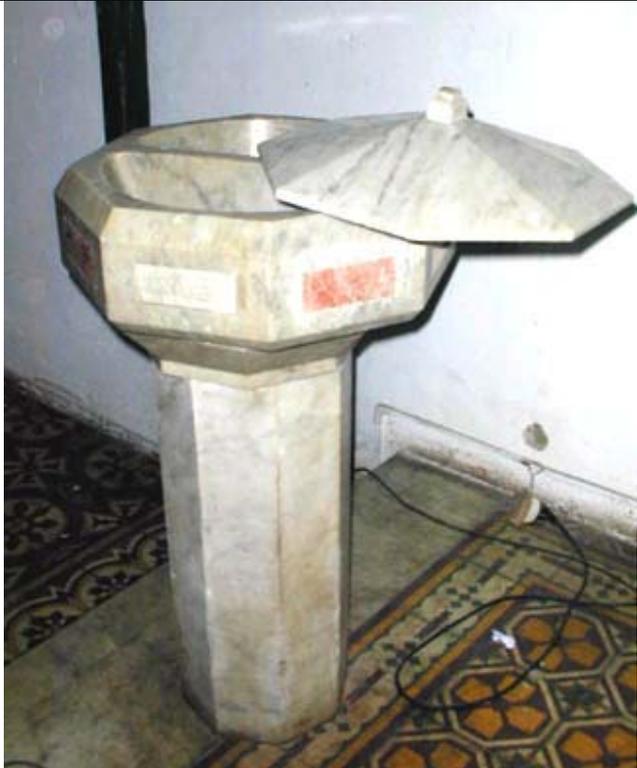
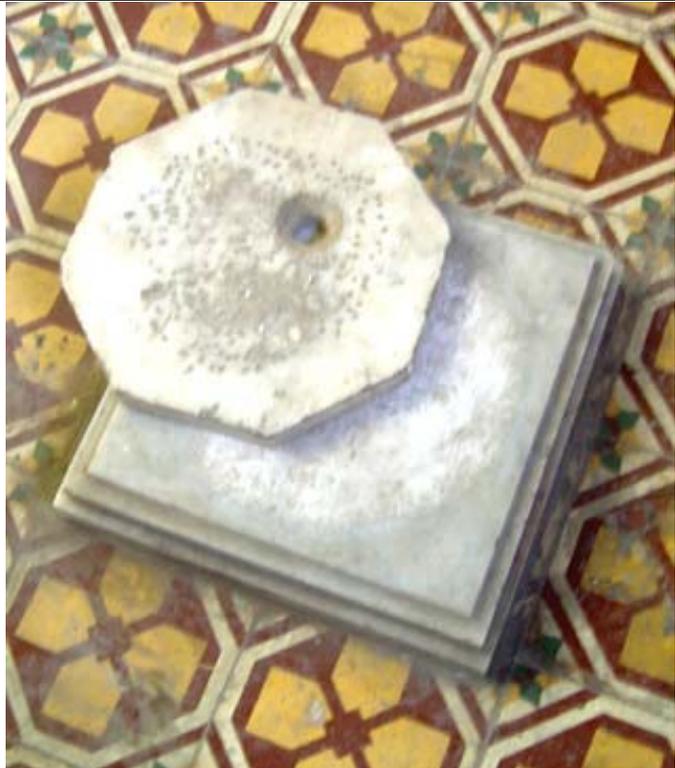
Current location in the presbytery		Remaining base in the baptistry	
DESCRIPTION			
Octagonal shaped marble vase over a pedestal, with colored marble incrustations in the sides The tap used to turn to close the vase			
HISTORICAL INFORMATION			
Author(s)		Style	
Donor		School	
TECHNICAL INFORMATION			
Height		Material	Marble
Width		Support	Marble
Length		Technique	Carved
Diameter		Finishing / Technique	
Weight		FRAME	
STATUS		Material	
Conservation Status	Regular	Form / Style	
Integrity	Incomplete	Finishing / Technique	
Last date of inventory			
OBSERVATIONS			
The tap is damaged, and doesn't turn, one piece of the marble incrustations had decayed Part of the Pedestal (a slice) and a squared base are still on the baptistry

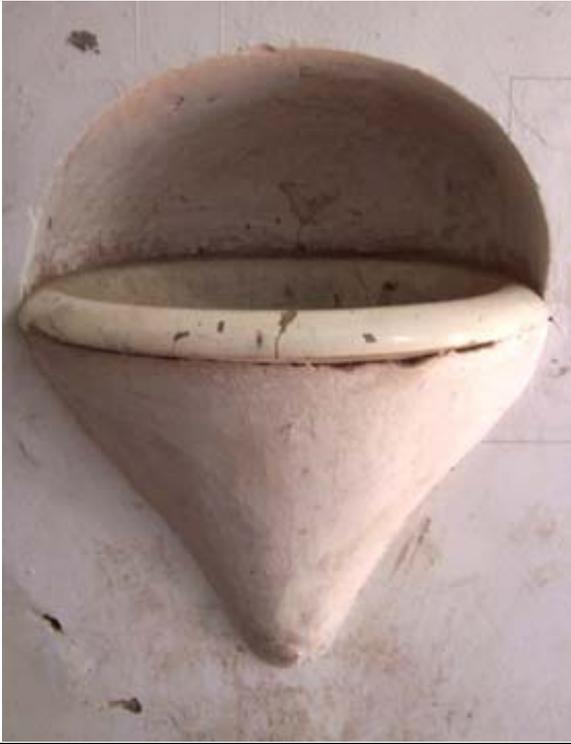
DESCRIPTION			
Round marble vase partially attached to the feet wall			
HISTORICAL INFORMATION			
Author(s)		Style	
Donor		School	
TECHNICAL INFORMATION			
Height		Material	Marble
Width		Support	Marble
Length		Technique	Carved
Diameter		Finishing / Technique	
Weight		FRAME	
STATUS		Material	
Conservation Status	Regular	Form / Style	
Integrity	Incomplete	Finishing / Technique	
Last date of inventory			
OBSERVATIONS			
Presents some cracks			
SOURCE OF INFORMATION

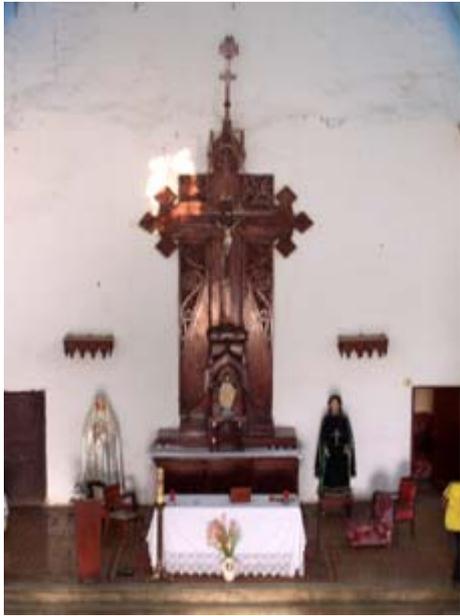
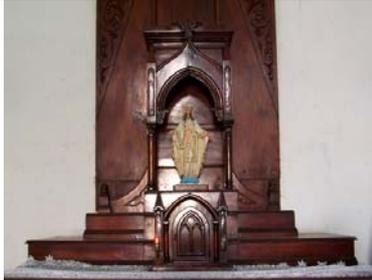
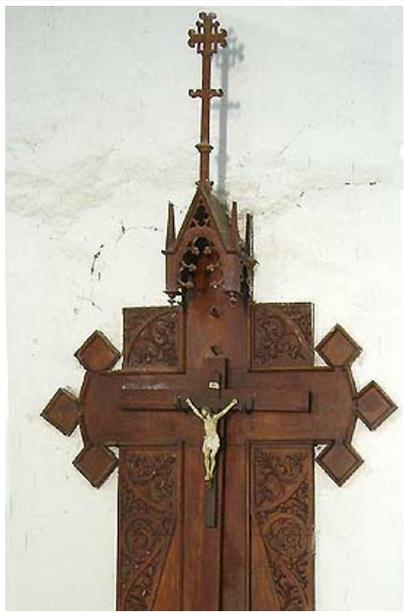
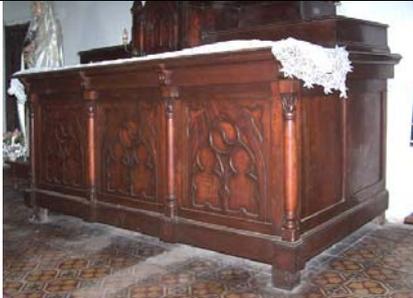
Frontal view	Table		Cross
DESCRIPTION			
Two parts altarpiece. The first, cross-shaped stuck to the head wall crowned by a canopy; the second body has the table, the tabernacle, and a small canopy above			
All with moldings in a gothic style			
HISTORICAL INFORMATION			
Author(s)		Style	Neo gothic
Donor		School	
TECHNICAL INFORMATION			
Height	7.7 m.	Material	Wood
Width	2.9 m.	Support	Wood
Length	2.0 m.	Technique	
Diameter	.	Finishing / Technique	Varnish
Weight		FRAME	
STATUS		Material	
Conservation Status	Regular - Good	Form / Style

Integrity	Complete	Finishing / Technique	
Last date of inventory			
OBSERVATIONS			
Has a cast plaster image of Our lady of Mercy inside the canopy above the tabernacle			
SOURCE OF INFORMATION

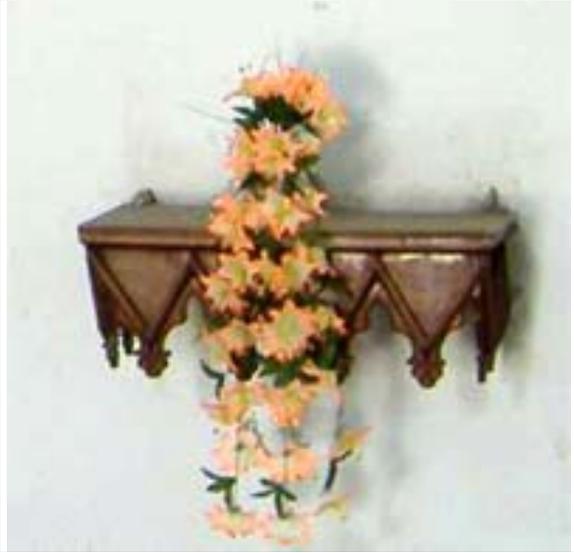
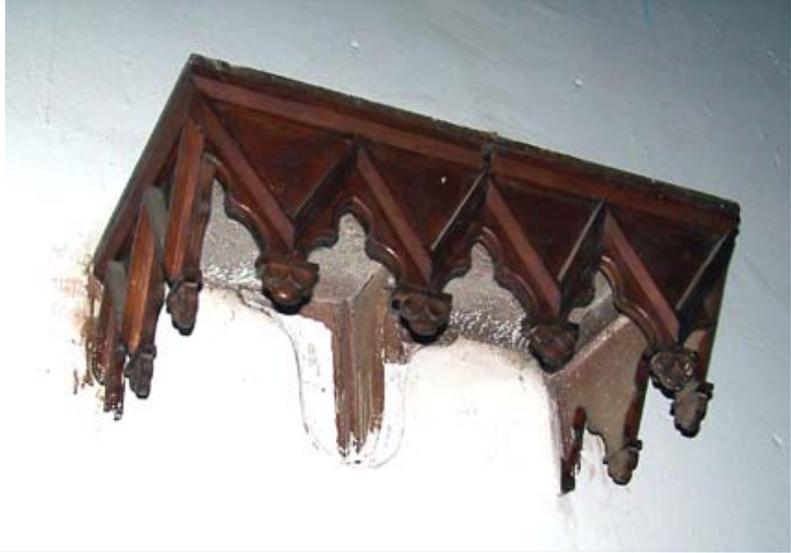
Gospel side shelf		Epistle side shelf	
DESCRIPTION			
Two wooden shelves located in each side of the Main altarpiece that , holding the			
HISTORICAL INFORMATION			
Author(s)		Style	Neo gothic
Donor		School	
TECHNICAL INFORMATION			
Height	0.65 m.	Material	Wood
Width	0.22 m.	Support	Wood
Length	0.30 m.	Technique	
Weight	.	Finishing / Technique	Varnish
Units	2	FRAME	
STATUS		Material	
Conservation Status	Regular - Good	Form / Style	
Integrity	Complete	Finishing / Technique	
Last date of inventory			
OBSERVATIONS

Is part of the group of the Main Altarpiece			
SOURCE OF INFORMATION

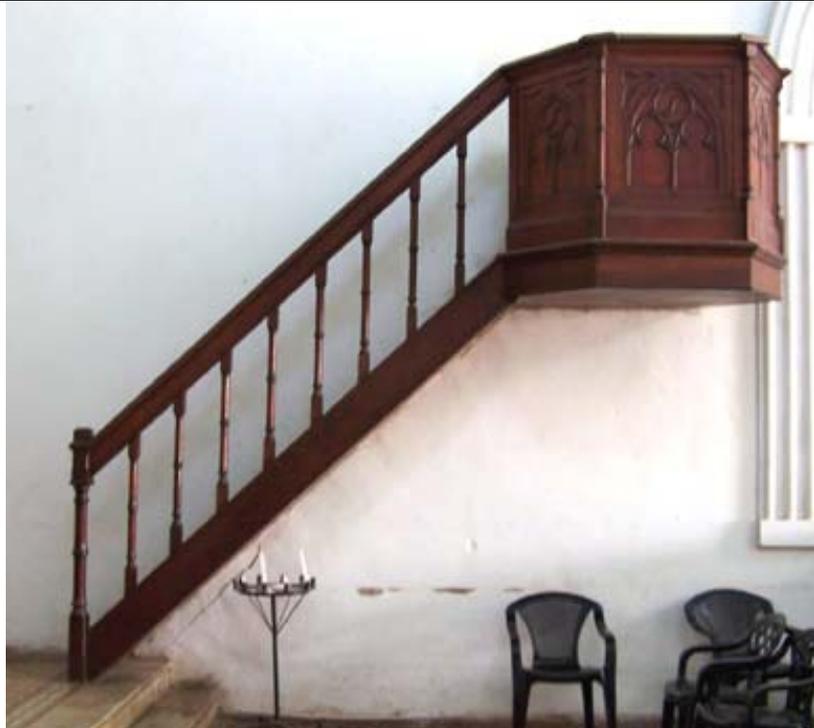
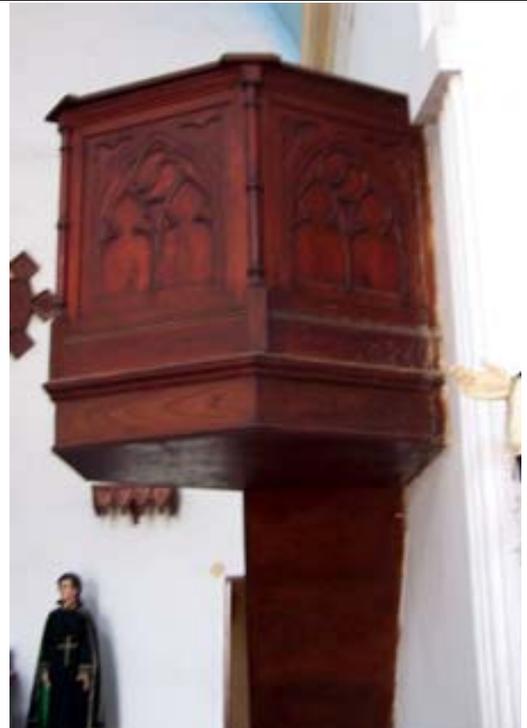
Frontal view			
DESCRIPTION			
Hexagonal shaped pulpit with relieved panels with gothic motifs Ladder with 11 steps and handrail with a simple balustrade (10 balusters)			
HISTORICAL INFORMATION			
Author(s)		Style	Neo gothic
Donor		School	
TECHNICAL INFORMATION			
Height	3.20 m.	Material	Wood
Width	1.25 m.	Support	Wood
Length	4.95 m.	Technique	
Diameter	.	Finishing / Technique	Varnish
Weight		FRAME	
STATUS		Material	
Conservation Status	Regular - Good	Form / Style	
Integrity	Complete	Finishing / Technique	
Last date of inventory

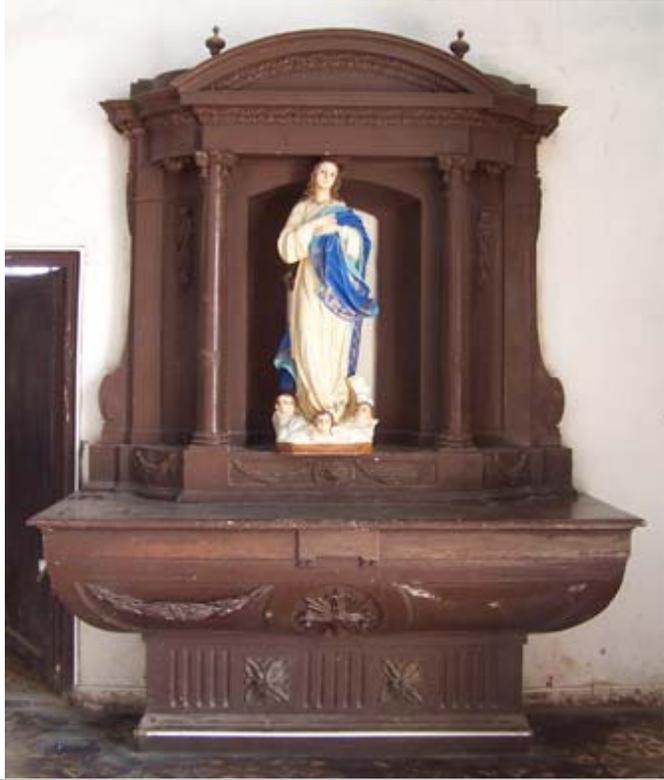
Frontal view		Lateral view	
DESCRIPTION			
Table with a vaulted niche side by two pilaster bellow a curved tympanum, where stands the Immaculate Conception			
HISTORICAL INFORMATION			
Author(s)		Style	Neoclassical
Donor		School	
TECHNICAL INFORMATION			
Height	2..30 m.	Material	Wood
Width	2.97 m.	Support	Wood
Length	0.80 m.	Technique	Wooden carpentry
Diameter	.	Finishing / Technique	Brown paint
Weight		FRAME	
STATUS		Material	
Conservation Status	Good	Form / Style	
Integrity	Complete	Finishing / Technique

Last date of inventory	2006		
OBSERVATIONS			
The back of the table function as candle depository			
SOURCE OF INFORMATION

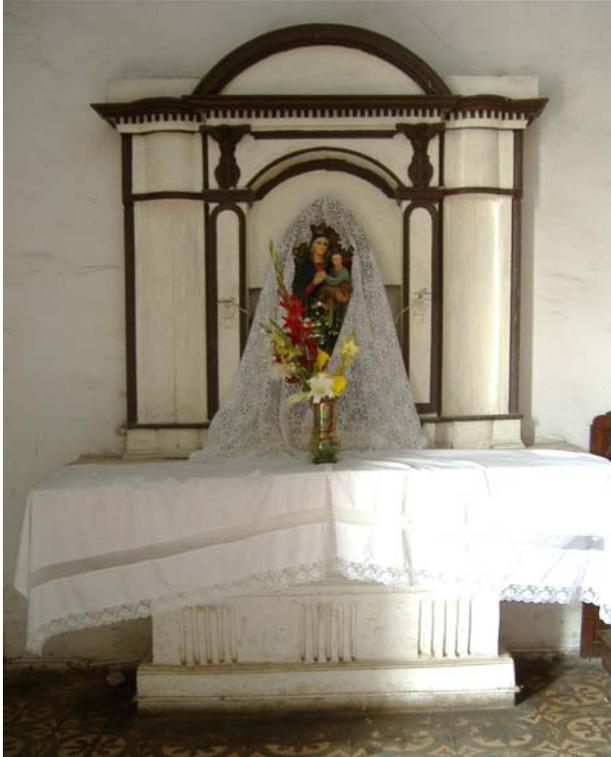
Frontal view			
DESCRIPTION			
Former Altar of St. Isidore The Farmer The table made of adobe. The upper side, is a wooden vaulted niche side by two pilaster bellow a curved tympanum decorated with a dentil course, where stands Our Lady of Perpetual Help			
HISTORICAL INFORMATION			
Author(s)		Style	Neoclassical
Donor		School	
TECHNICAL INFORMATION			
Height	2..26 m.	Material	Mud & Wood
Width	0.87 m.	Support	Mud & Wood
Length	1.10 m.	Technique	Mud & Wooden carpentry
Diameter	.	Finishing / Technique	White & golden enamel paint

Weight		FRAME	
STATUS		Material	
Conservation Status	Good	Form / Style	
Integrity	Complete	Finishing / Technique	
Last date of inventory	2006		
OBSERVATIONS			
The back of the table function as candle depository			
SOURCE OF INFORMATION

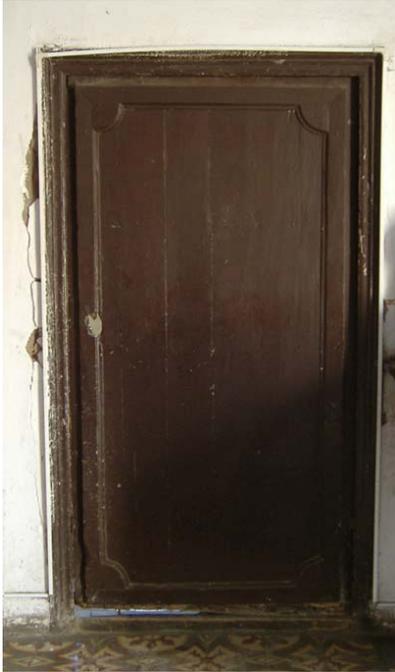
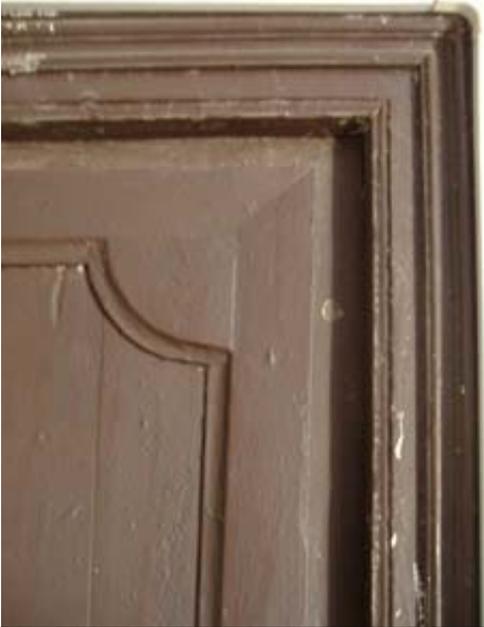
Frontal view from the nave		Casement & door detail	
DESCRIPTION			
Door that connects the Nave with the baptistry Has a frame with a casement that faces the nave			
HISTORICAL INFORMATION			
Author(s)		Style	
Donor		School	
TECHNICAL INFORMATION			
Height	1.95 m.	Material	Wood & metal
Width	1.20 m.	Support	Wood
Length	.010 m.	Technique	
Weight	.	Finishing / Technique	Painted in brown
Number	1	FRAME	
STATUS		Material	Wood
Conservation Status	Regular	Form / Style	
Integrity	Complete	Finishing / Technique	Painted in brown

Last date of inventory			
OBSERVATIONS			
Conserves its original hinges			
SOURCE OF INFORMATION

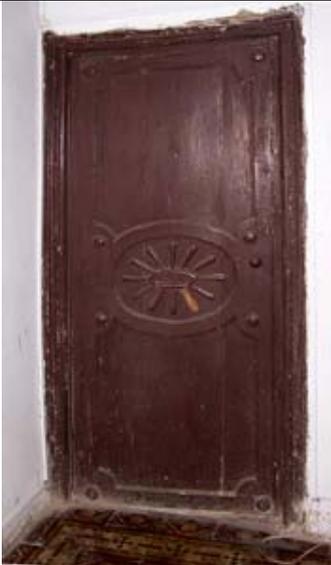
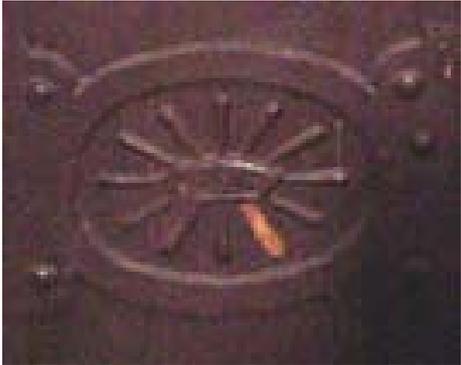
Frontal view from the presbytery		Detail	
DESCRIPTION			
Door that connects the presbytery with the sacristy in the gospel side Has a frame, a casement and a stylized sun attached in the middle panel that faces the presbytery			
HISTORICAL INFORMATION			
Author(s)	Unknown	Style	Art deco
Donor	Unknown	School	
TECHNICAL INFORMATION			
Height	1.96 m.	Material	Wood & metal
Width	0.94 m.	Support	Wood
Length	.010 m.	Technique	
Weight	.	Finishing / Technique	Painted in brown
Units	2 (1 is lost)	FRAME	
STATUS		Material	Wood

Conservation Status	Regular	Form / Style	
Integrity	Incomplete	Finishing / Technique	Painted in brown
Last date of inventory	2006		
OBSERVATIONS			
One of the doors, the one in the epistle side, were replaced after being totally eaten by the moths One of the rays of the sun had decay			
SOURCE OF INFORMATION			
Oral information
