ANNEX 5

File inventory of the collection (valuable goods)

Universidad Católica Sedes Sapientiae		CHURCH OF ST. PETER OF CARABAYLLO	
		INVENTORY OF PIECES	
		SEQ Code	PC-001/93
		INC Code	V-2,1/B-56/6 - INC
LOCATION		UCSS Code	01-001
Precedence		IDENTIFICATION	
Collection	Church of St. Peter of Carabayllo	Name	Eternal Father
Location (former)	Baptistry	Typology	Sculpture
Location (actual)	Unknown	Date	XVIII c.
IMAGES

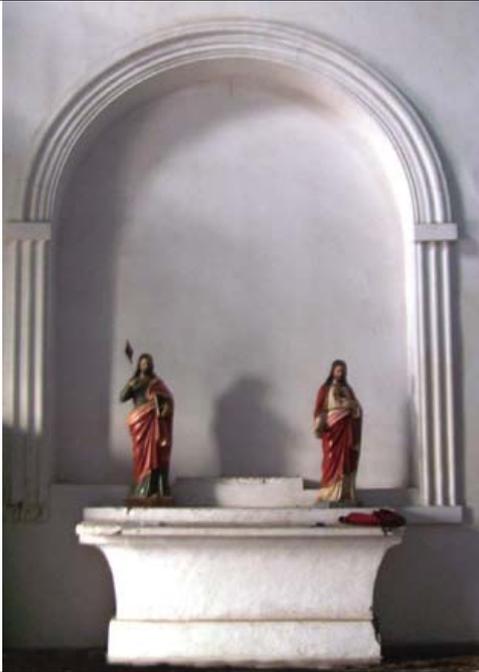
Frontal view			
DESCRIPTION			
Niche in the mud brick wall, with a molding made of cane & plaster The mud table has hand painted tiles is the countertop			
HISTORICAL INFORMATION			
Author(s)		Style	Neoclassical
Donor		School	
TECHNICAL INFORMATION			
Height	5.40 m.	Material	Mud & plaster
Width	4.30 m.	Support	Mud
Length	1.15 m.	Technique	Mud bricks & cast plaster
Diameter	.	Finishing / Technique	Lime paint
Weight		FRAME	
STATUS		Material	Material
Conservation Status	Regular	Form / Style	Cast plaster
Integrity	Complete	Finishing / Technique	Lime paint

Last date of inventory			
OBSERVATIONS			
The moldings seems to be modern, doesn't follow any classical scheme The table has a notorious addition in the left side, to gain asymmetry with the niche			
SOURCE OF INFORMATION

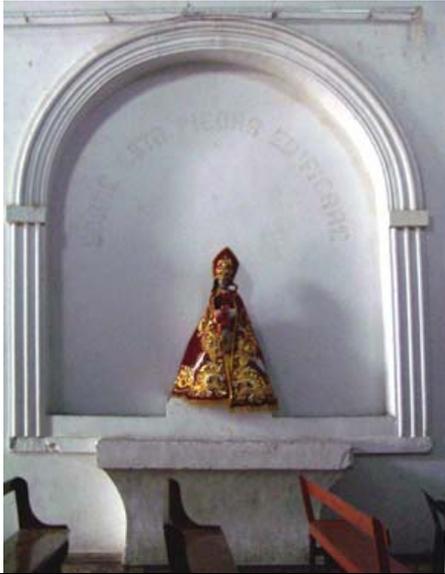
Frontal view			
DESCRIPTION			
Niche in the mud brick wall, with a molding made of cane & plaster The mud table has hand painted tiles is the countertop			
HISTORICAL INFORMATION			
Author(s)		Style	Neoclassical
Donor		School	
TECHNICAL INFORMATION			
Height	5..40 m.	Material	Mud & plaster
Width	4.30 m.	Support	Mud
Length	1.15 m.	Technique	Mud bricks & cast plaster
Diameter	.	Finishing / Technique	Lime paint
Weight		FRAME	
STATUS		Material	Material
Conservation Status	Regular	Form / Style	Cast plaster
Integrity	Complete	Finishing / Technique	Lime paint

Last date of inventory			
OBSERVATIONS			
Reconstructed, the moldings seems to be new, doesn't follow any classical scheme			
SOURCE OF INFORMATION

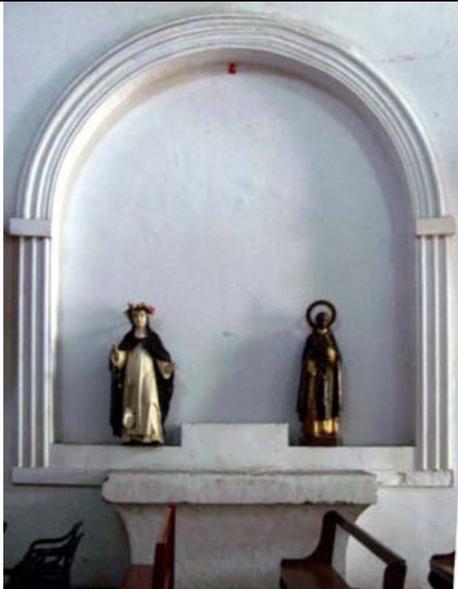
Frontal view			
DESCRIPTION			
Niche in the mud brick wall, with a molding made of cane & plaster The mud table has hand painted tiles is the countertop			
HISTORICAL INFORMATION			
Author(s)		Style	Neoclassical
Donor		School	
TECHNICAL INFORMATION			
Height	5..40 m.	Material	Mud & plaster
Width	4.30 m.	Support	Mud
Length	1.15 m.	Technique	Mud bricks & cast plaster
Diameter	.	Finishing / Technique	Lime paint
Weight		FRAME	
STATUS		Material	Material
Conservation Status	Regular	Form / Style	Cast plaster
Integrity	Complete	Finishing / Technique	Lime paint

Last date of inventory			
OBSERVATIONS			
Reconstructed, the moldings seems to be new, doesn't follow any classical scheme			
SOURCE OF INFORMATION

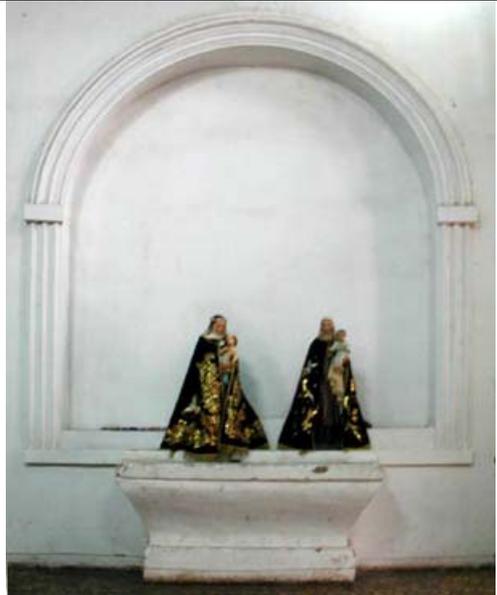
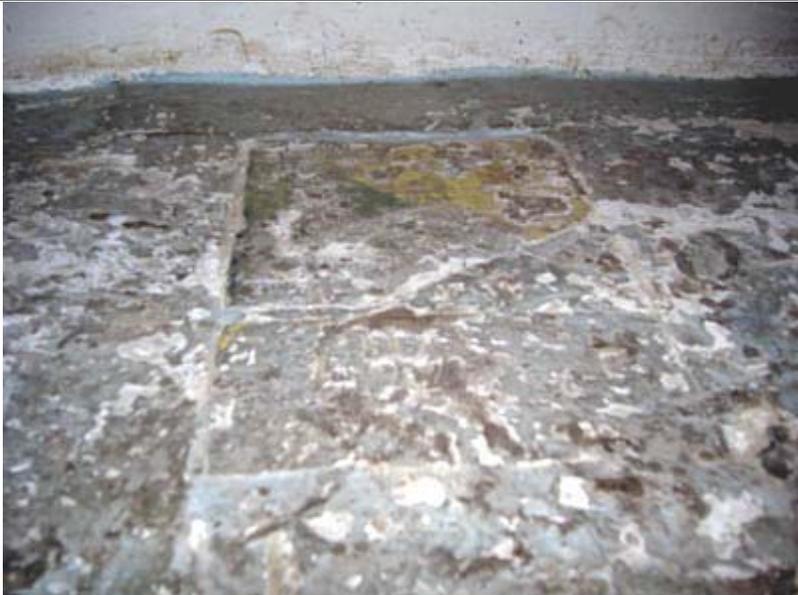
Frontal view		Tile detail	
DESCRIPTION			
Niche in the mud brick wall, with a molding made of cane & plaster The mud table has hand painted tiles is the countertop			
HISTORICAL INFORMATION			
Author(s)		Style	Neoclassical
Donor		School	
TECHNICAL INFORMATION			
Height	5..40 m.	Material	Mud & plaster
Width	4.30 m.	Support	Mud
Length	1.15 m.	Technique	Mud bricks & cast plaster
Diameter	.	Finishing / Technique	Lime paint
Weight		FRAME	
STATUS		Material	Plaster
Conservation Status	Regular	Form / Style	Cast plaster

Integrity	Complete	Finishing / Technique	Lime paint
Last date of inventory			
OBSERVATIONS			
Reconstructed, the moldings seems to be new, doesn't follow any classical scheme			
SOURCE OF INFORMATION
