# La Parroquia Santa Cruz de Roma (The Holly Cross of Rome Church), Panchimalco, El Salvador

## Guidelines for a Conservation Plan

*Celina Ganuza Durán*

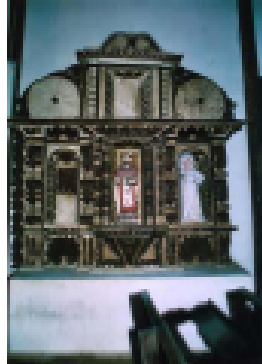
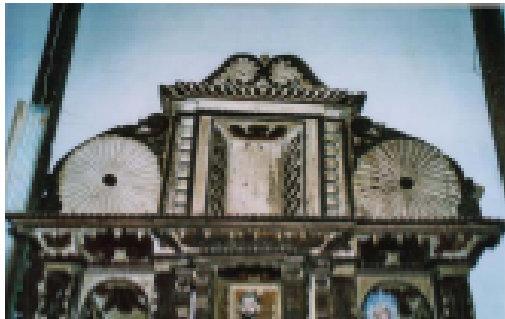
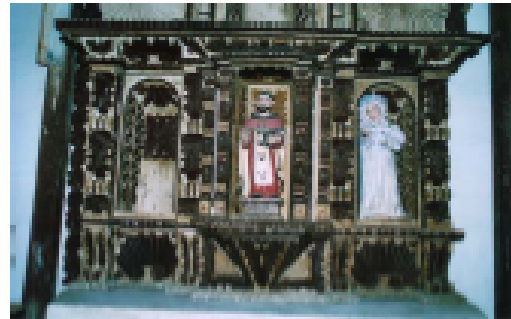
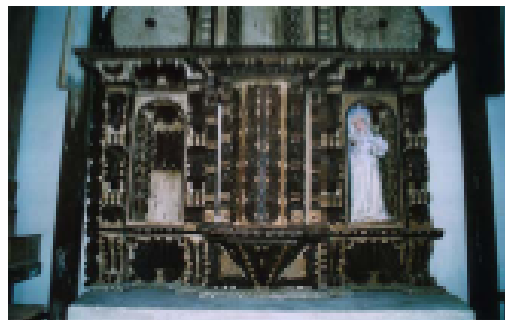
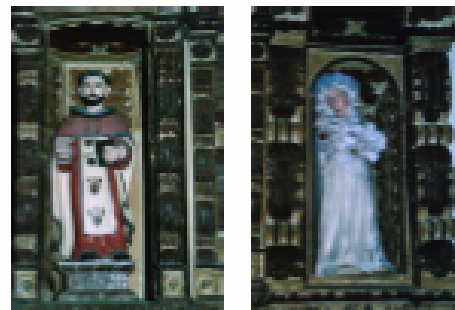
<b>ESTADO DE CONSERVACIÓN.</b> (Incluir datos como piezas faltantes, desprendimientos del color o de la textura, perforaciones, corrosión, etc.) El Retablo se encuentra en regular estado de conservación. Presenta desprendimientos del color, daños ocasionados por las termitas y piezas e imágenes faltantes. Se observa suciedad y polvo en todo el retablo.	
<b>TRADICIONES Y COSTUMBRES:</b> (Anotar si el Bien esta relacionado con un ritual público)	
<b>BIBLIOGRAFÍA:</b> (publicaciones relacionadas con el Bien Mueble) 1º Ficha de Inventario de Bienes Culturales Inmuebles, IBCI - CONCULTURA. 2º Esquema de Planta Arquitectónica, Inventario de Bienes Culturales Inmuebles, IBCI - CONCULTURA.	
<b>LEVANTAMIENTO DE CAMPO:</b> Arq. Ana Mercedes Salazar, Arq. Alicia Pino de Monge, Sr. José C. Torres	<b>FECHA DE LEVANTAMIENTO:</b> 27 de Febrero de 2007 <b>FOTOGRAFÍA:</b> Sr. José C. Torres
<b>ELABORACIÓN DE FICHA:</b> Arq. Alicia Beatriz Pino de Monge	<b>FECHA DE ELABORACIÓN:</b> 27 de Marzo de 2007 <b>REVISÓ:</b> Arq. Ana Mercedes Salazar
