Reclaiming the Sounds of Silenced Walls: Urla Design Library

Tevfik Balcioglu

Izmir University of Economics

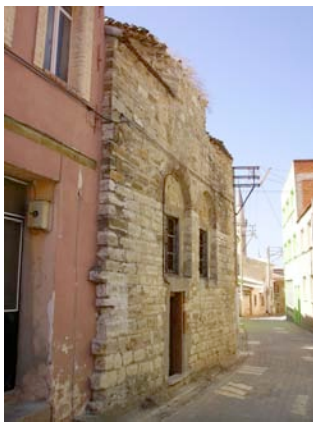
East Elevation,
Blocked

Unfortunately, whole of this facade is unrevealed because of the neighbouring building.

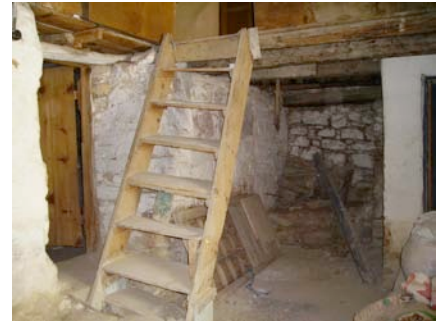
Entering from the second door in the middle of the interior wall, the second volume appears to be empty. The wooden door was again a later addition. The only eye catching detail is the gap on the right half of the west facade wall which was filled with stone. Since the exterior side of the wall was hidden behind the neighbouring building, further research about the reasons behind this attitude and even the use of west facade was left to a later date. Nevertheless, one of the most possible location of the original entrance was probably on the west facade.

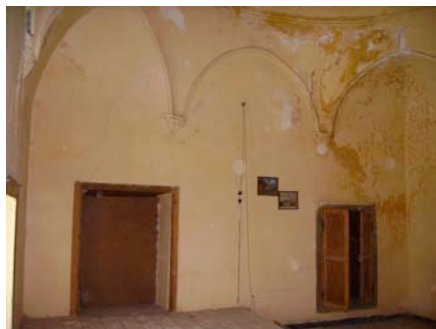
First floor, East view

The east wall has two gaps with different dimensions. The first gap has a wooden frame and no shutters. The second gap is also wooden but there are two shutters on the each side. They might have been used as storage cupboards, but from the exterior which is totally closed by the neighbouring building, the unrevealed parts might tell more about the original form and functions in later studies.

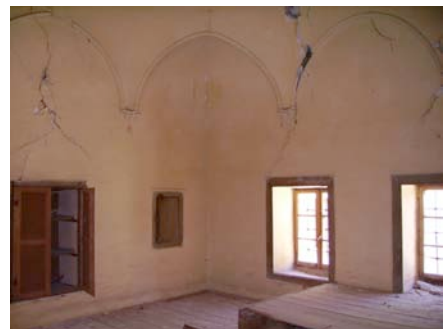
First floor, South-west view

The west wall again has three gaps. The one in the middle is a wooden cupboard, but from the exterior an arch can be seen which requires further examination. It is probably another window, but closed at a later date. On the left and right side of this cupboard, there are two small gaps. One is rectangular and wooden with a shutter, and the other has an arch. The function was probably to hold a candle inside these gaps.

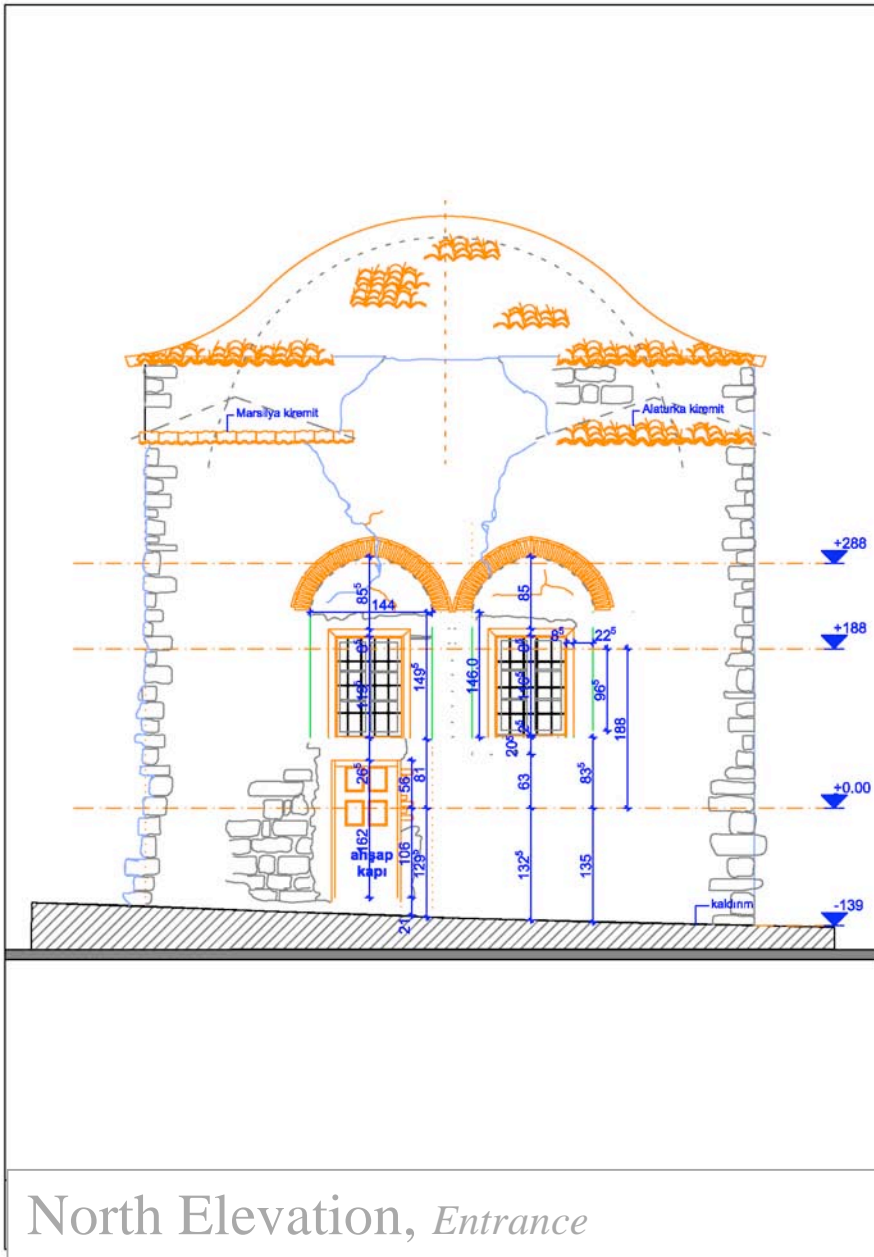
North Elevation, *Entrance*

The settlement pattern and the structure of Kapani Street has important information that north elevation of the existing building was not the original entrance facade. In addition, there is no real evidence to conclude that there was even a street on the northern side. Recent repairs around the door, down to the materials used, has proved that originally there was not an opening on that elevation used as an entrance.

There are two brick arches on the north façade and they are connected only on this facade. The original function of the arches should be questioned. They could either define the windows or share the load of the dome since the polygon that connects the circular shape of the dome to the rectangle beneath has eight feet two of which are on this facade. Moreover, the wooden framed windows might have been constructed later than the original openings were formed, because the arches were filled with stone different than the upper level type and later covered with mortar which makes it difficult to give an exact reason.

No deformation related to damp (such as mold growth) has been observed at the bottom level of the wall. This may point out that no underground water existed close to that site. A color-change on the upper northwest corner of the wall was obviously soot probably caused by an external chimney or an oil lantern.
