SAN FRANCISCO LEARNING CENTER GABALDON CONSERVATION

THE DOCUMENTATION / CULTURAL HISTORIC VALUES

EXISTING CONDITION

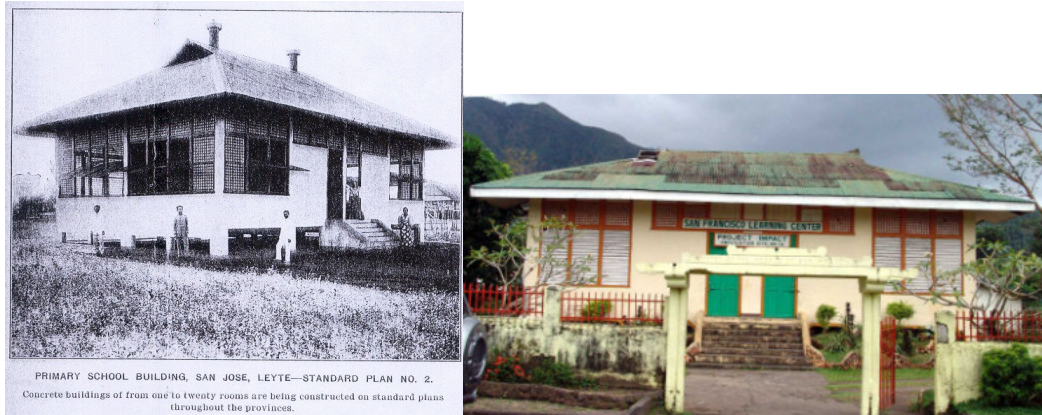
Fig. 3 Old Picture Type 2 Gabaldon (Left) & existing Type 2 Gabaldon San Francisco Learning Center, Albay

no available old picture of the building itself but other schools of the same type were found that was used also as basis for the restoration of the façade.

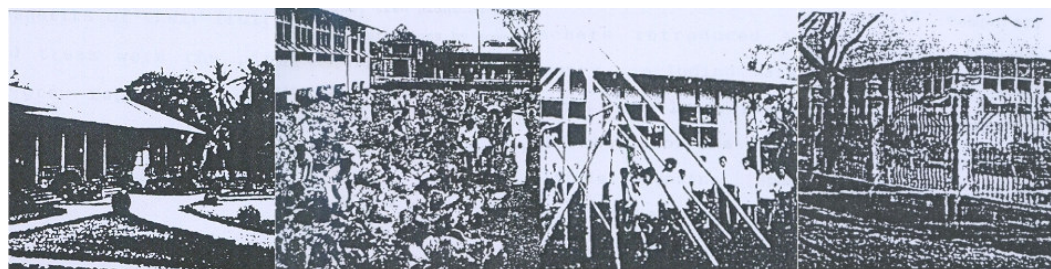
Fig . 5 Old Pictures of (from left to right) Front lawn landscaping, Garden, Playground & fence

The building is located at the main entrance of the school & offset by 20 mtrs from the street. It has a front lawn & a central driveway. New landscaping is placed already in the front of the building. The site has retained big open playfield at the back portion & gardening & nursery are located at the back part of the lot. See Fig. 5 for the old pictures of a typical Gabaldon site.

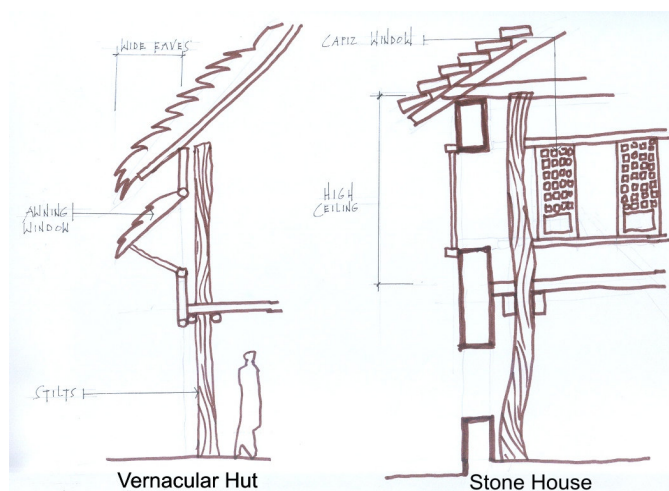
Fig.9 Design Ideas extracted from existing structures

The conservation work will take into account the original intent of the design of the Gabaldon School that is a **School CONDUCIVE TO LEARNING in order to teach & prepare Filipinos the ideas of good citizenship & governance. The design of the building maximizes natural air ventilation for the students to have a cool & pleasant environment.** This is achieved by providing high ceiling for hot air to go up, awning windows to take 100% air flow & raised flooring for air to circulate around the building. The students experienced also visual comfort as they are not hit directly by sunlight. The capiz shells in the windows produced a pleasant opalescent light. The school building was built to be last a long time by using durable materials. It was also ECONOMICAL as it used local materials, employed local workers & accepted volunteer students & locals to help in the construction at the same time value engineering was introduced. The building was designed to be termite-free even if it's made of wood. This is done by raising the floor so that the columns below can be checked if termites are going up to the structure. The site still has the characteristics of having an imposing structure as it has retained the wide front lawn & open playfield at the back. Retaining it will be useful in educating the people that intellect can be gain not through number of school buildings but through how conducive to learning the place is. These ideas have to be considered in the conservation program of the Gabaldon School.

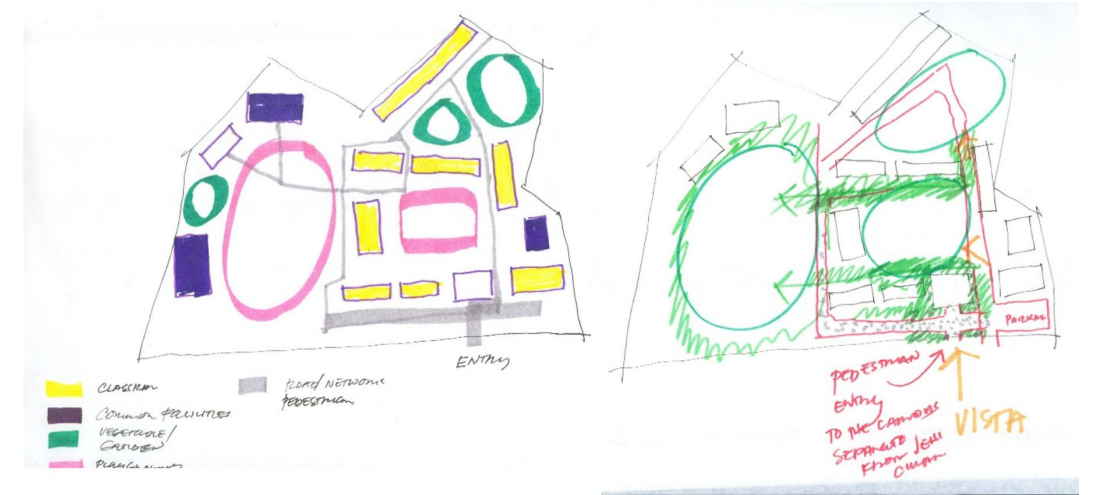
Fig. 12 Schematic study of the School Campus Historical Development & Conservation

Before the conservation planning started, it was kept in mind the values & original intent of the building in order to come up again with a conducive learning environment. Schemes for the plan of the building & immediate site development were proposed to the central Office & also to the stakeholders of the school & they readily approved it. It is important to come up with a master plan for the campus in order to prevent construction of new building without respect to a historical building, worse they might even put up buildings in front of the old building as what happened to other old structures in the country. In order to come up with a master plan for the campus, History of construction of the buildings were analyzed and even without any written documents, the school officials agreed on the stages of the construction. From this analysis, the building growth & pattern were produced. Basing from historical data that the Gabaldon is the center piece of a site, the analysis proved that as the other buildings were constructed around the original Gabaldon School. See Fig. 12.
