Methods and Strategies in the Rehabilitation of the Luneta Hotel

Rehabilitation and Adaptive reuse

John Joseph T. Fernandez, MSArch.

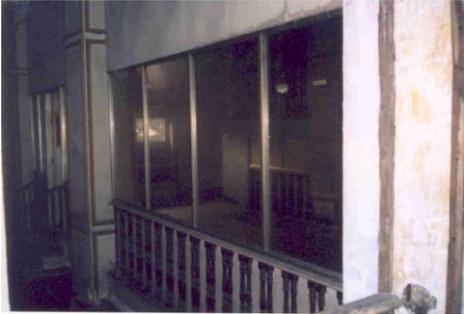
Fig. 19 Elevated Lobby Restaurant

As one enters the lobby, one can't help noticed the difference in floor elevation between the sidewalk and the lobby. This negative change of elevation of the lobby floor was brought about by the several changes in elevation of the T.M. Kalaw st.. (see figure 35)

Left of the lobby is a raised enclosed area which served as a restaurant. A section of this restaurant is also elevated. These restaurants were constructed of wood materials and clearly was a poor remedy of elevating these area to avoid flood waters in the lobby, during rainy days. (see figure 36)

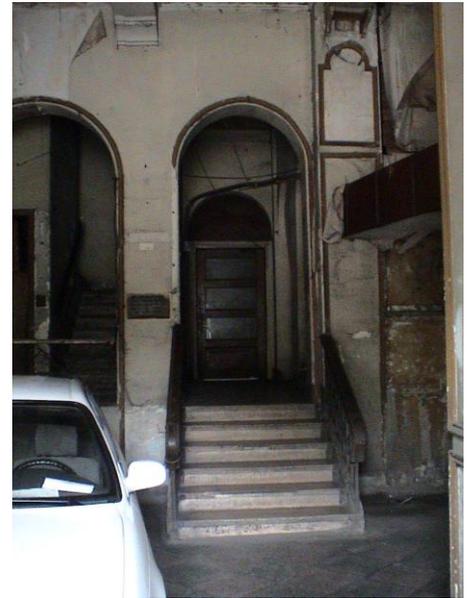
Fig. 22 Elevator Lobby staircase

To access the upper floors one may use the elevator or the staircase which ran around the elevator shaft. (see figure 41 and 42) The narrowness and darkness within the stairwell despite the presence of light clearly shows that the elevator in fact was not originally to the building. These strengthen the earlier claim regarding the raising of the elevator lobby to accommodate the elevator. Based on old *Figure 40 As-built plans of the 1st floor of the Luneta Hotel 1910 and 1930 pictures, the building used to have an atrium above the staircase. Should this have been maintained the stairwell without the elevator would have been well lighted. The addition of the elevator also created an obtrusive element on the sixth floor, the elevator machine room.*

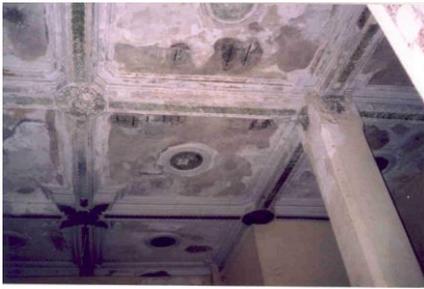
Fig. 26 Ceiling Pattern

One noticeable feature of the rooms is the ceiling design. (see figure 44) Each room has a similar pattern which also grids not only the room but the entire floor. And if one follows the pattern of the ceiling, one can easily detect walls that were not original to the designs due to the interruption of the patterns. This was evident to all the rooms with toilets wherein the patterns are abruptly terminated by a wall of the toilet. Often ceiling medallions are also covered by the additional walls. The termination of the toilet walls inside the rooms in relation to the ceiling patterns also proves that indeed the toilets were not part of the original building and was a later addition. A typical floorplan of the 2nd to the 4th floor has been provided for easier orientation within the building. (see figure 44)

One conspicuous addition to every floor was the presence of 4 additional rooms found in the front and rear side of the building, referred to as bdrm 7,6,13 and 14 in the 2nd to 4th floor plan. (see figure 44) Based on the ceiling pattern earlier mentioned it could be seen that the four rooms are later additions. (see figure 45)
