**Conservation and Maintenance plan for
Residential buildings within the
Main Dutch Fort of Matara
Matara, Sri Lanka**

**Presented
at
SIDA' s International training Programme
Conservation and Management of Historic Buildings
Phnom Penn, 20th February 2006**

**By
Ms. Shanthini Balasubhramaniam
University Of Moartuwa,
Sri Lanka**

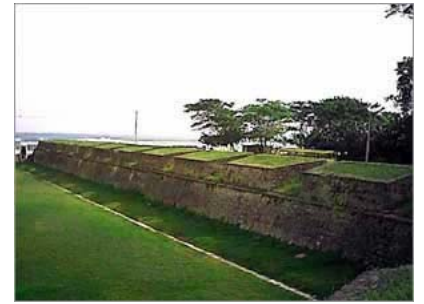
Fig. 10. The Rampart

The rampart with its north bastion, central projection and gun embrasures remains same to date. They are in a fair state of preservation. However the half bastion in the south adjoining the sea has been demolished and a costal road built. Also it has been mentioned that there had been a ditch in front of the rampart and a draw bridge across the ditch at the gate. These had been dismantled in the early 19th century hence they no longer exist.

The rest of the rampart is maintained by the Department of Archeology. The rampart also has parasite plants growing on its walls. These need to be eradicated.

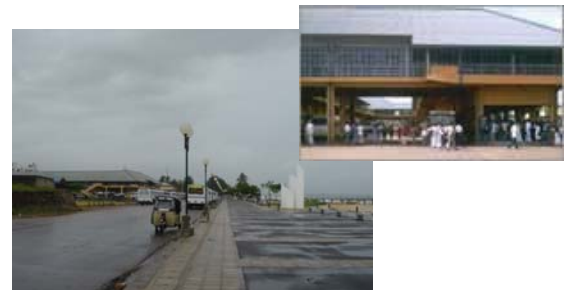
Historically in front of the rampart the Dutch company is said to have had an oblong vegetable garden and a guard hut of the lascars, native soldiers. Today the vegetable garden and the open area in front have been turned into a sports stadium and a bus terminal. These functions and building scales of the bus stand and stadium grandstand have disturbed the visual landscape.

Fig. 16. The Bus terminal

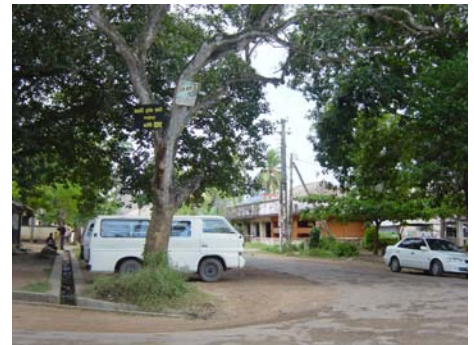
The grid iron street pattern a characteristic of Dutch street layout is not strongly visible in the Main Dutch Fort. They follow the natural topography of the land. The streets are narrow and catered to the pedestrians and an occasional horse carriages or bullock cart. However today the motorized vehicles have taken over these roads. Add to the vehicles the services such as telephone and electricity cables and post take up further space making the road feel small and non pedestrian friendly. These are also visible polluters of the environment. The parking of in administrative buildings and the residential vehicles too has become an issue.

Fig.19. The visual polluters.

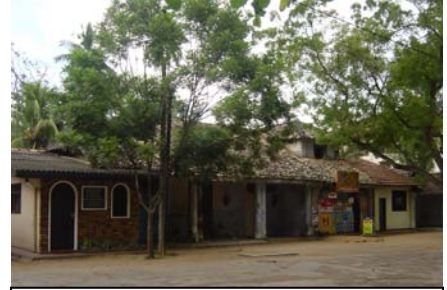
Fig. 26. The modern façade to a dutch street houses

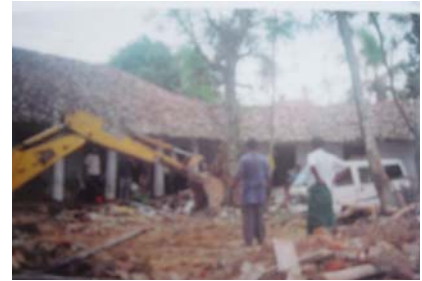
Fig. 34. Then. Days after the Tsunami

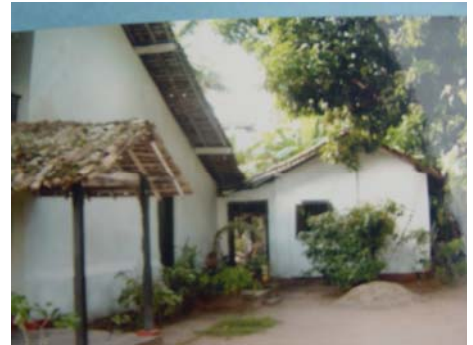
Fig. 45. Wijetunga walawwa Before the tsunami . Note the building at the side.

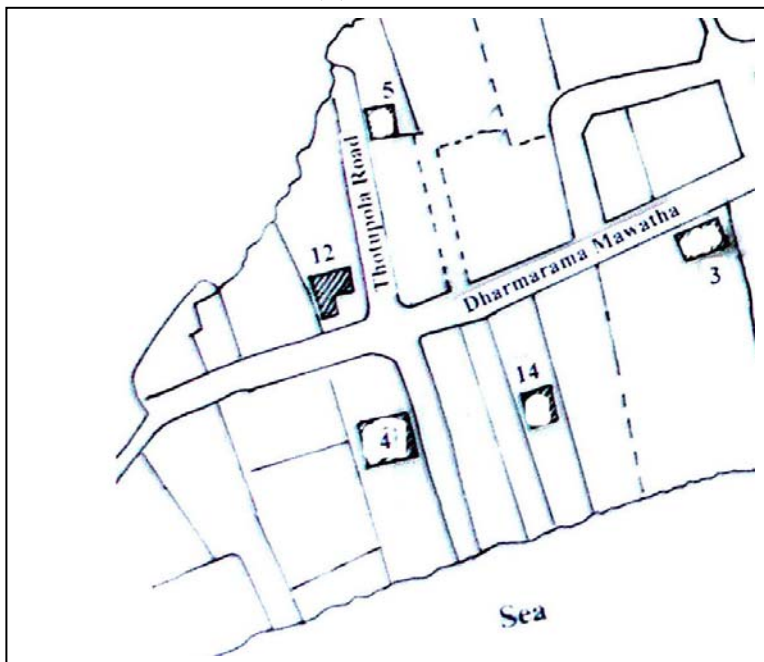
01	Name of the Building	House (Wijethunga Walawwa)	
02	Address / Location	Mr. A H Benat De Silva, No.78, Dharmarama Mawatha, Kotuwa , Matara	
03	Historical Significance	150 years old	
04	Socio – Cultural background	An upper middle income dwelling at present.	
05	Architectural Value	Dutch Town House – Verandah type	
06	Date / Period of Construction	150 years	
07	Date / Period (s) of subsequent interventions	2005	
08	Architect / Creator of the project		
09	Original Usage	House	
10	Present usage	House	
11	Original owner	Ms. Wilment P Wijethunga	
12	Present owner	Name	Mr. A H Benat De Silva
13		Address	No.78, Dharmarama Mawatha, Kotuwa , Matara
14		Telephone No.	22 27548
15		Email	
16		Approximate site Extent.	45 perches
17	Present condition of the Building. Damages in terms of percentages.	Roof	20%
18		Walls	20%
19		Doors and Windows	10%
20		Floor	25%
21		Foundations	
22		Other Building Elements	5%. Part of the house has been totally destroyed.

23	Recommended Use / Conservation Actions		
24	Identification of building under reference on the Map	12	
25	GPS Reading of the Building	05° 56.629 N, 80° 32.473 E

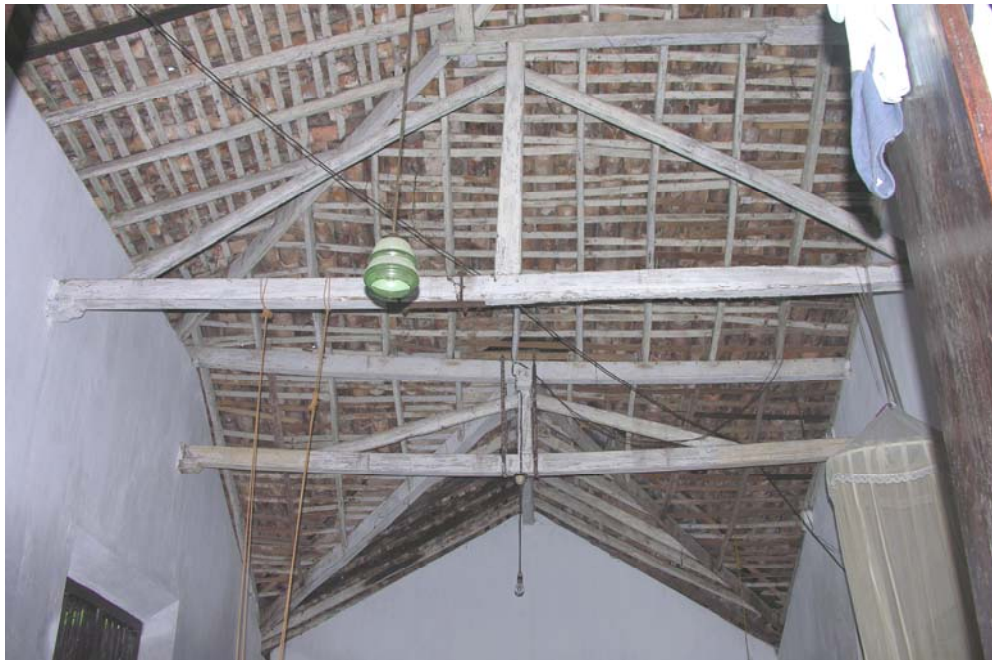
Interior roof structure

1.4.4	Walls	22" tk cabook walls	Cracks are visible – BR1, BR2, K, L	To be checked by a structural eng.
1.4.5	Roof Timber	Timber Truss with 2" x4" exposed rafters with 2"x 1" reepers.	45% of timber needs to be replaced. Some trusses are sagging - K	Provide structural stability to sagging trusses.
