Advanced International Training Programme 2009/10

**CONSERVATION AND MANAGEMENT PLAN OF
SAO BAPTISTA FORT**

SAO BAPTISTA FORT

IBO Island

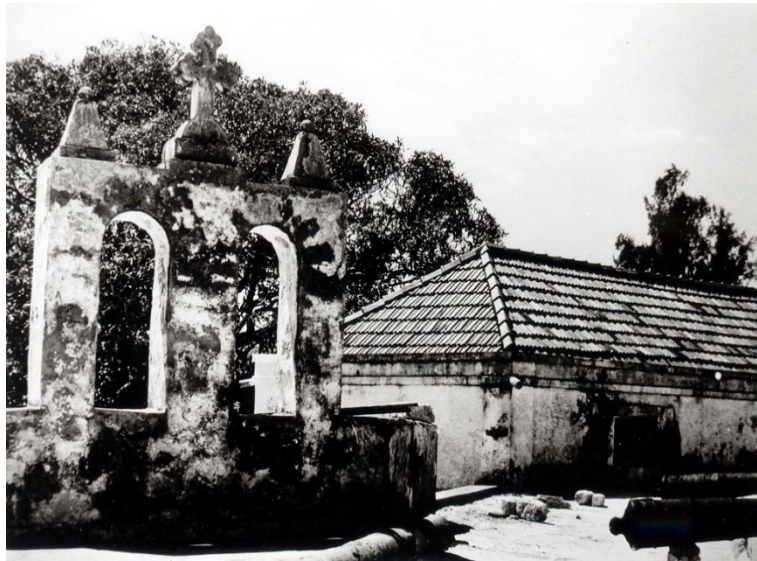
At one time, the building had a double pitched clay tile roof. (Credit)

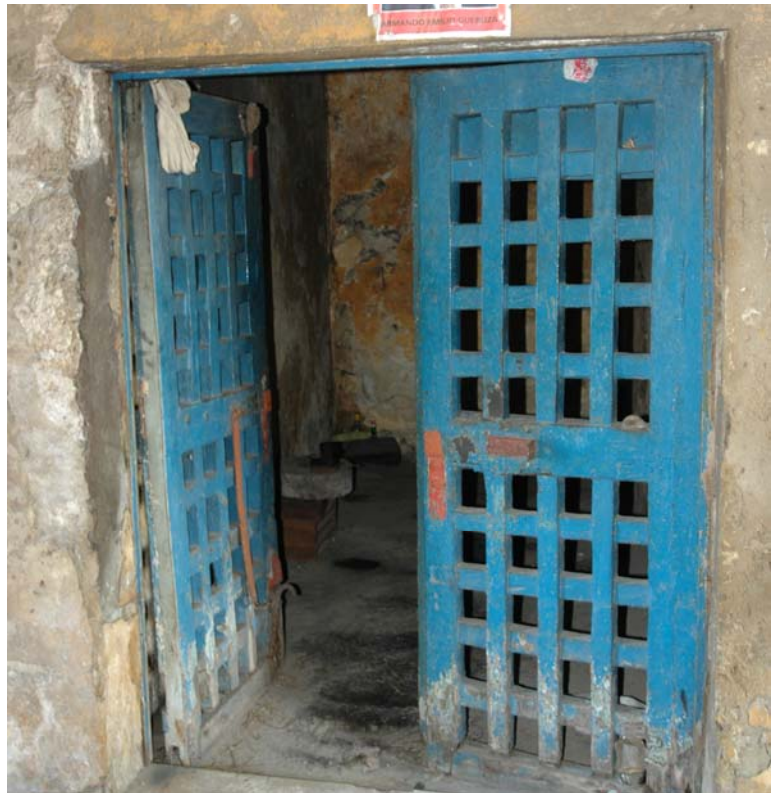
The Two Cells (Prisons) - At the entrance, two small cell rooms are located on the left and right of the lobby. Each cell is about 3m by 1.7m with a high of about 4m. The cells have no windows and the walls are damp and saturated with water and depressing. The timber doors of the cells have regular square slots (100 by 100 mm) which help to ventilate the cells.
