Site of the Proclamation of Philippine Independence

Management Plan for the Emilio Aguinaldo Shrine

Alvin R. Alcid

Senior Historic Sites Development Officer
National Historical Institute

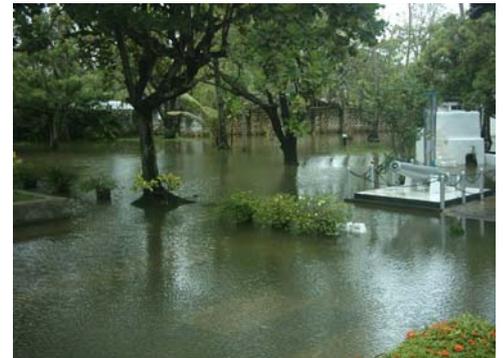
Picture 1- Photo shows the flooded grounds of the Shrine

The municipality of Kawit is a coastal town; it lies just a few inches above sea level. The Shrine itself is located near the *Marulas* River. Kawit is one of the catch basins for water coming from the upland towns of Cavite. But even with this situation, the Shrine has never experienced any problem as regards flooding. However, the rapid development of the upland towns into industrial zones and residential subdivisions resulted in the uprooting of trees and leveling of natural waterways. The negative effects of these developments are being experienced by the municipality and the Shrine during the last five years (see pictures 1 and 2). Today, it is not unusual for the streets of the municipality to be flooded due to occasional high tide even during the summer season. This, coupled with the clogged

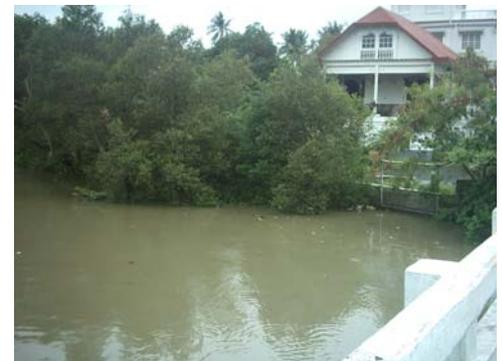
Picture 2 – The Marulas river on the left side of the Shrine

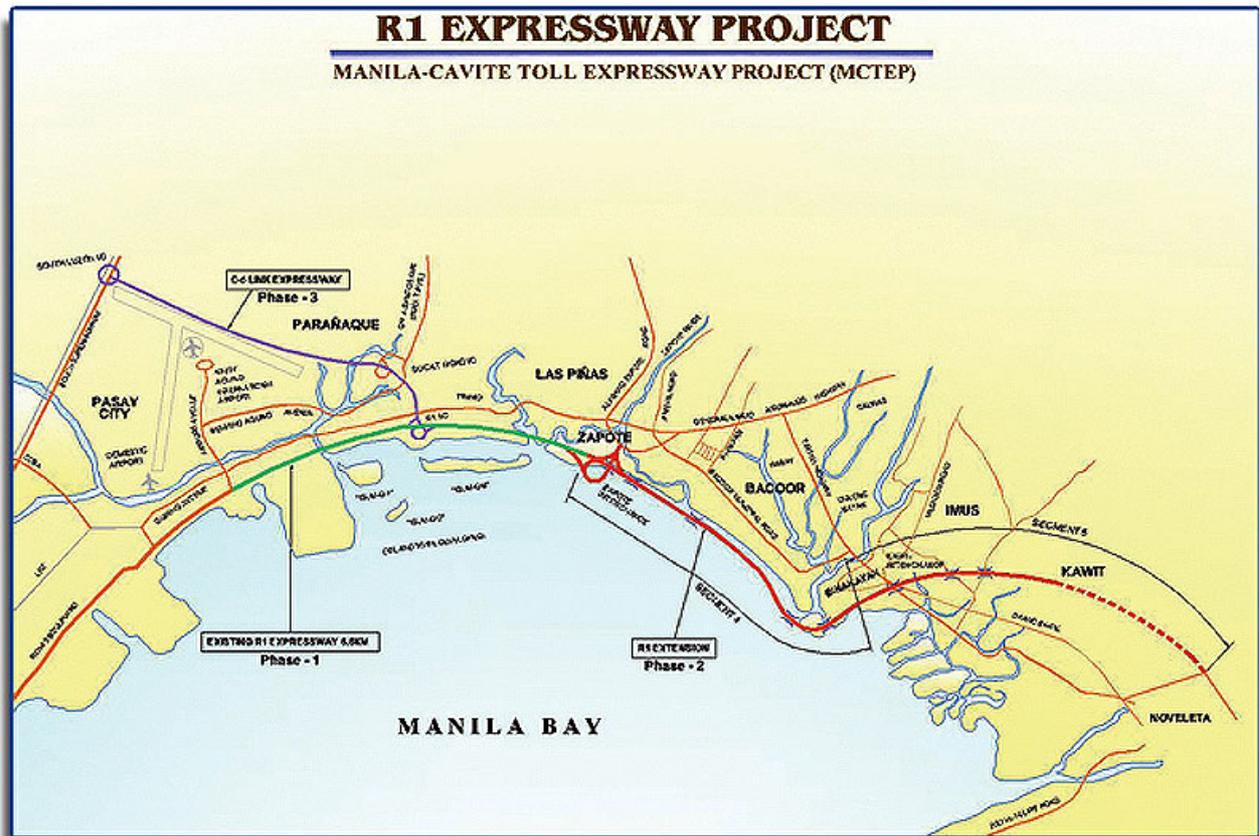
Preliminary Study Report for R1 Expressway Extension Manila - Cavite Toll Expressway Project (MCTEP), Segment 4, Cavite, Philippines

Proposed Expressway Extension – The green line indicates the existing expressway while the red line indicates the expressway extension being developed presently.
