Seat of the First Philippine Republic

Management Plan for the Barasoain Church Historical Landmark

National Historical Institute

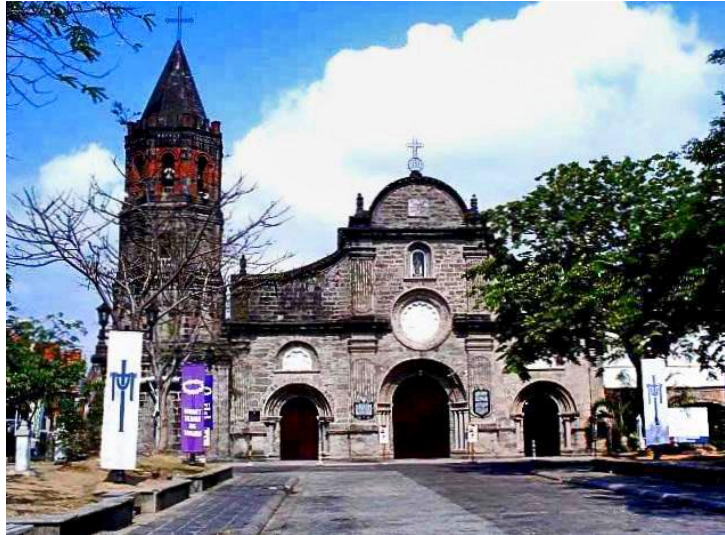
Façade of the Barasoain Church Historical Landmark

The features of the façade are Neo-classic in style. The semicircular pediment is like the opening bar to a symphony of variations on a circle motif. The shoulders of the pediment swing into curvilinear slopes and terminate in the contrapuntal sphere-topped urn finials. The smaller entrances are the repetitions of the main entrance with recessed arches rest on triple columns with graceful cylindrical shafts. The recurring melody is faintly played out in the arched niche on the pediment, which is rendered deep and narrow by the recessed arch and by the slim obscure statue it houses. At present, it continues to function as a church.
